**REAL ESTATE & FACILITIES MANAGEMENT**
Facilities Planning & Development**Hazardous Materials Survey Of:****1305 West 70th Avenue - MARPOLE PLACE****Building Code: 2035****Address: 1305 West 70th Avenue, Vancouver, BC****Surveyor: Patrick Li****Work Notification Number: 10291082****Requested By: Patricia Darling**

**Purpose: ADDITIONAL TARGETED HAZARDOUS MATERIAL SAMPLING****Executive Summary**

HAZARDOUS MATERIAL SURVEY	1305 West 70 th Ave - Marpole Place	DECEMBER 2016
---------------------------	--	---------------

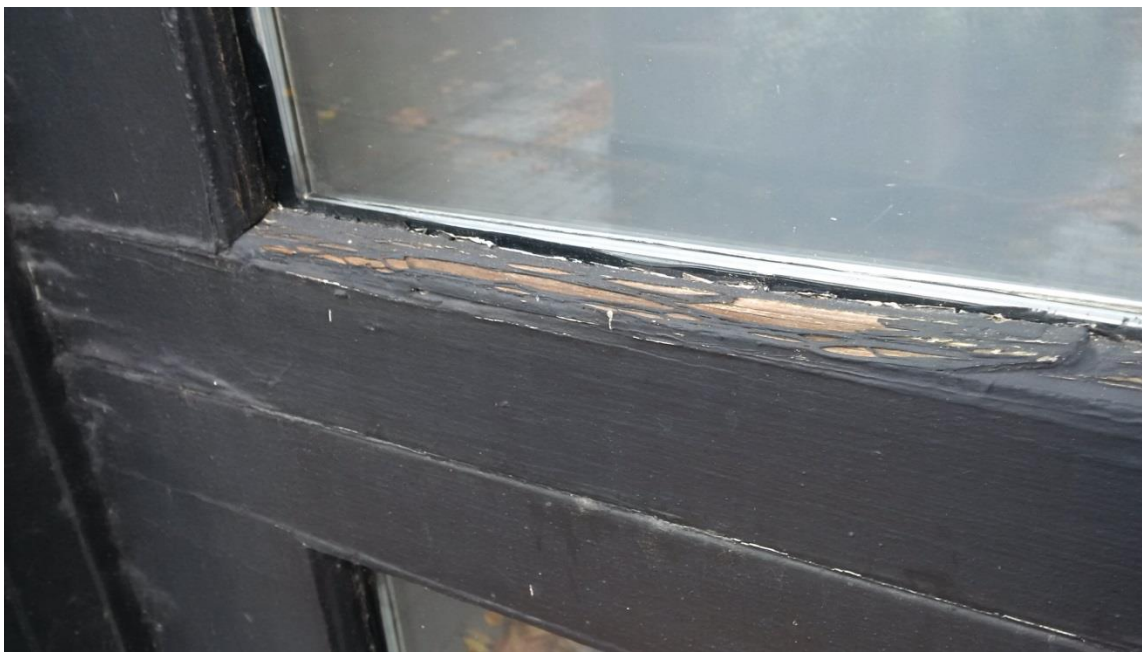
Sample No.	Location	Description	RESULTS (mg/kg)
2035EXT-L03	Exterior Wood Trim	Beige Paint On Exterior Wood Trim	4100
2035EXT-L04	Wooden Garage Doors	Black Paint on Wooden Garage Door	123

Photo1: **Lead Based** Black Paint On Wooden Garage Doors (South East Side of Building).

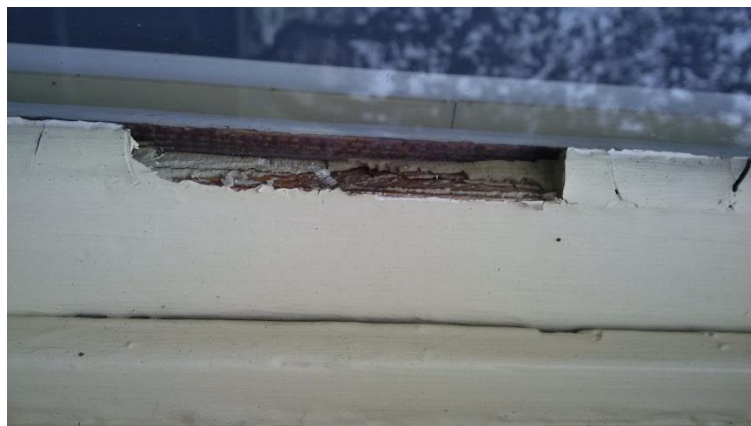
Photo2: **NON-Asbestos** Grey Putty on Exterior Wood Window Frame

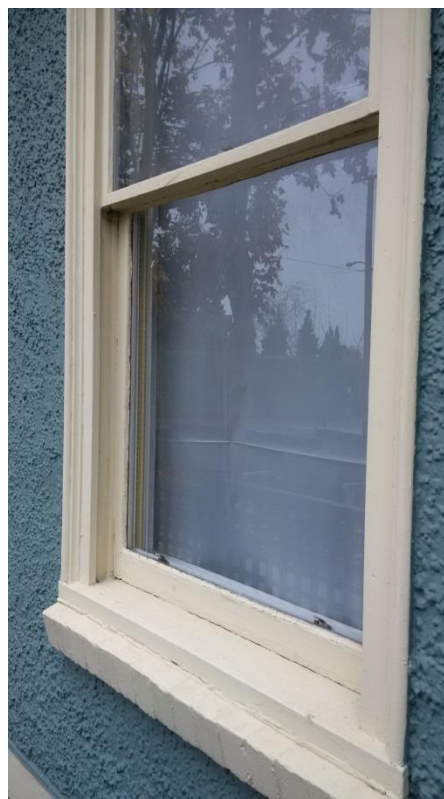
Photo3: **Lead-Containing** Beige Paint on Wood Trim

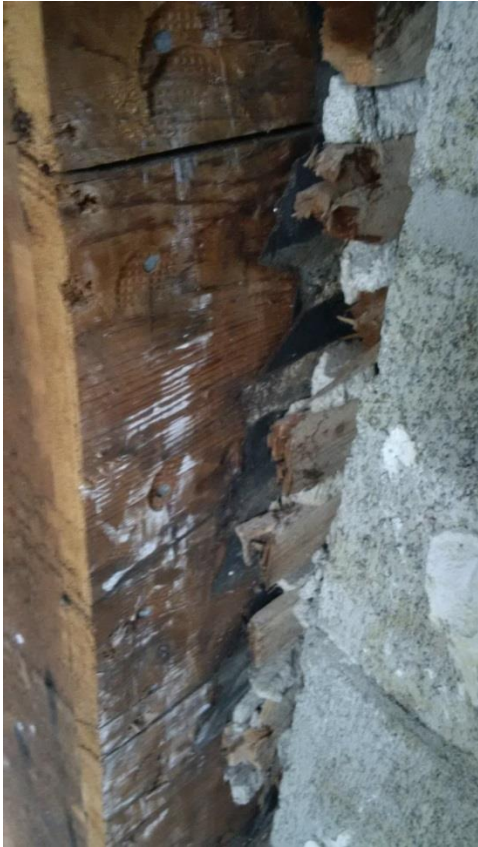
Photo4: NON-Asbestos Black Insulation Paper Behind Exterior Walls

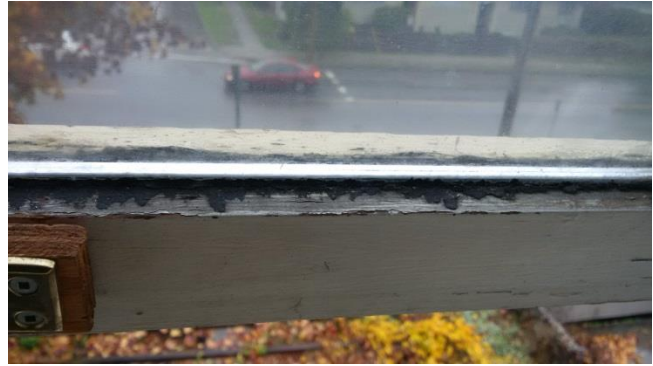
Sample No.	Location	Material	Result
2035EXT-A02	Exterior - SE End	Grey Putty on Exterior Wood Window Frame	Asbestos Fibres Not Detected
2035EXT-A02	Exterior - NE End	Grey Putty on Exterior Wood Window Frame	Asbestos Fibres Not Detected
2035EXT-A04	Exterior Perimeter Walls	Black Insulation Paper Behind Exterior Walls	Asbestos Fibres Not Detected
2035-3KIT-A01	3 rd Floor Kitchen - S Wall	Black Mastic on Wood Framed Windows	10-30% Chrysotile Asbestos

Photo5: Asbestos-Containing Black Mastic on Wood Framed Windows (3rd Floor Kitchen - South Wall)

Prior to renovation or demolition activities, the hazardous materials identified in this report must be safely contained before disturbance. Depending on the areas to be renovated or demolished, additional destructive sampling may be required to identify asbestos-containing materials that were not accessed during this targeted hazardous materials survey.

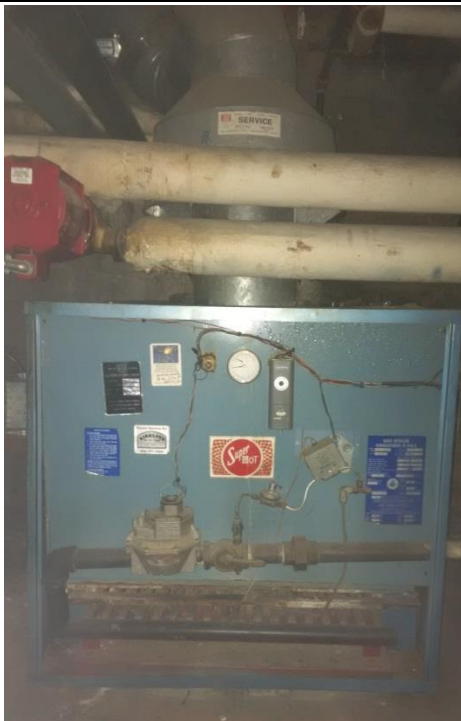
Photo6: Super-Hot Boiler Unit (Furnace Room)

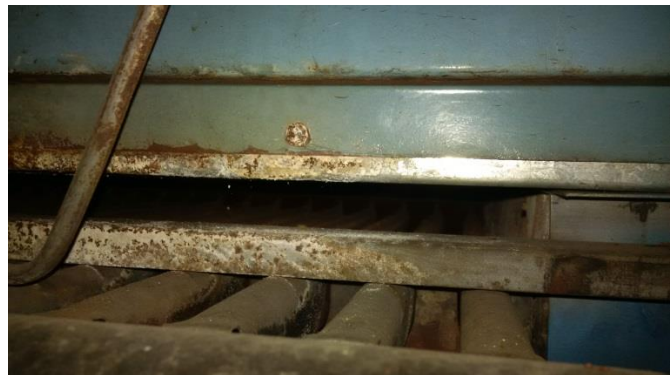
Sample No.	Location	Material	Result
009-A05	(Furnace Room) Inside Left Metal Panel of Super-Hot Boiler Unit	Grey Insulation Material	Asbestos Fibres Not Detected

Photo7: NON-Asbestos Grey Insulation Inside Left Metal Panel of Super-Hot Boiler Unit (Furnace Room)
