# ***SURE Hazmat and Testing***

**Reference: Pre-Renovation Asbestos Roofing Materials Investigation**  
**2090 West 5<sup>th</sup> Avenue, Vancouver, BC**

Ref: 10310-R02

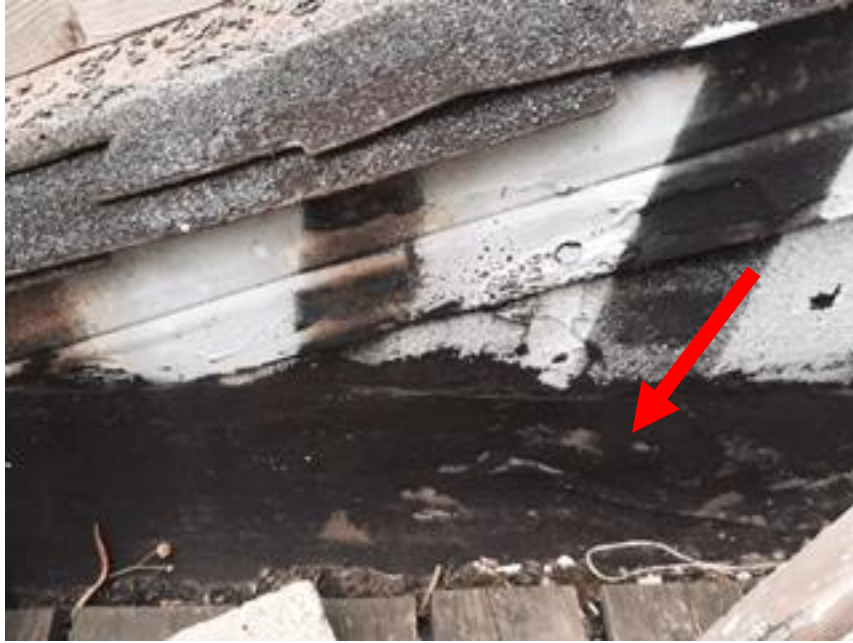
Six (6) samples of black and grey mastic were collected from exterior flashings. All six samples were determined to be asbestos-containing.

- Black/Grey mastic present on flashings and edge of roof shingles and fascia board.

**Photo # 1** – Asbestos-containing mastic

All asbestos-containing materials must be removed prior to demolition activities by a qualified hazardous materials contractor using appropriate work procedures as defined by WorkSafe BC.

During the removal of asbestos-containing flashing mastic, **Moderate Risk** asbestos safe work procedures must be followed, including the following at a minimum:

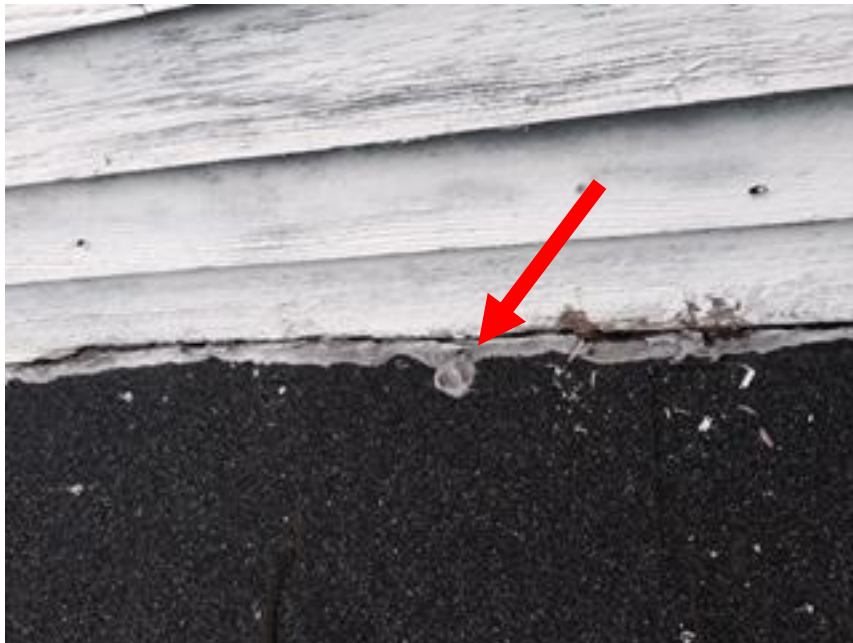
**Photo # 2** – Asbestos-containing mastic
