**Hazardous Materials Survey of 1710 East Kent Ave,  
 Vancouver, BC**
**Sampling Date: 2017-02-24 and 2017-03-10**
**Address: 1710 East Kent Ave, Vancouver, BC**
**Surveyor: Rebecca Yanciw**
**Previous sampling, YEAR (#): N/A**
**Purpose: HAZARDOUS MATERIALS MANAGEMENT SURVEY**
**Executive Summary**

HAZARDOUS MATERIAL SURVEY	1710 East Kent Ave, Vancouver, BC	2017-04-05
---------------------------	-----------------------------------	------------

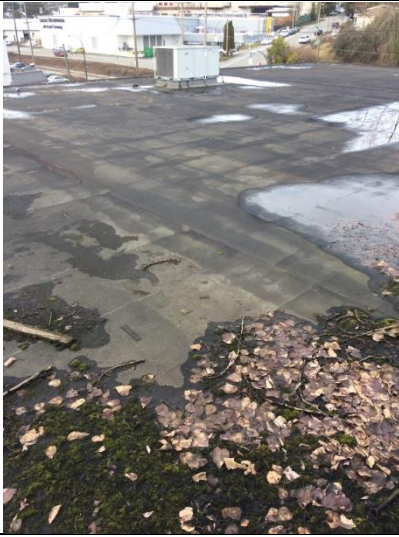
Photo 1: Non-asbestos containing roofing material

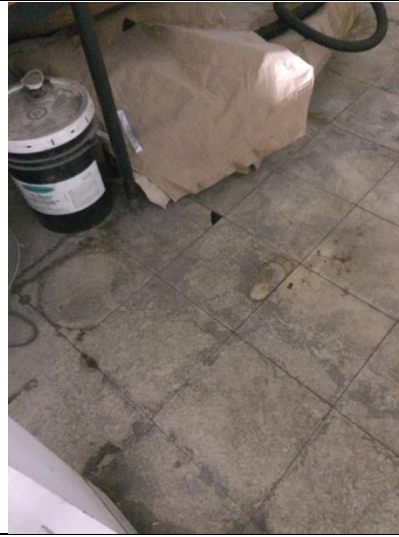
Photo 2: Non-asbestos containing 12" x 12" beige floor tiles with non-asbestos underlying mastic

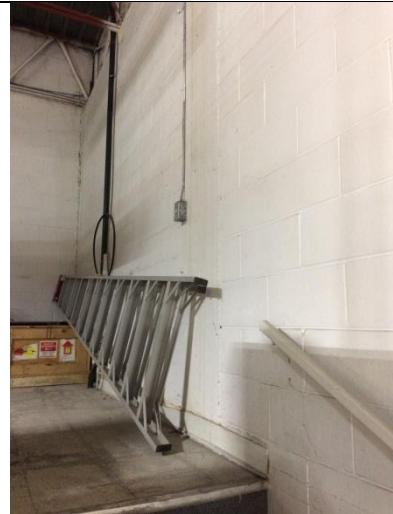
The cinderblock walls may contain vermiculite. The roof wall between 1710 East Kent and 1728 East Kent may have insulation concealed behind the wall. The cinderblock and roof walls are in good condition and do not require immediate action.

Photo 3: Non-lead containing white paint on cinderblock walls. Cinderblock walls may contain vermiculite.

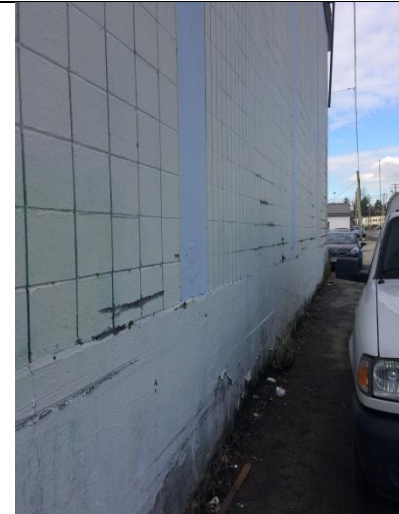
Photo 4: Non-lead containing exterior paint.
