Phase I Environmental Site Investigation

124 Dunlevy Avenue Vancouver, BC

PGL File: 38-23.01

January 2015

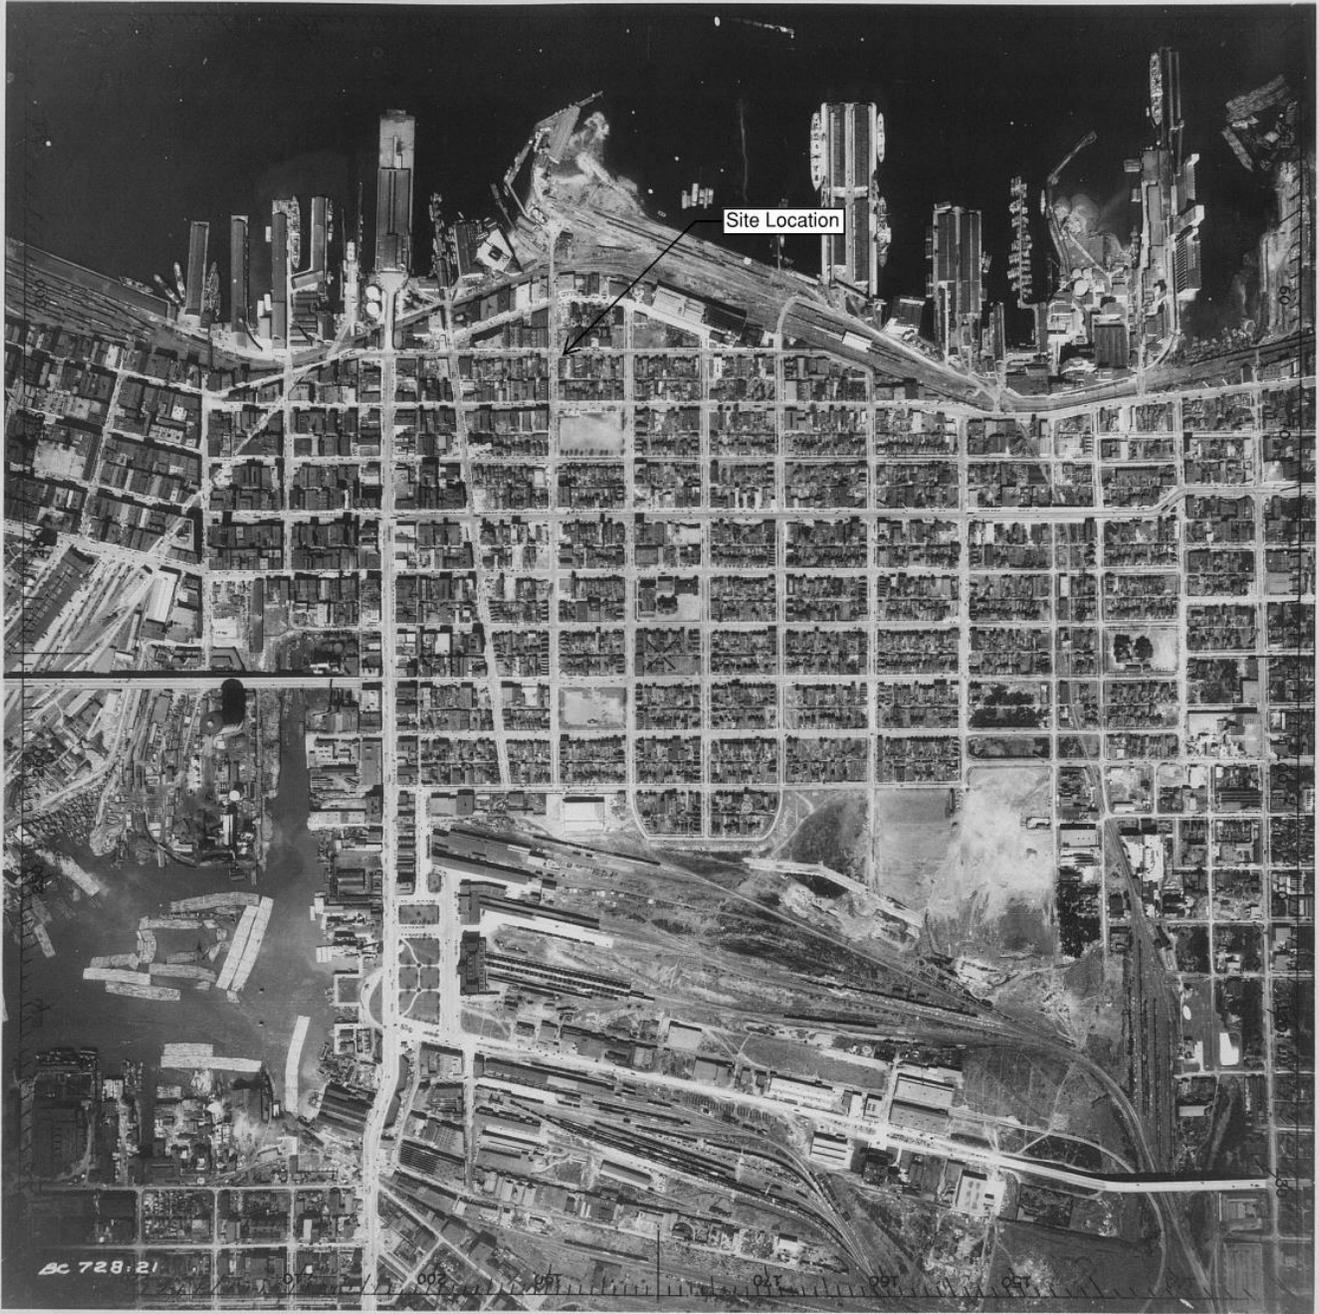
Aerial Photograph – 1949

Year	Serial No.	Photo No.	Notes
1949	BC 728	20/21	Low-quality image. The Site appears to consist of two rectangular buildings running north/south centrally on the property. Four small buildings are visible on the eastern section, and the rest of the property appears to be used as a scrap yard. The surrounding area is industrial. A storage yard is visible directly north of the Site.
1954	BC 1673	93/94	A small building is now visible on the south west corner of the Site. There are no other significant changes from the 1949 photograph.
1963	BC5061	93/94	The Site has been redeveloped into a service station. It appears the pump stand is located on the northern portion of the Site. Several buildings have been improved directly north of the Site.
1969	BC 5323	116/117	Another building north of the Site has been improved with a larger industrial building.
1973	Xxxx56	41/42	There are no significant changes from the 1969 photograph.

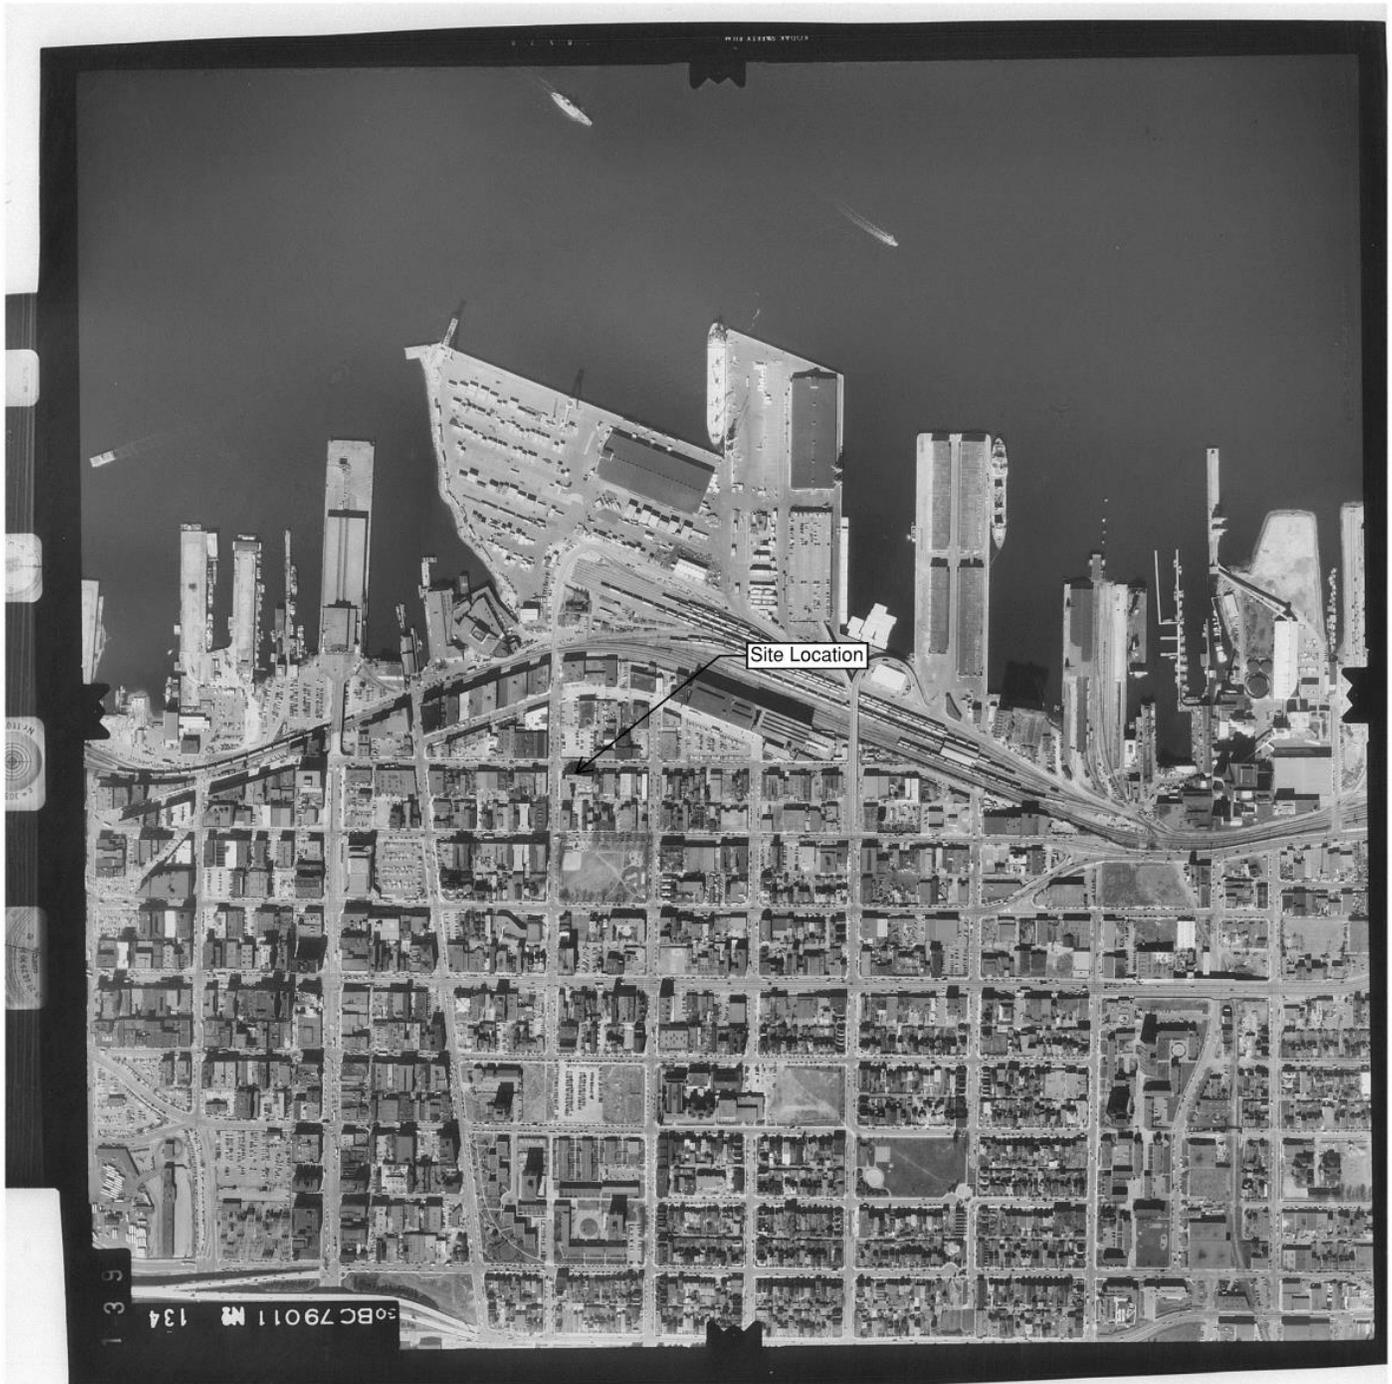
Aerial Photograph – 1979

1979	30BC79011	133/134	The Site has been improved and now consists of the current structure. The property directly to the west has been redeveloped into a larger building encompassing the entire lot.
1986	30BC86039	267/268	There are no significant changes from the 1979 photograph.
1993	FFC9300	62	There are no significant changes from the 1986 photograph.
1999	SRS 6068	44/45	The property directly north of the Site now consists of the current apartment structure. There are no other significant changes.
2004	SRS 6929	98/99	A property to the north east of the Site has been improved with a larger commercial building.
2009	SRS 7987	363	There are no significant changes from the 2004 photograph.

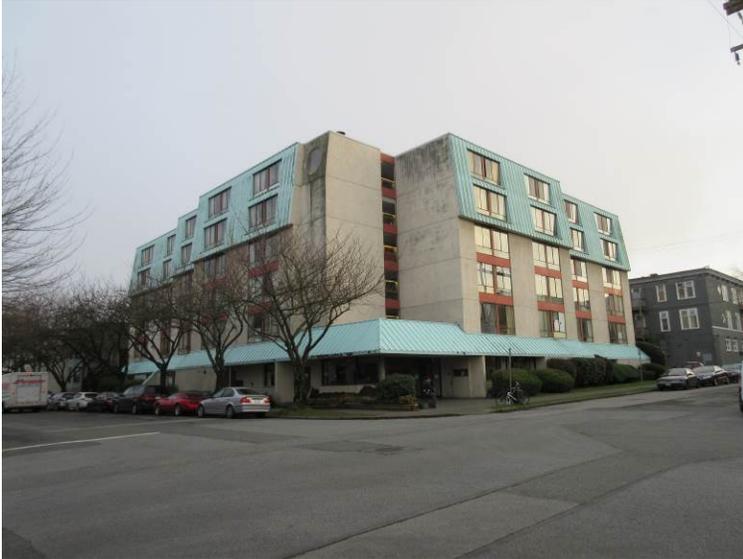
Photograph 1:

The Site.

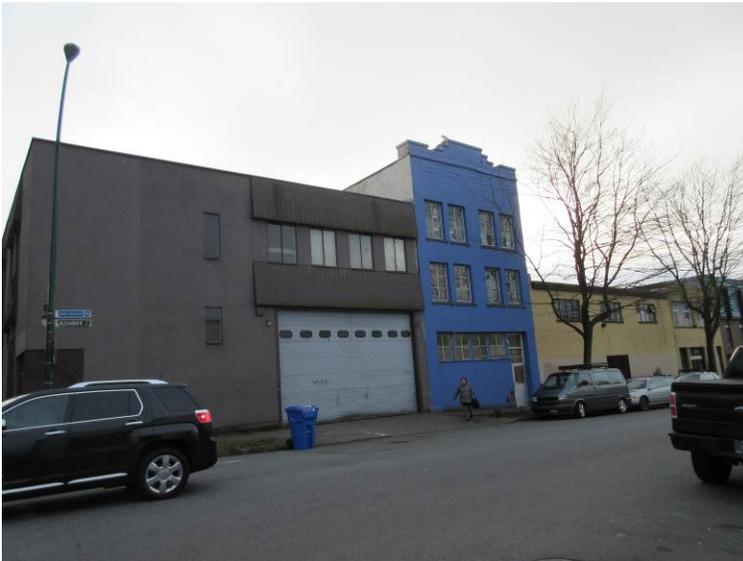
Photograph 2:

**Properties to the west, across
Dunlevy Avenue.**

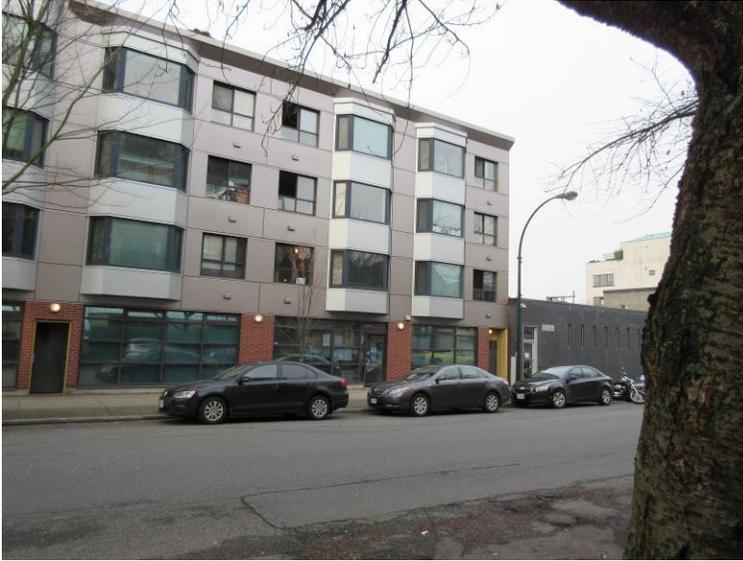
Photograph 3:
Looking north.

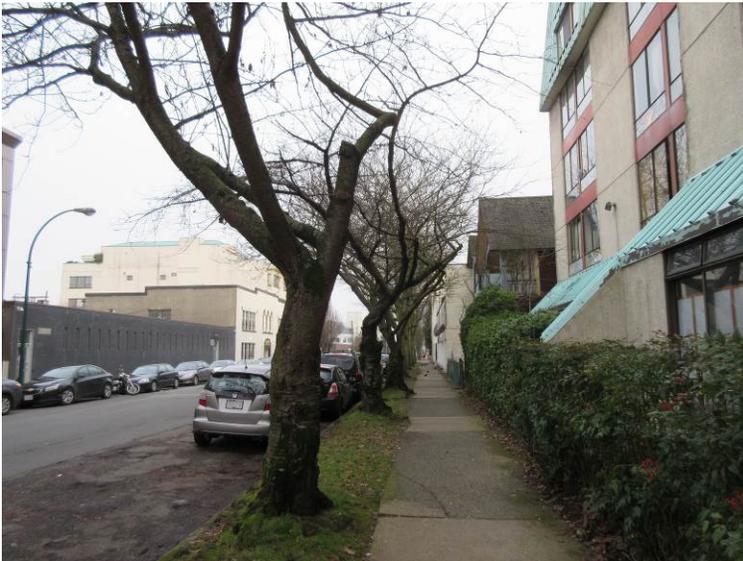
Photograph 4:
Looking east.

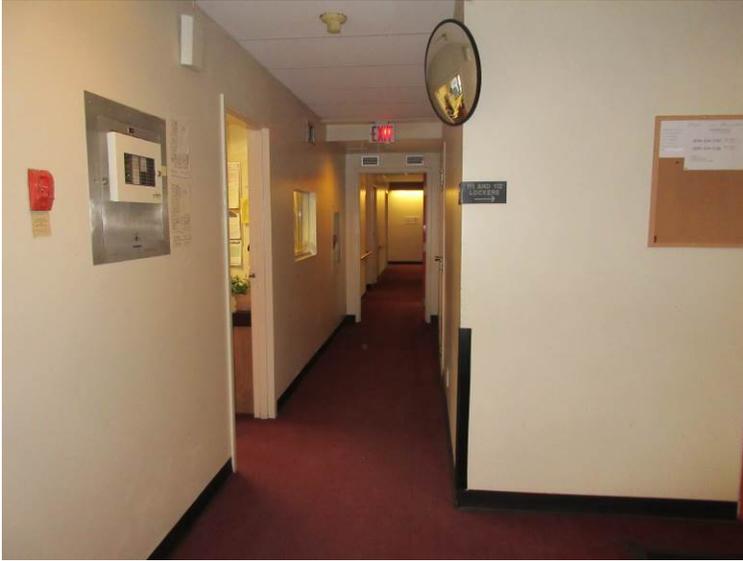
Photograph 5:
Interior of building.

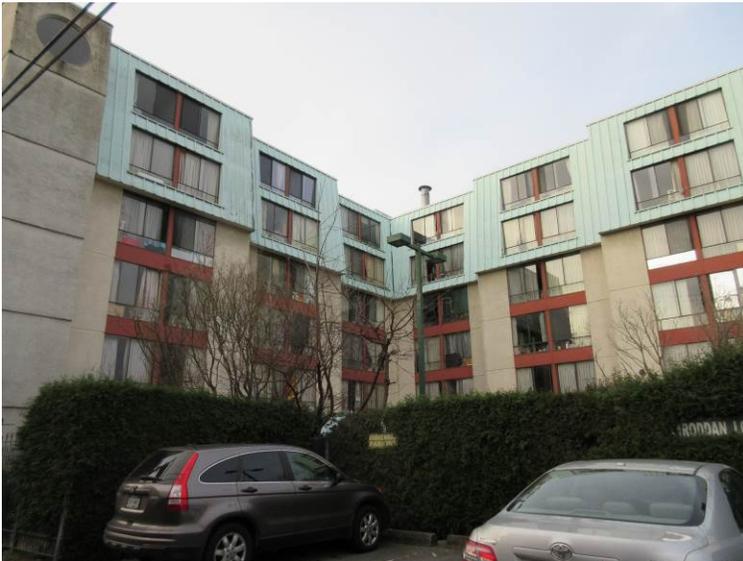
Photograph 6:
Back (south side) of Site.

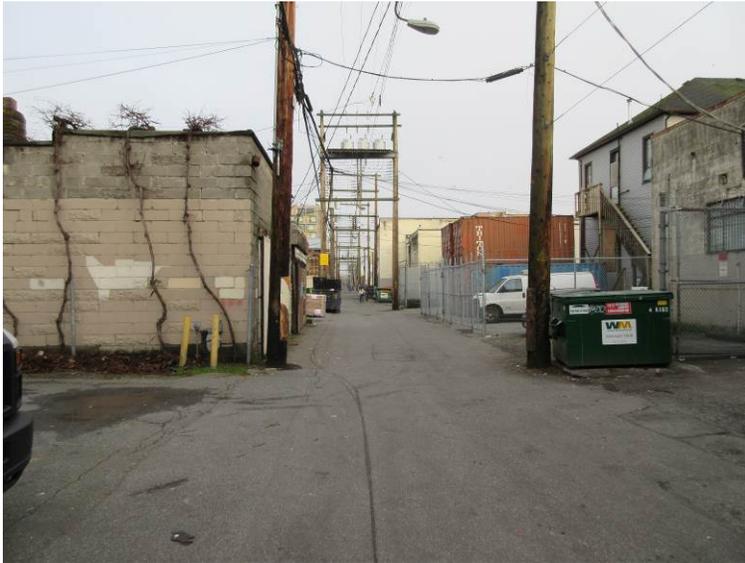
Photograph 7:

Alley behind (south side) of Site.
