# ***SURE Hazmat and Testing***

December 21, 2017

**Reference: Pre-Renovation Building Materials Investigation**  
**PNE Garden Auditorium, Vancouver, BC**

Ref: 12438-R01

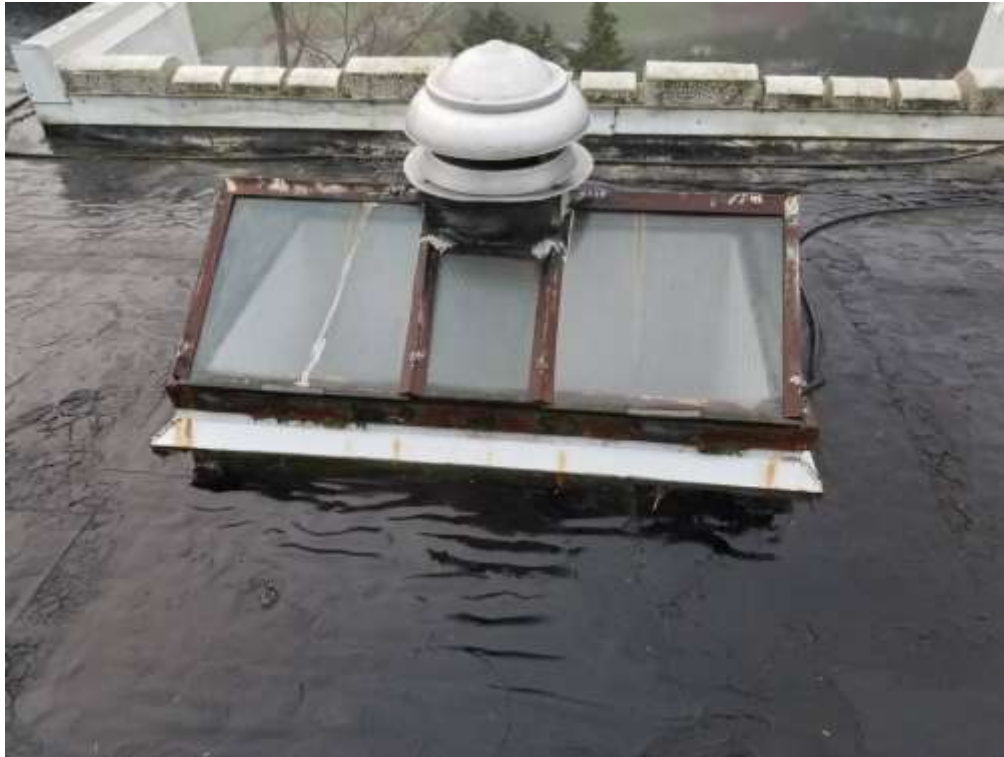
Samples 13, 15, 16, 17, 19 & 20 were determined to be asbestos-containing. Based on these results all rooftop caulking is assumed to be asbestos-containing. Caulkings are present on the metal cap flashings, skylights and between the metal flashings and concrete walls.

**Photo # 1** – Asbestos-containing mastic on the skylight – upper roof, south section

All asbestos-containing materials must be removed prior to demolition activities by a qualified hazardous materials contractor using appropriate work procedures as defined by WorkSafe BC.

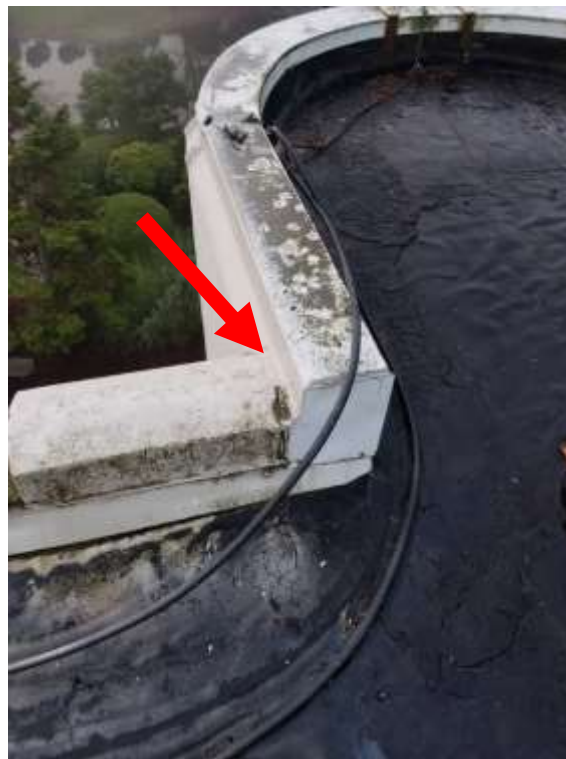
**Photo # 2** – Asbestos-containing caulking between the metal flashing and exterior wall

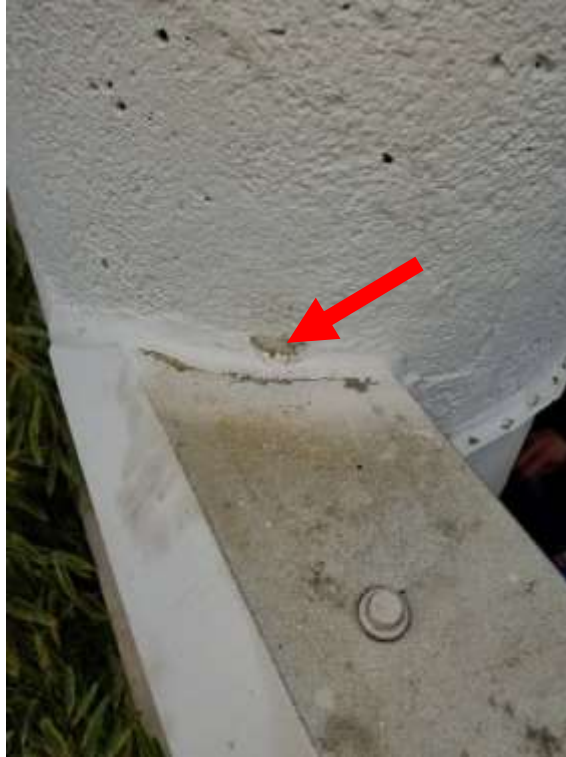
**Photo # 3** – Asbestos-containing caulking between the metal flashing and exterior wall

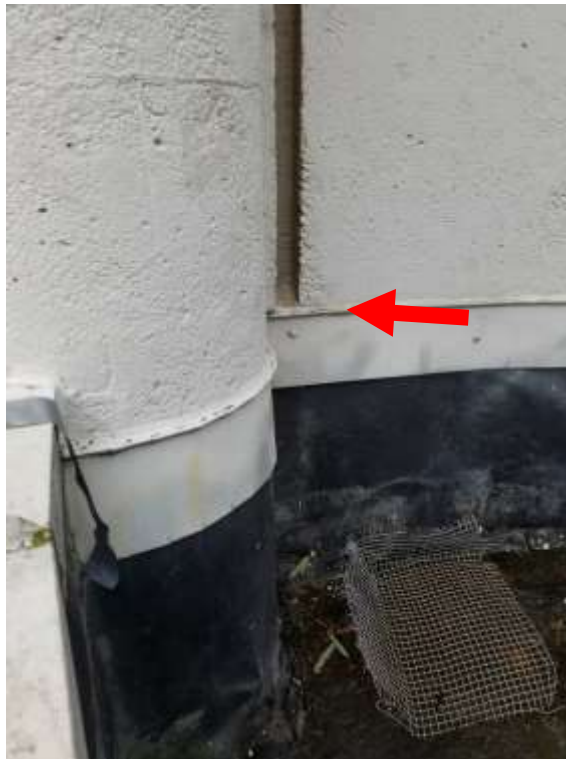
**Photo # 4** – Asbestos-containing caulking between the metal flashing and exterior wall

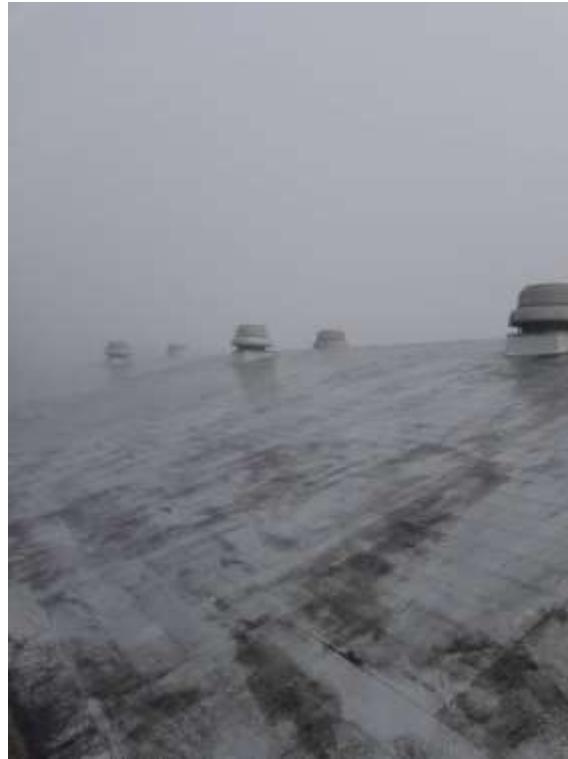
The exhaust vents on the top of the building were inaccessible at the time of the investigation (See attached site photos). Any caulking present is assumed to be asbestos-containing.

**Photo # 5** – Upper exhaust flashings that were inaccessible during our investigation, all caulking are assumed to be asbestos-containing

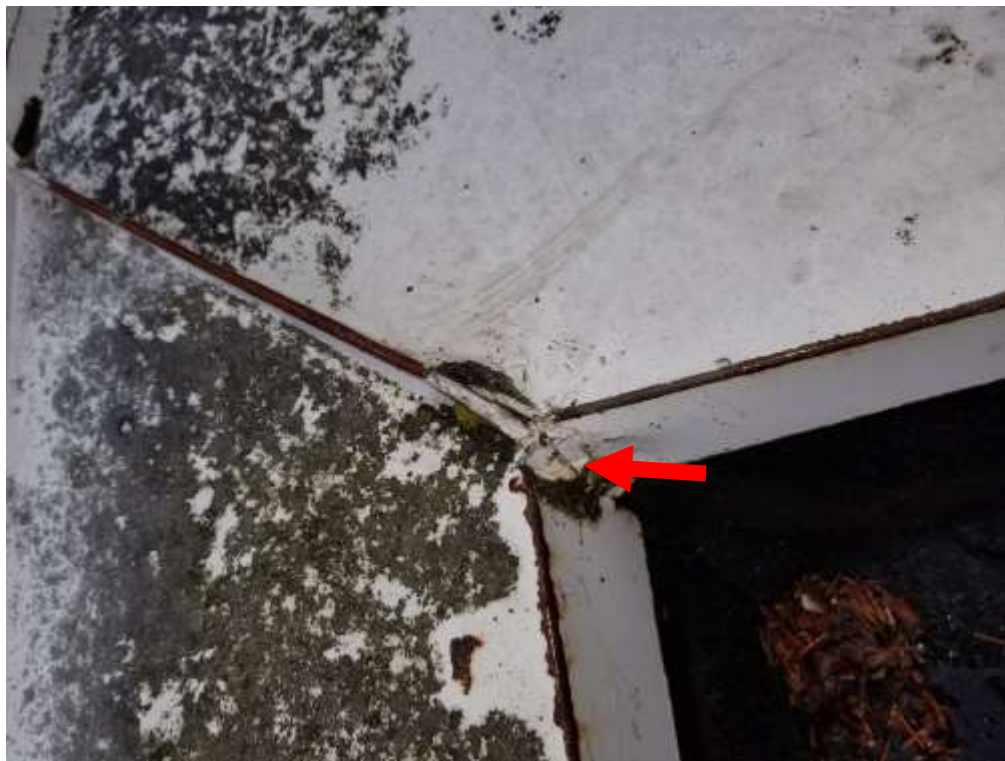
**Photo # 6** – Asbestos-containing caulking on the perimeter metal cap flashing
