Targeted Hazardous Materials Survey of:

Kitsilano Ice Rink

Address: 2690 Larch Street, Vancouver

Purpose: TARGETED HAZARDOUS MATERIAL SAMPLING

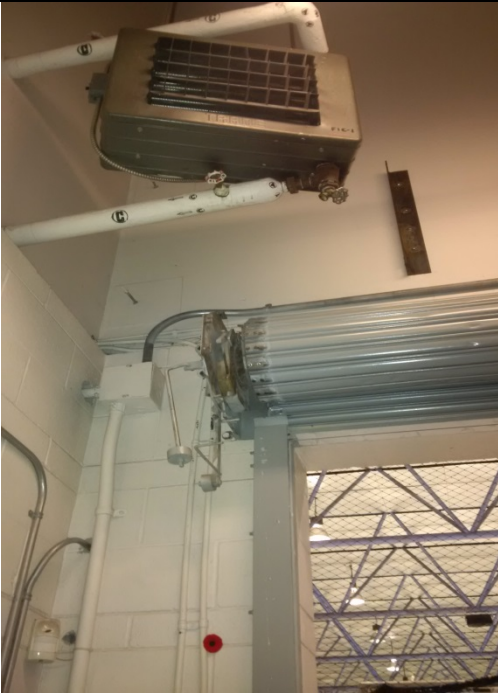
Asbestos-containing materials were identified in the Hard Mudded Mechanical Pipe Insulation and the Drywall Joint Compound located throughout this building.

Photo 1: Hard Mud Elbows do contain asbestos.

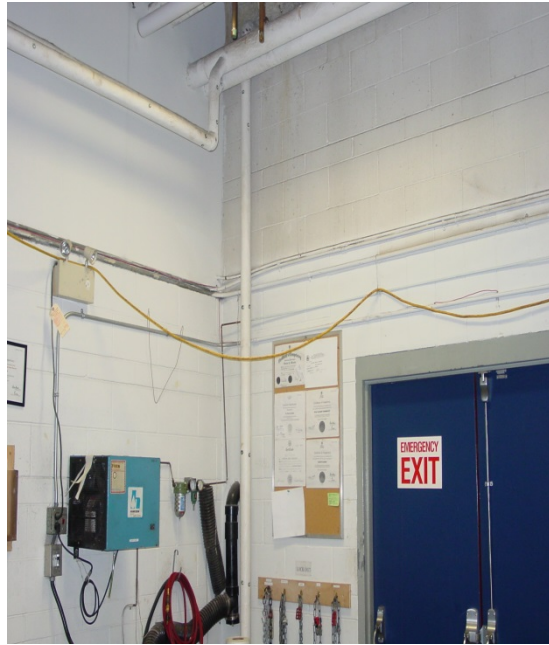
Photo 2: Painted Mud on Drywall walls do contain asbestos

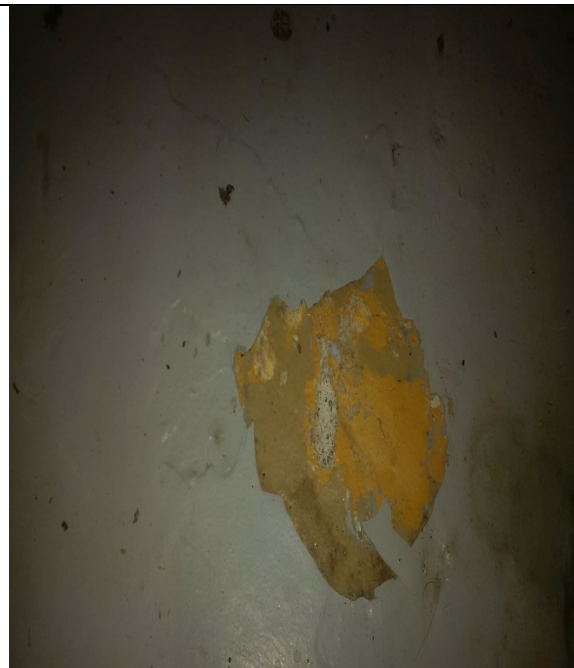
Due to the age of the building, representative samples of paints to test for the presence of lead were not collected . All exterior and interior painted surfaces must be treated as lead based containing.

Photo 3: New grey paint coat on multiple layers of old paint - Lead based paints.

In the event that the surfaces to which lead-based paint has been applied are to be disturbed by sanding, grinding, burning, cutting or otherwise disturbing lead-based paint, then the paint must be removed prior to these activities. The removal of lead paint must be accomplished in compliance with the requirements of the WorkSafeBC Occupational Health & Safety Regulation (current edition).

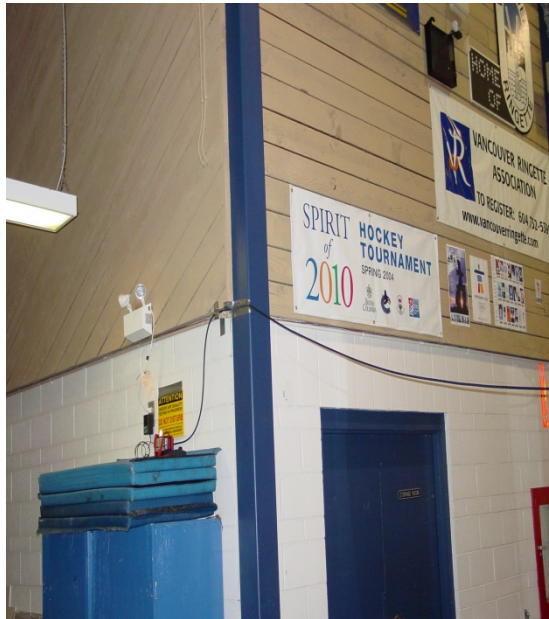
Photo 4: Interior Cinderblock Walls may contain Vermiculite Insulation within.
