**INVITATION TO TENDER NO. PS20180920
PROVISION OF CONTRACTOR SERVICES FOR WASHROOM UPGRADES
AT 3214 W 10 AVE**

ADDENDUM NO. 1

"Hazmat Investigation Report"

RJFR – St. James Community Square	RJFR180829
Final Report – Hazardous Materials Investigation	Effective: August 29, 2018

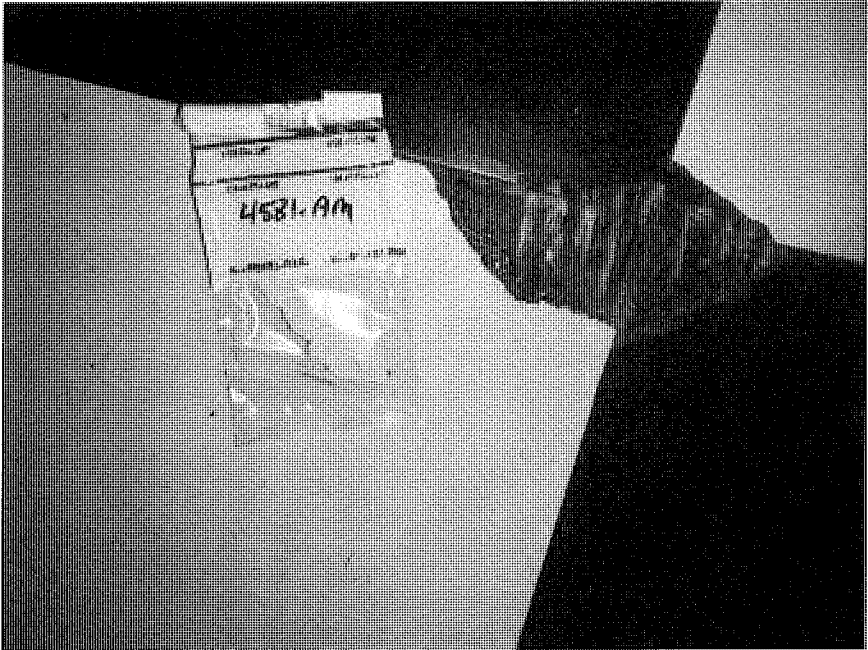
<p>General view of the exterior of the St. James Community Square.</p>
<p>Location</p> <p>Entry Hallway, Level 2</p> <p>Results</p> <p>Floor Tiles: 1-5% Chrysotile Asbestos;</p> <p>Mastic: non-asbestos</p>

<p>View of black and white 12" x 12" vinyl floor tiles with underlying black mastic (4581-AM) laid on plywood.</p>

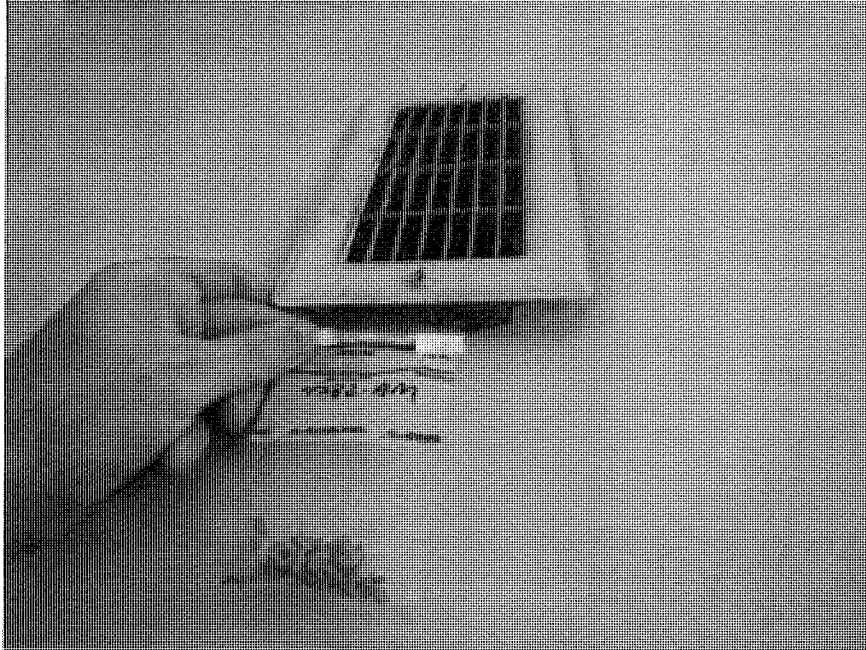
<p data-bbox="509 1056 1370 1119">View of beige painted plaster material (4582-AM) over gypsum board wall.</p>
Washroom, Level 2	
Results <0.5% Actinolite Asbestos	
Location

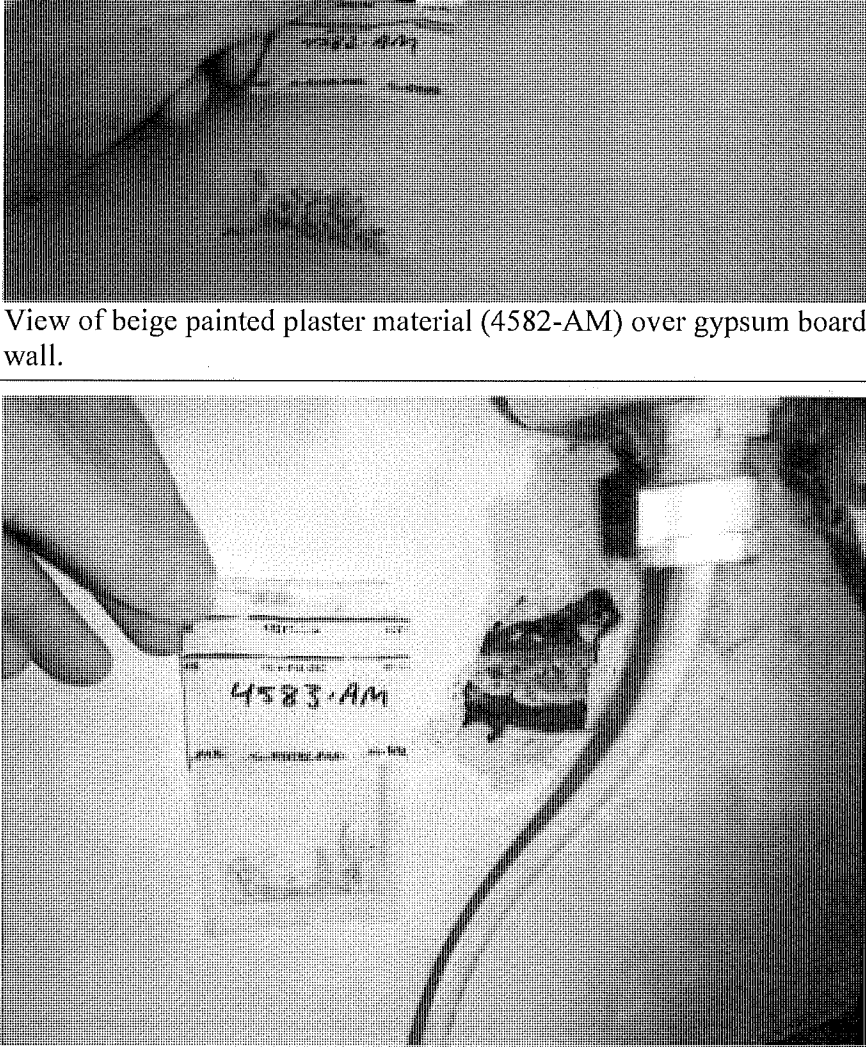
<p data-bbox="509 1797 1370 1860">View of thick white compound over sparkle plaster coat (4583-AM) on wall.</p>
Washroom, Level 2	
Results <0.5% Actinolite Asbestos

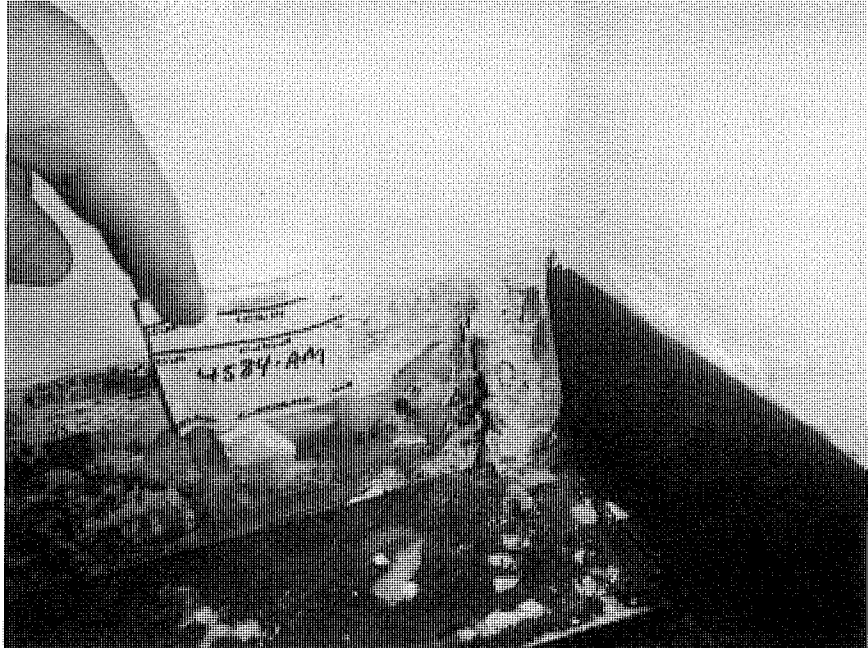
Description	Photo
Suspect Asbestos-Containing Materials	
<p>Location</p> <p>Washroom, Level 2</p>

<p>Results</p> <p>1-5% Chrysotile Asbestos</p>	
<p>View of beige painted off-white compound on white hard gypsum wall board (4584-AM).</p>	
<p>Location</p> <p>Kitchen, Level 2</p>

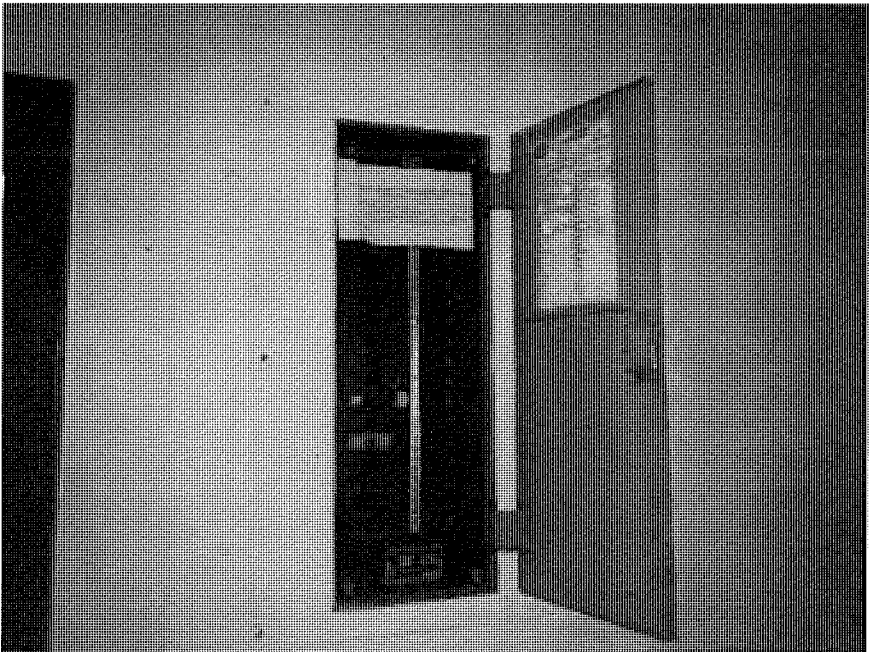
<p>Results</p> <p>Presumed Chrysotile Asbestos</p>	
View of electrical panel presumed to contain arc-insulation pads.

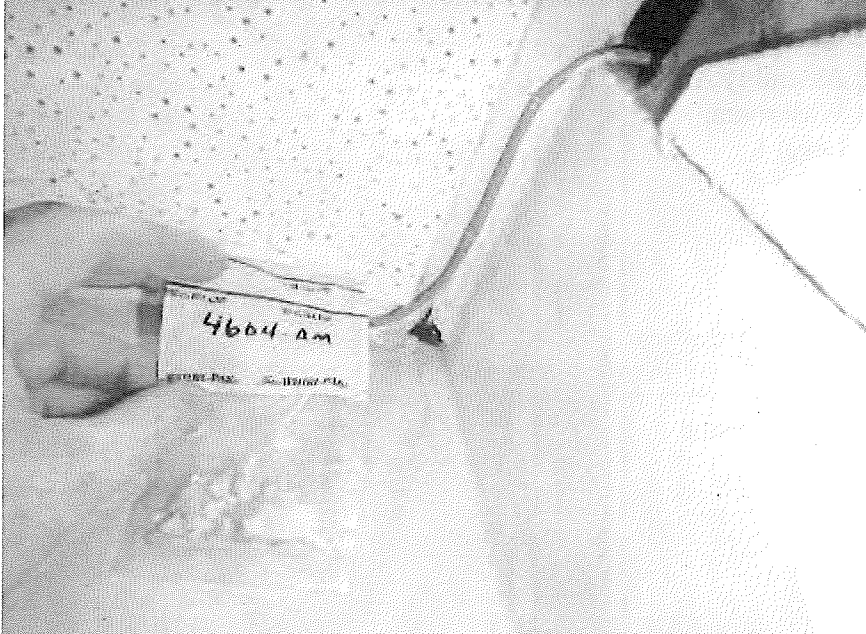
<p data-bbox="511 1050 1372 1123">View of yellow painted mudded drywall joint compound (4604-AM) above ceiling tiles.</p>
<p>Results</p> <p>1-5% Chrysotile Asbestos</p>	
<p>Location</p> <p>Daycare Area, Level 1</p>

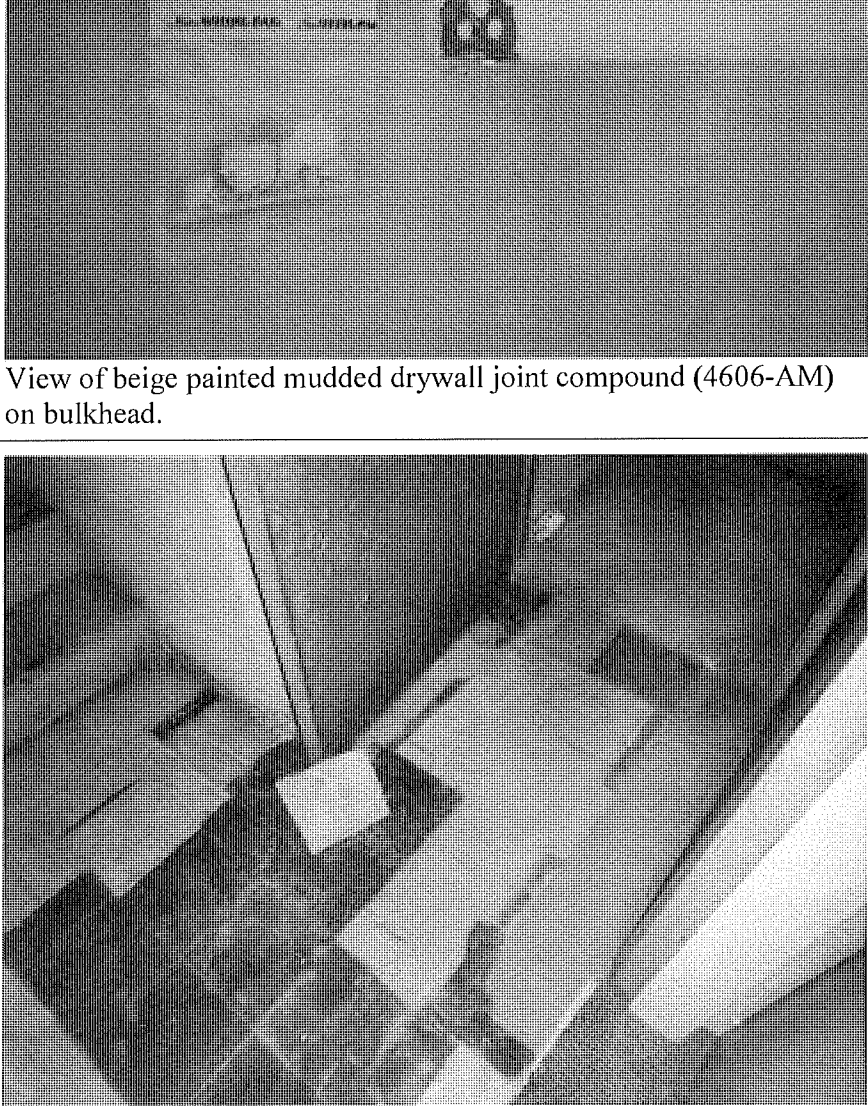
Service Room Stair Landing, Level 1	
Results	<p>View of 9" x 9" brown & red vinyl floor tiles with underlying black mastic in poor condition.</p>
<p>Floor Tiles: 1-10% Chrysotile; Mastic 10-30% Chrysotile (Based on previous sample report)</p>

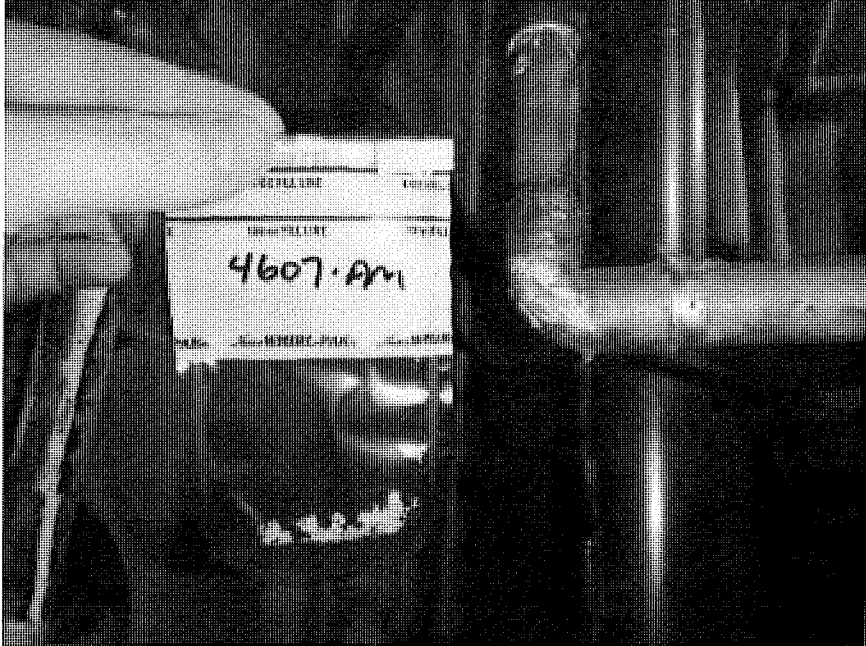
Description	Photo
Suspect Asbestos-Containing Materials	
<p>Location</p> <p>Service Room, Level 1</p>

<p>Results</p> <p>40-60% Chrysotile Asbestos</p>	
View of residual mud insulation on exposed copper pipes from Domestic Hot Water Tank.	
<p>Location</p> <p>Service Room, Level 1</p>

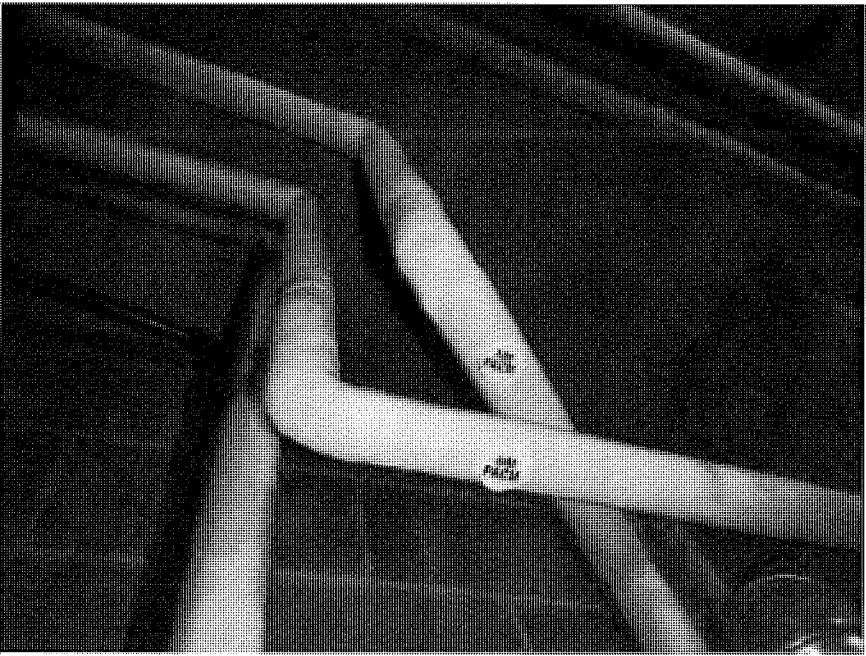
<p>Results</p> <p>60-80% Chrysotile Asbestos (Based on previous sample report)</p>	
View of hard mudded elbow insulation on 2" diameter crème canvas wrapped mechanical pipes.

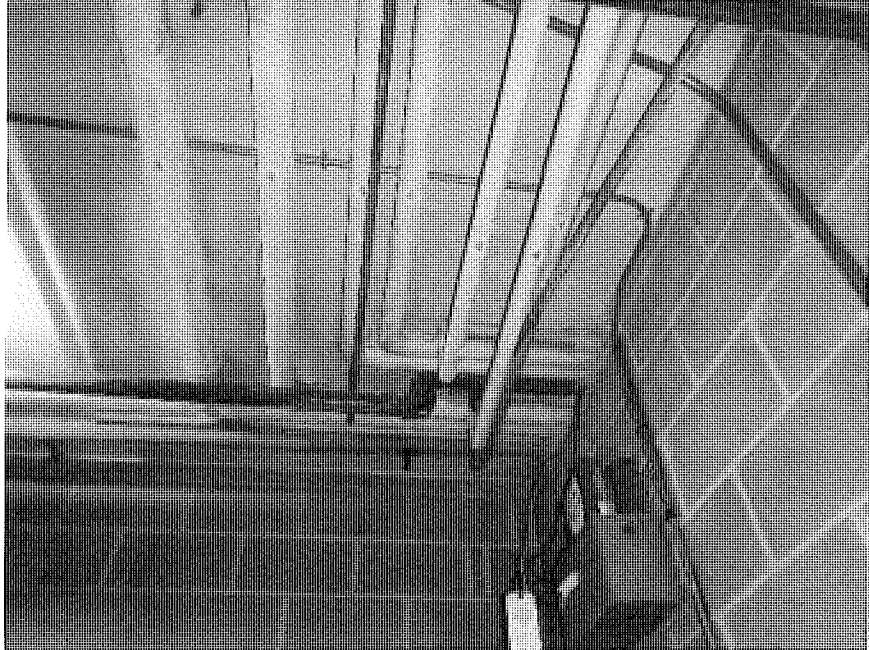
Description	Photo
Suspect Asbestos-Containing Materials	
<p>Location</p> <p>Service Room, Level 1</p>

<p>View of compressed paper pipe insulation on 2" diameter mechanical pipes.</p>
<p>Results</p> <p>70-90% Chrysotile Asbestos (Based on previous sample report)</p>	
<p>Location</p> <p>Service Room, Level 1</p>

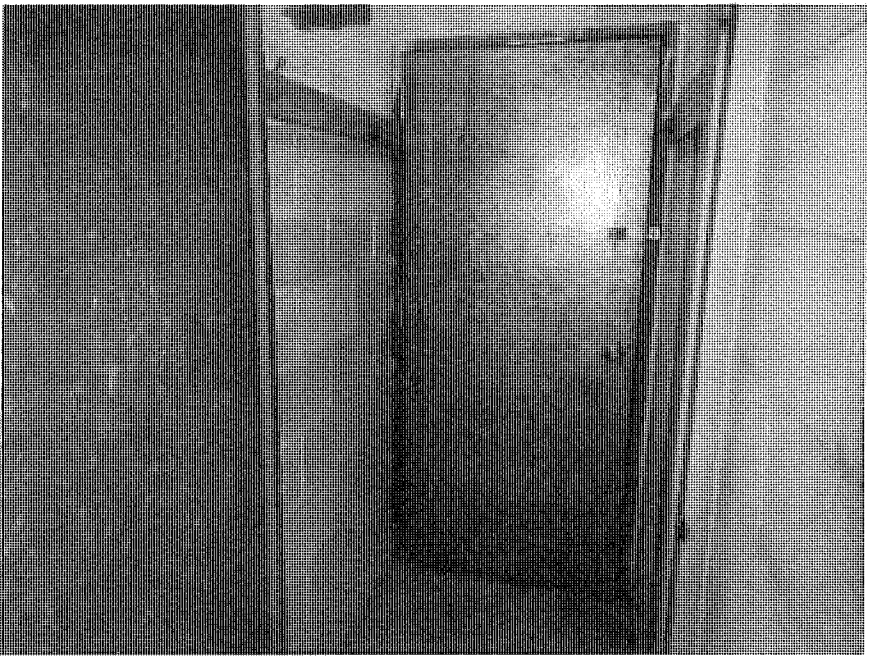
<p>View of fire door of the Service room.</p>
<p>Results</p> <p>Presumed Chrysotile Asbestos</p>

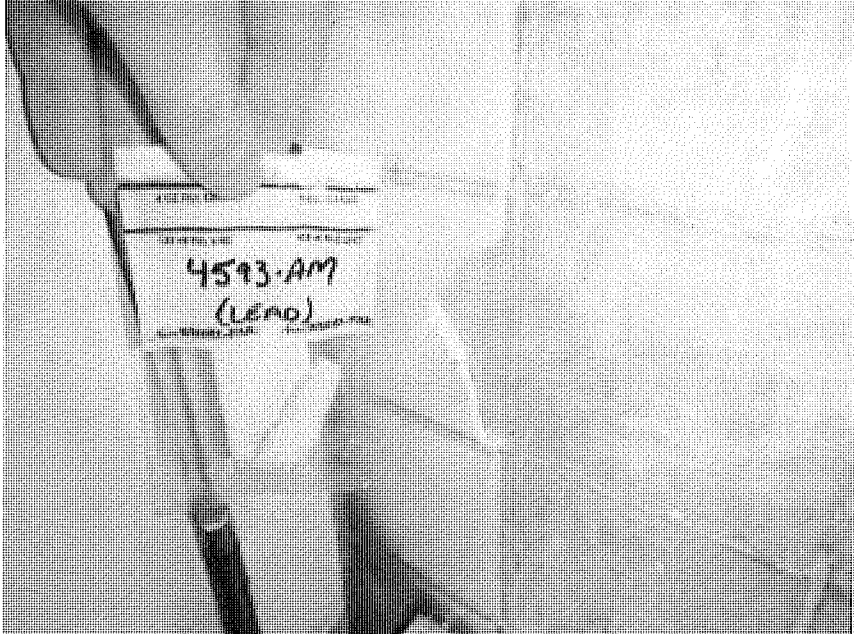
Photographs – St James Community Square, 3214 W 10 th Ave, Vancouver, BC.	
Description	Photo
Suspect Lead-Containing Materials	
<p>Location</p> <p>Men's Washroom, Level 1</p>

<p>Results</p> <p>2560 mg/kg of Lead</p>	
View of green 4" x 4" ceramic tiles (4593-AM) on lower half of walls inside Men's Washroom.	
<p>Location</p> <p>Women's Washroom, Level 1</p>

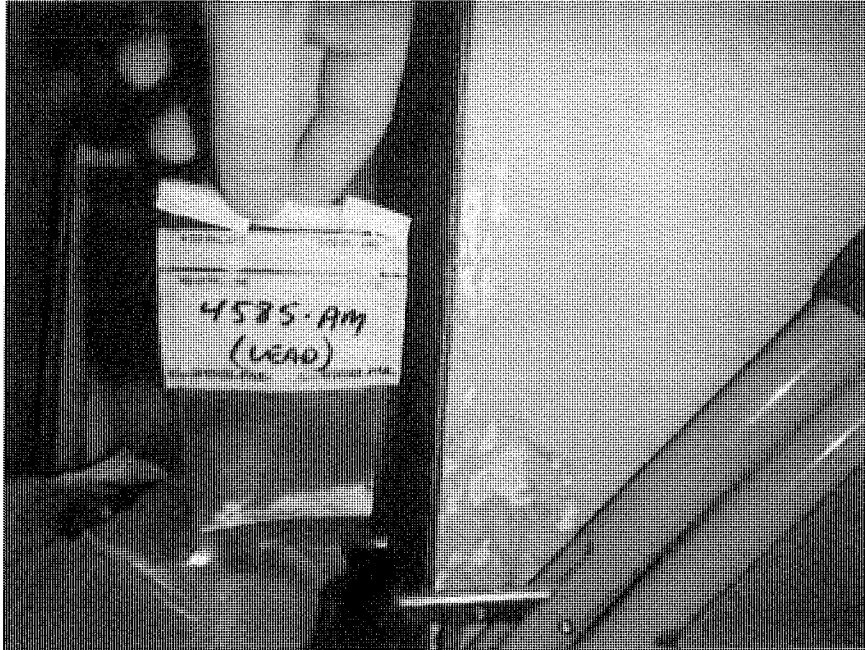
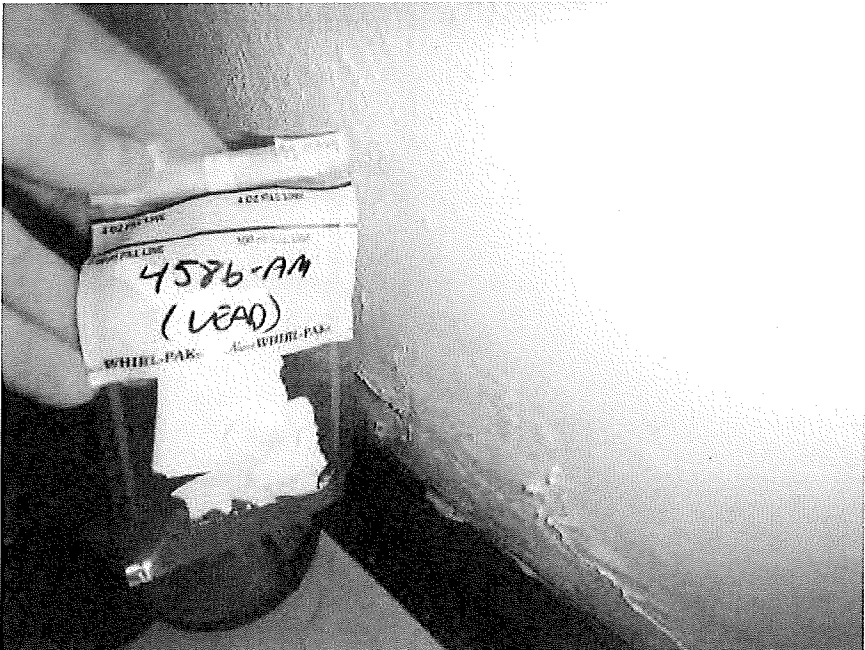
Janitor Closet, Level 2	
Results

217 mg/kg of Lead	
Location

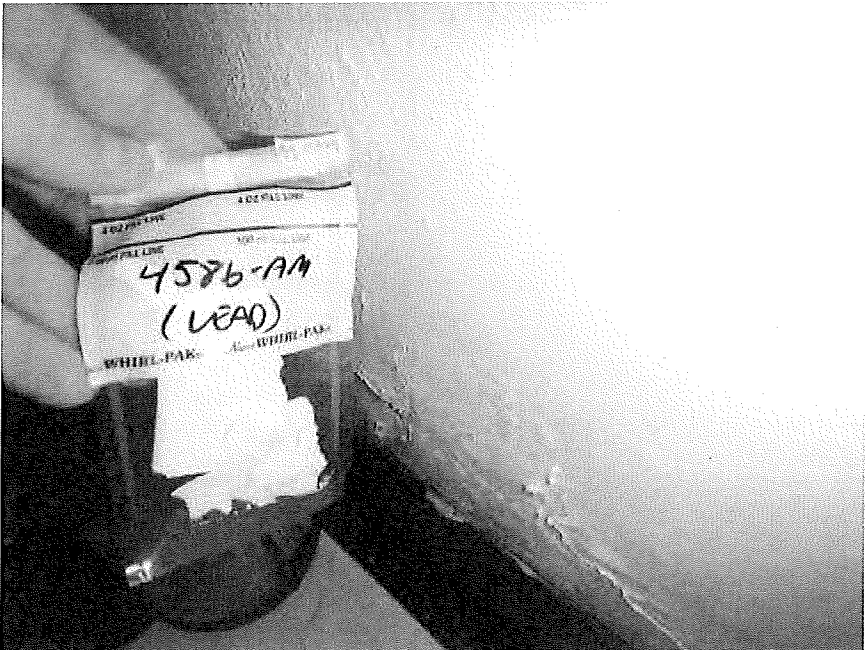
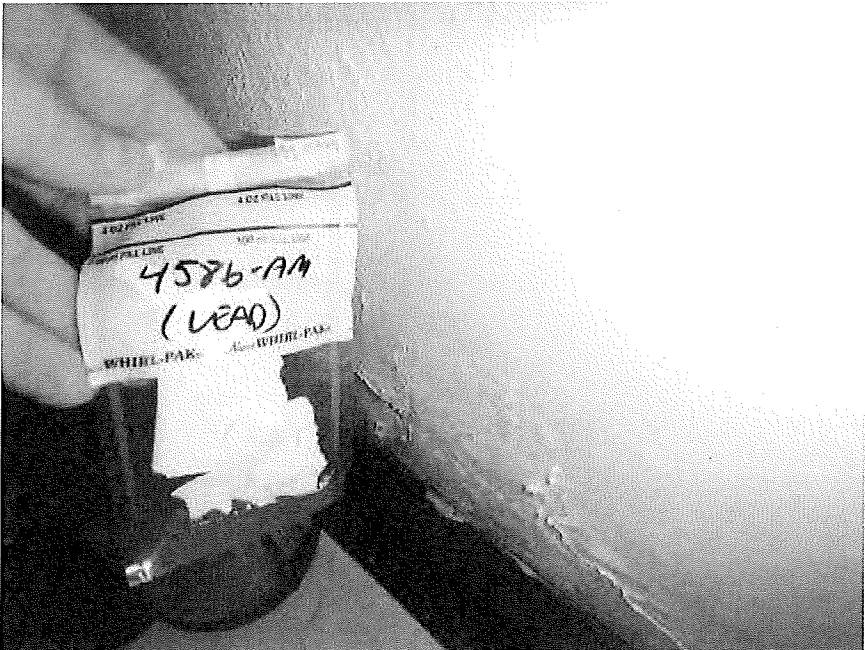
Washroom, Level 2	
Results

2210 mg/kg of Lead	
<p style="text-align: center;">View of beige paint coat (4586-AM) on drywall wall.</p>

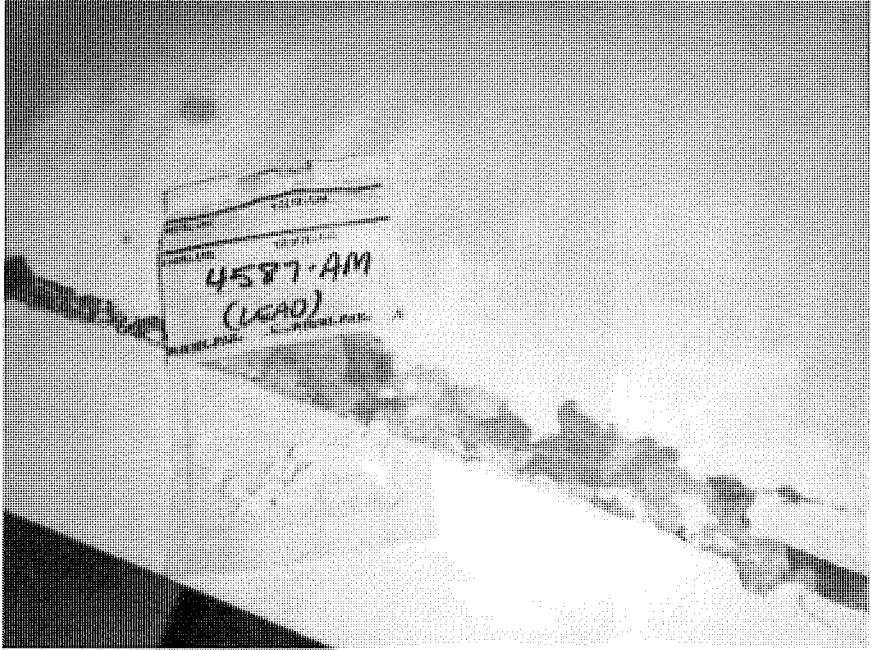
Kitchen, Level 2	
Results	
2360 mg/kg of Lead	View of yellow paint (4587-AM) on metal siding of former dumbwaiter.

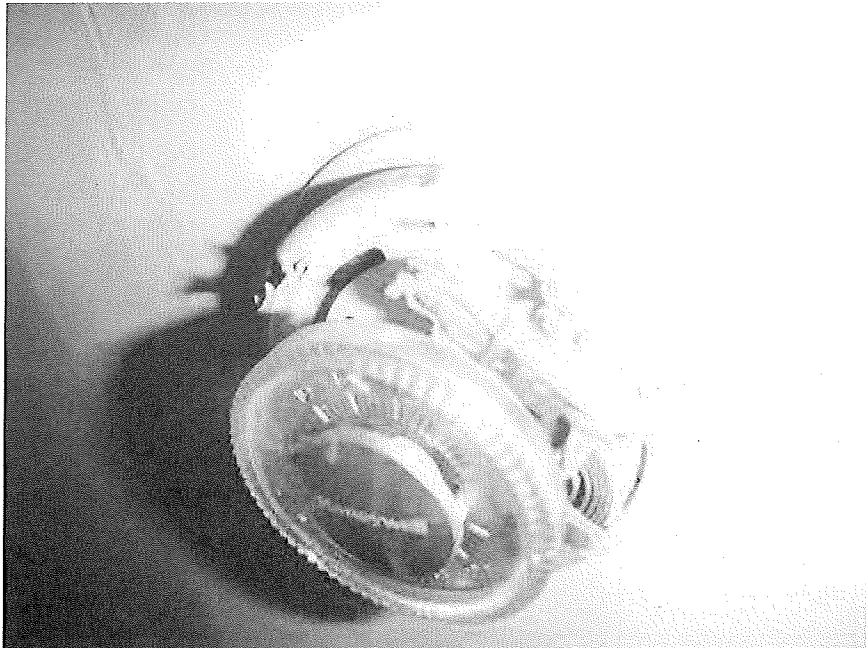
<p>Location</p> <p>Hallway, Lower Floor</p>

<p>View of wall-mounted thermostat with mercury vial in control mechanism</p>
<p>Results</p>	
<p>Mercury-containing vial</p>	
<p>Location</p> <p>Washroom, Level 2</p>

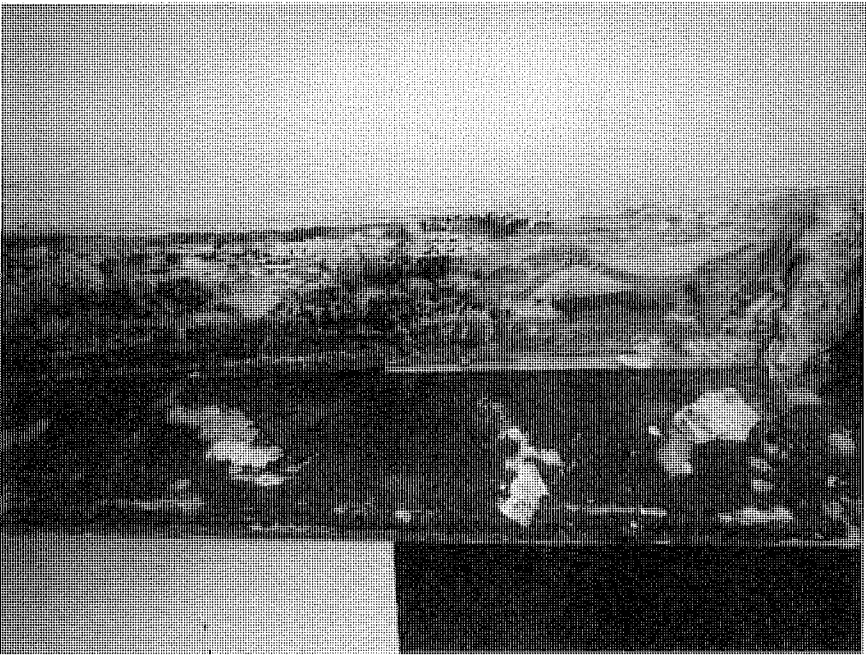
Suspected black mould growth was observed behind baseboards within the Level 2 Washroom.

<p>View of suspect black mould growth on wall behind baseboard.</p>
<p>Results</p>	
<p>Suspected mould growth</p>

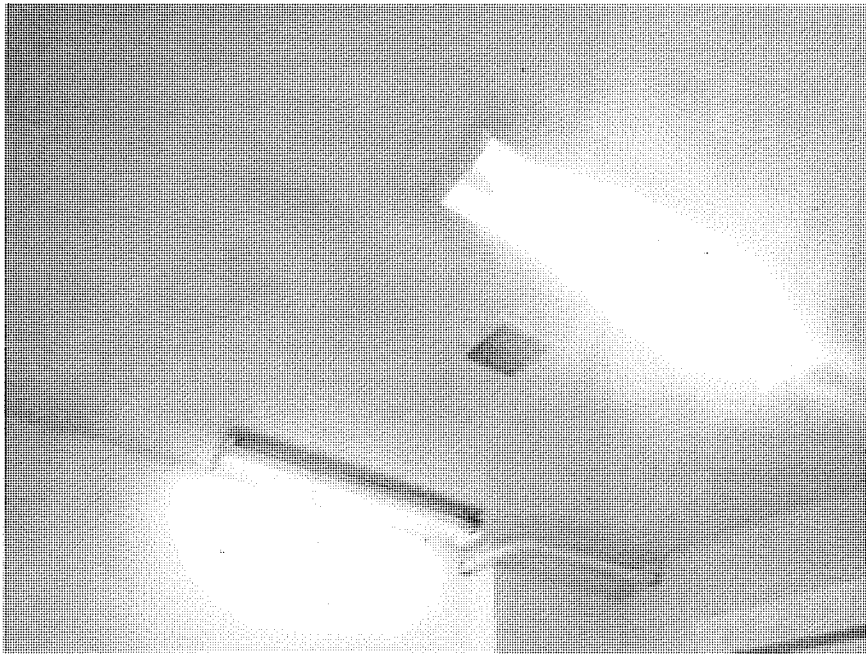
Throughout building	
Results	
Suspect PCB in ballast Suspect Mercury in light tube	
View of fluorescent light fixtures.
