**Targeted Hazardous Materials Survey of:****Bloedel Conservatory - Lighting Retrofit Project****Building Code: 6477****Address: 4600 Cambie Street, Vancouver BC****Surveyor: Patrick Li****Work Notification Number: 10382829****Requested By: Richard Tse****Purpose: TARGETED HAZARDOUS MATERIAL SAMPLING**

HAZARDOUS MATERIAL SURVEY	BLOEDEL CONSERVATORY - LIGHTING RETROFIT PROJECT	JULY-2018
---------------------------	--	-----------

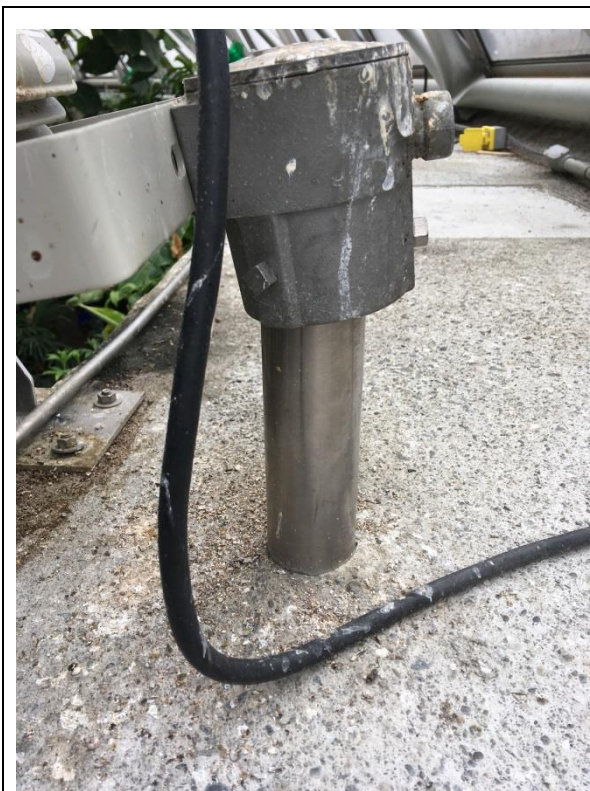
Photo1: Perimeter Lighting - Close up

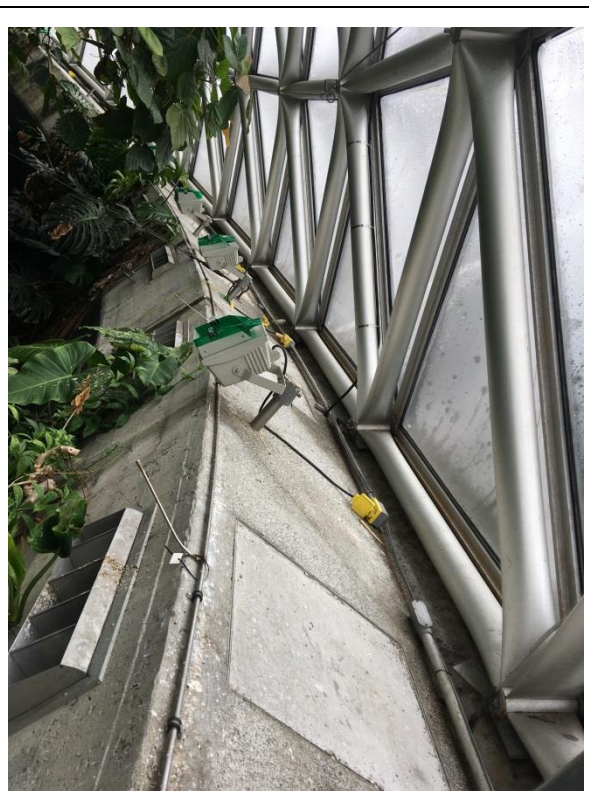
Photo2: Perimeter Lighting

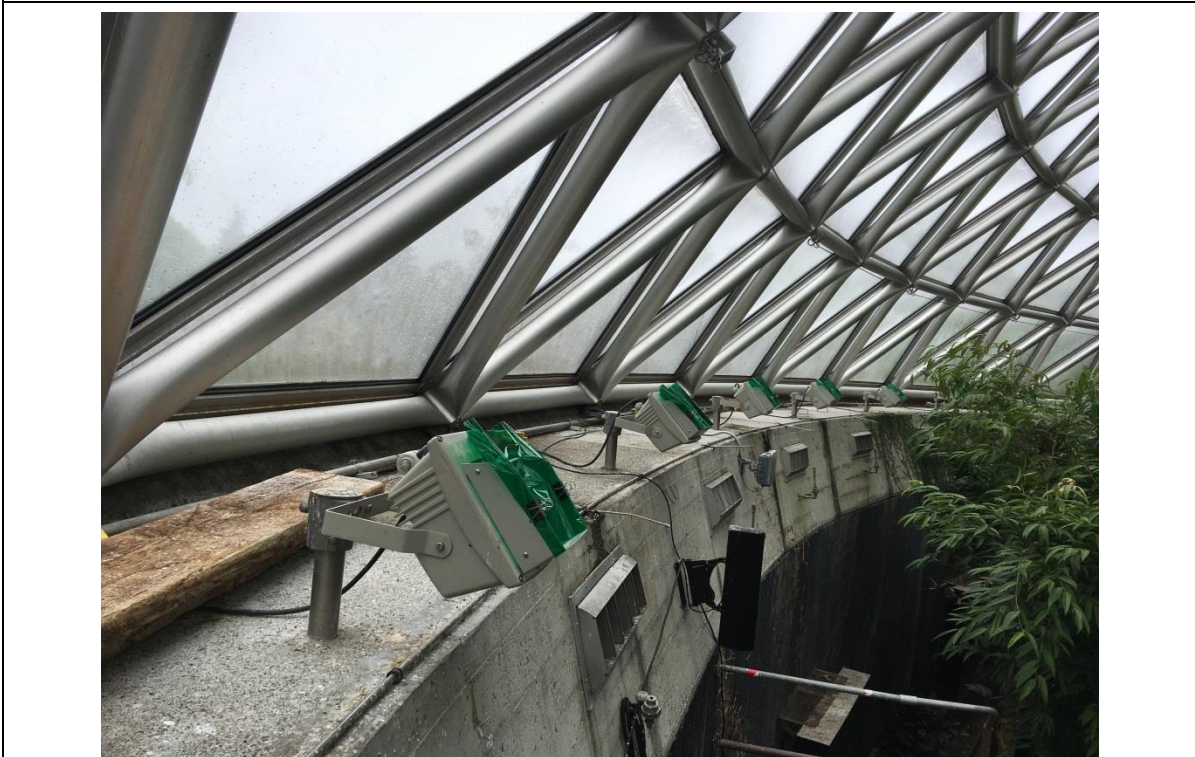
Photo3: Perimeter Lighting

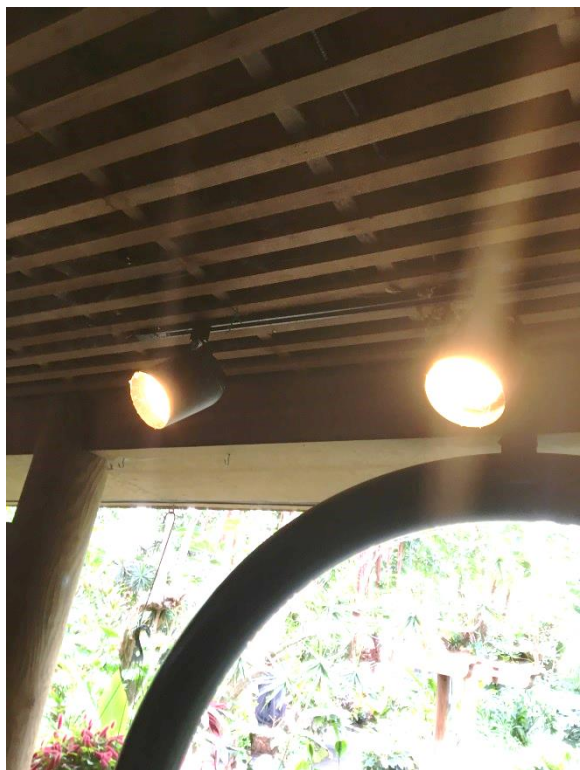
Photo4: Lighting By Washrooms

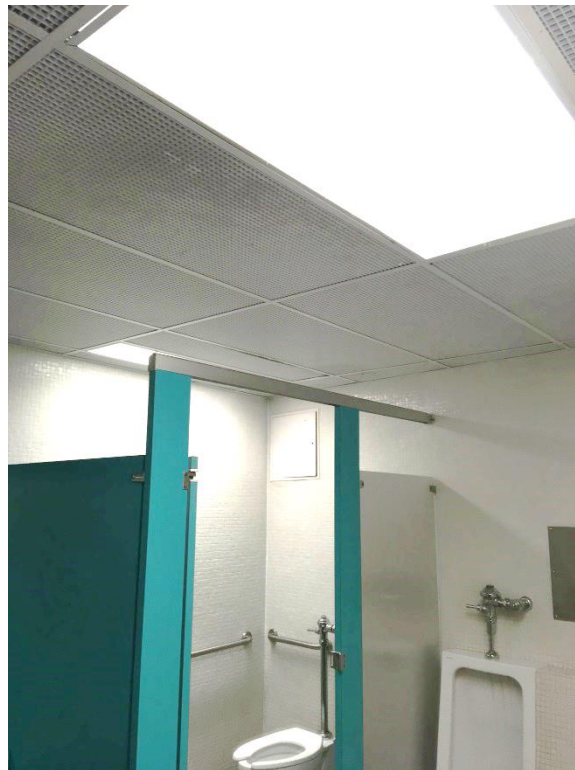
Photo5: Lighting Inside Washroom

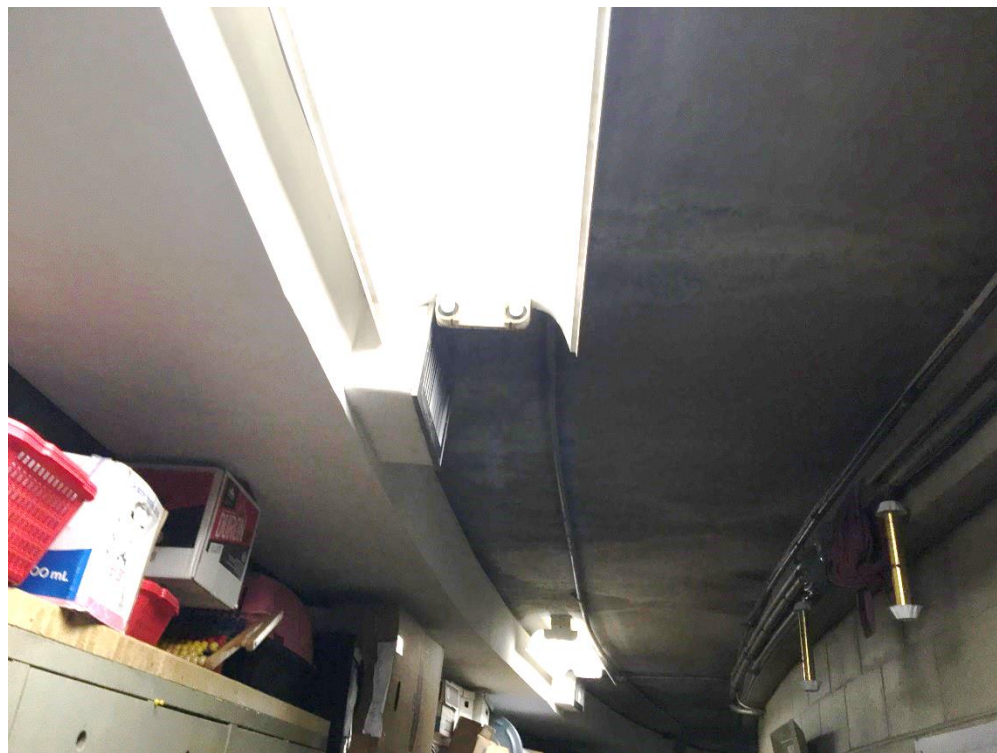
Photo6: Lighting in Tunnel
