Hazardous Materials Sampling: Vancouver Art Gallery

Address: 800 West Georgia

Purpose: TARGETED HAZARDOUS MATERIAL SAMPLING

HAZARDOUS MATERIAL SURVEY	Vancouver Art Gallery	2019/05/03
---------------------------	-----------------------	------------

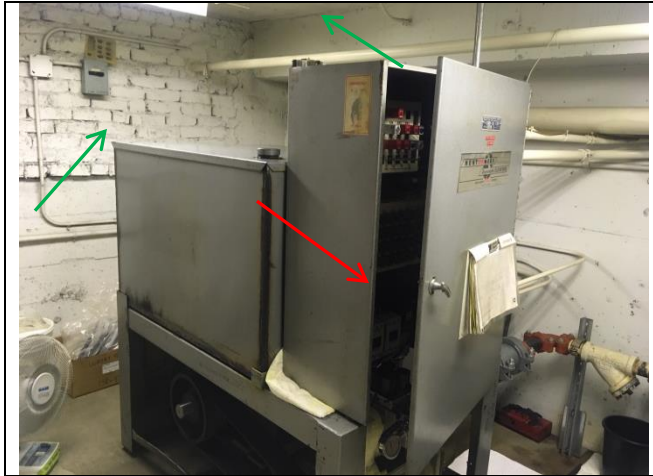
Colour	Location	TOTAL LEAD (mg/kg)	CHPA LEAD-BASED PAINT? (90 mg/kg)	TCLP LEAD (mg/L)	HAZ WASTE ? (Y/N)
White	Elevator Machine Room (Gallery Hydraulic Elevator) - White Paint on North Concrete Wall	10.7	No	-	-
White	Elevator Machine Room (Gallery Hydraulic Elevator) - White Paint on East Concrete Wall	47.9	No	-	-
White	Elevator Machine Room (Gallery Hydraulic Elevator) - White Paint on Concrete Ceiling	6.4	No	-	-
Grey	Elevator Machine Room (Gallery Hydraulic Elevator) - Grey Paint on Metal Elevator Machine Equipment	1010	Yes	-	-

Photo 1: Grey paint on Metal Elevator Machine Equipment is lead containing. Paint on walls and ceiling throughout is not lead containing. Brick mortar is also non-asbestos.

In the event that the surfaces to which lead-based paint has been applied are to be disturbed by sanding, grinding, burning, cutting or otherwise disturbing lead-based paint, then the paint must be removed prior to these activities. The removal of lead paint must be accomplished in compliance with the requirements of the WorkSafeBC Occupational Health & Safety Regulation (current edition).
