Targeted Hazardous Building Materials Survey and Review:

PNE Hastings Room - ROOF

Building Code: 7311 AB/HR

Address: 2901 Hastings Street, Vancouver BC

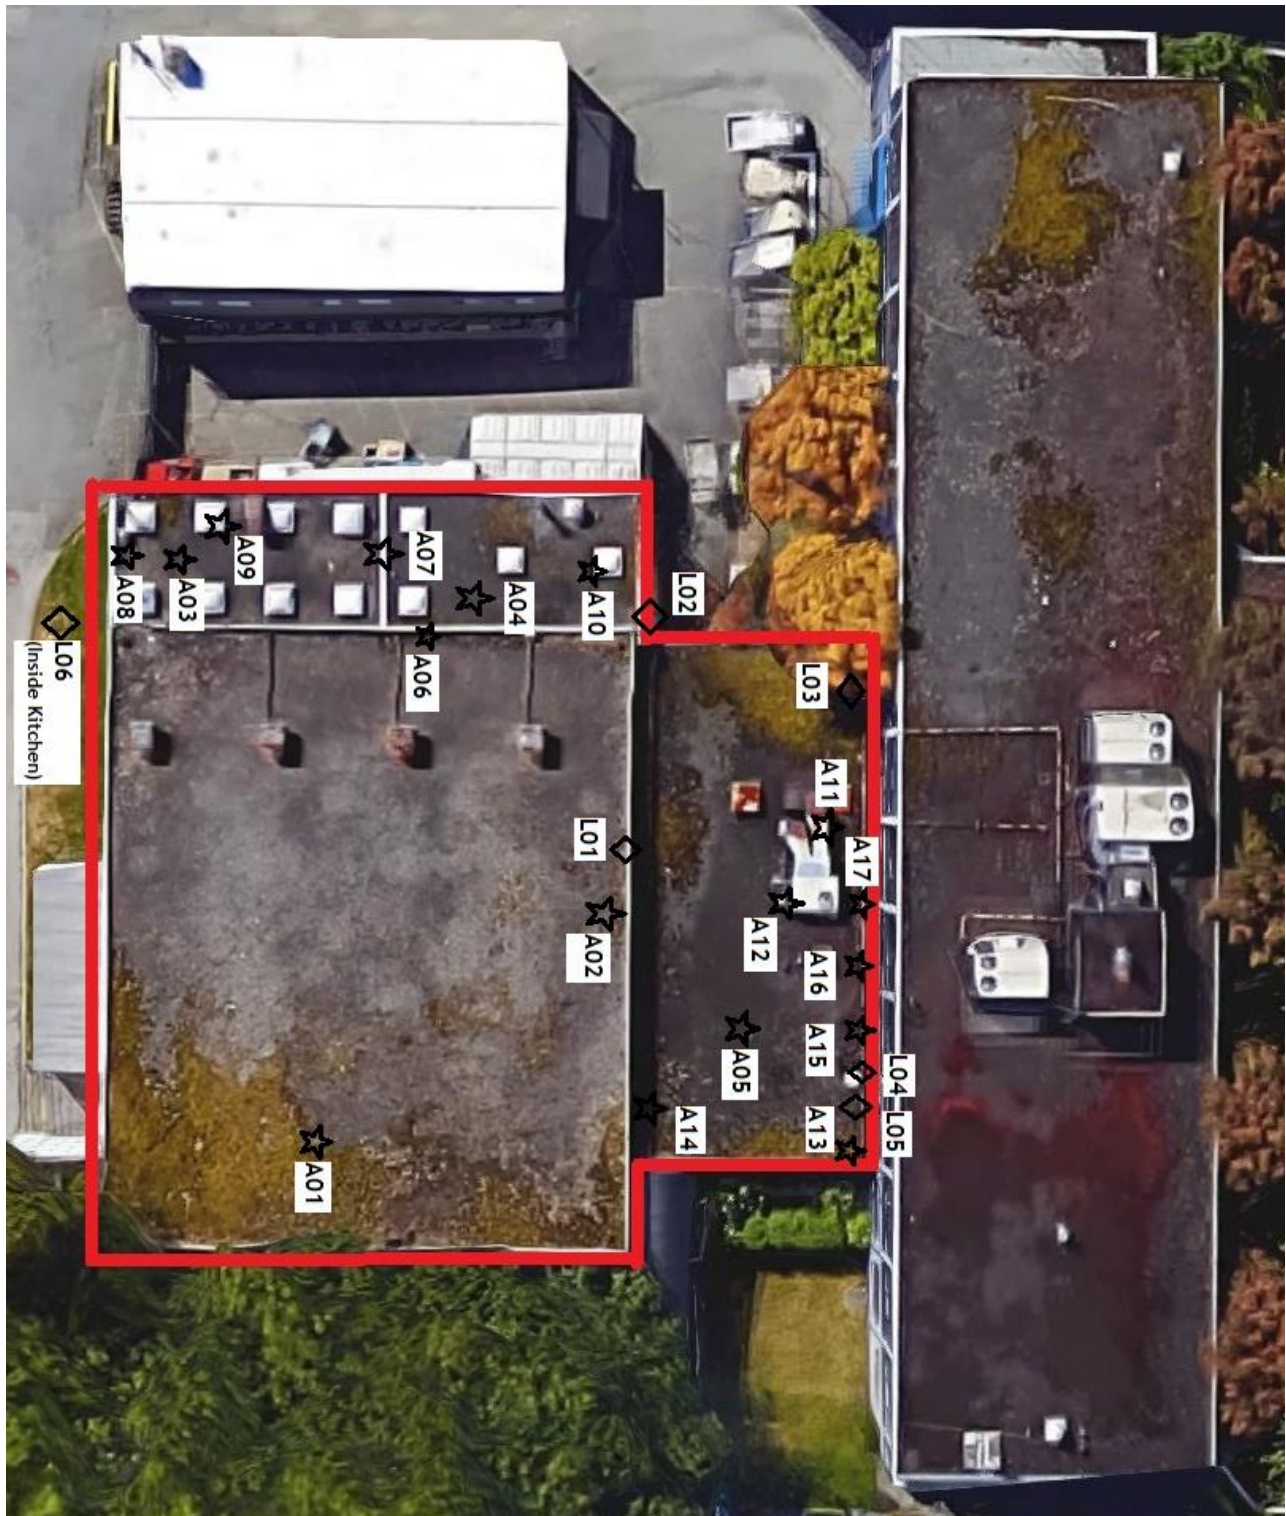
DRAWINGS: (Sample Locations)

- This survey and review was completed with the understanding that the roof renewal work only includes the East and Middle roofs (above the Hastings Room - as outlined in red on the drawings)

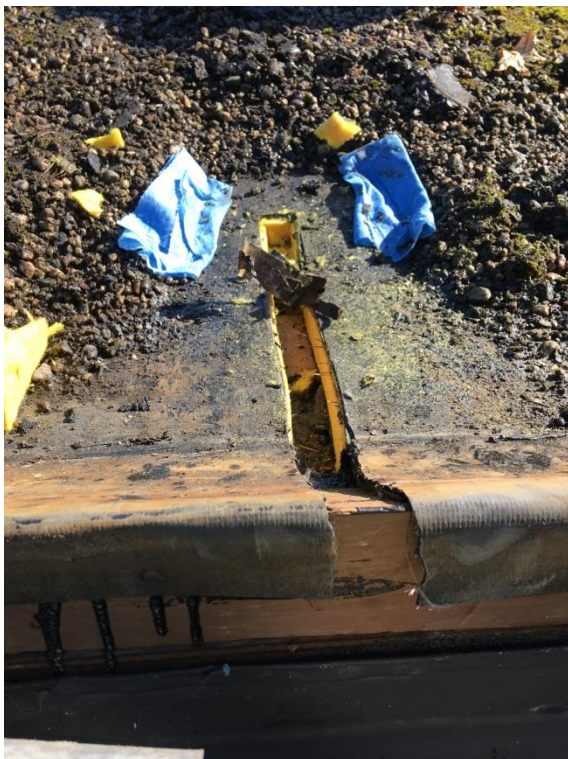
Sample No.	Location	Material	Result
7311-A01	East Roof (N) - North End	Roofing Materials	Asbestos Fibres Not Detected
7311-A02	East Roof (N) - West End	Roofing Materials	Asbestos Fibres Not Detected
7311-A03	East Roof (SE) - East End	Roofing Materials	Asbestos Fibres Not Detected
7311-A04	East Roof (SW) - West End	Roofing Materials	Asbestos Fibres Not Detected
7311-A05	Middle Roof - North End	Roofing Materials	Asbestos Fibres Not Detected
7311-A06	East Roof (N/S)	Grey Mastic on Metal Flashing	5-10% Chrysotile Asbestos
7311-A07	East Roof (E/W)	White Caulking on Metal Flashing	Asbestos Fibres Not Detected
7311-A08	East Roof (SE)	Black Tar on Vent Collar	Asbestos Fibres Not Detected
7311-A09	East Roof (SE) Skylights	Black Tar on Skylights	30-40% Chrysotile Asbestos
7311-A10	East Roof (SW) Skylights	Black Tar on Skylights	Asbestos Fibres Not Detected
7311-A11	Middle Roof	Black Tar on HVAC Duct	30-40% Chrysotile Asbestos

Photo1: East Roof (N) - North End Test Cut [7311-A01]

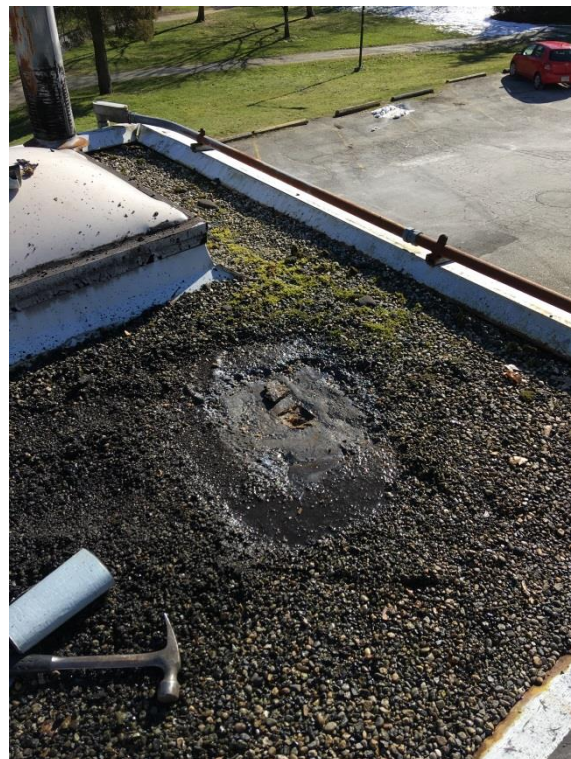
Photo2: East Roof (N) - West End Roof Test Cut [7311-A02]

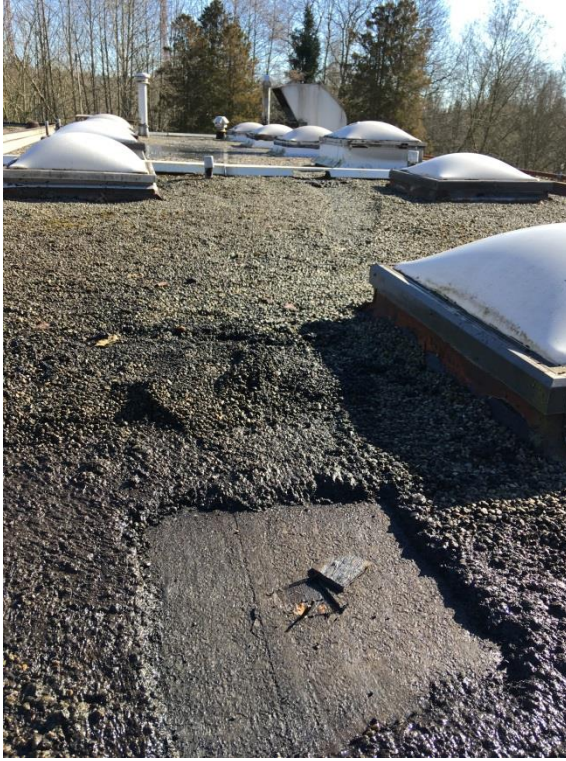
Photo3: East Roof(SE) - East End Roof Test Cut [7311-A03]

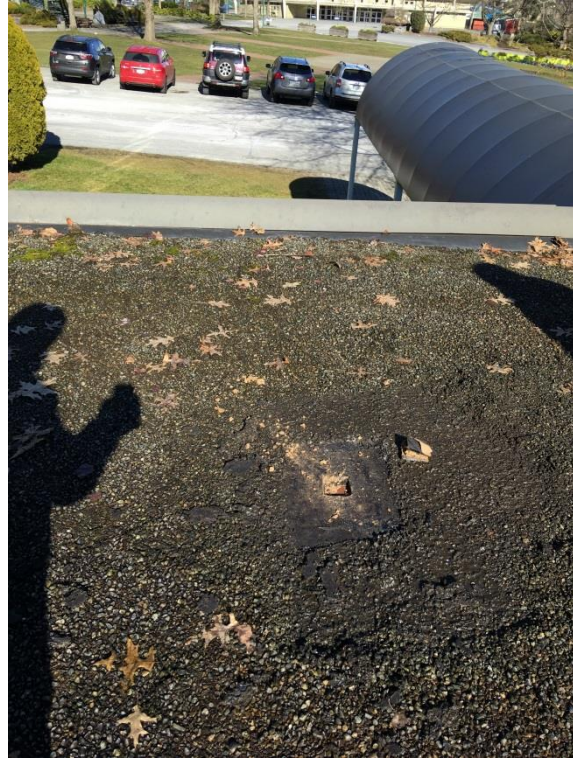
Photo4:East Roof (SW) - West End Roof Test Cut [7311-A04]

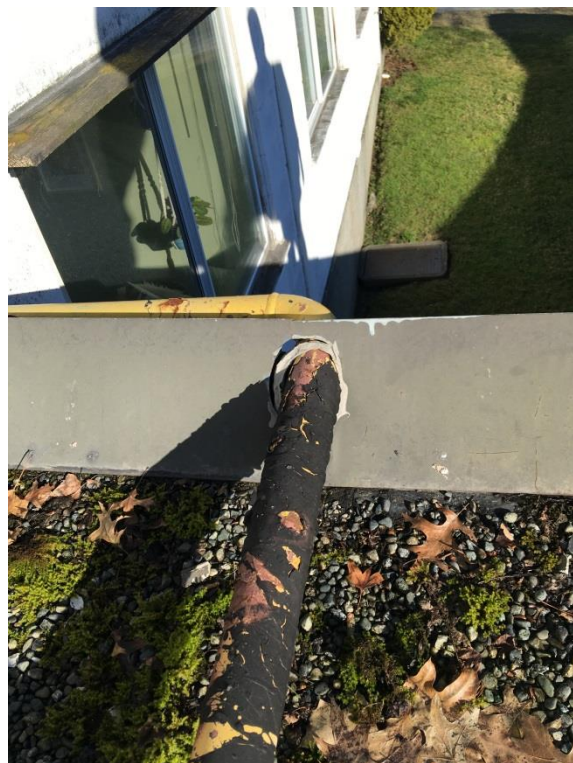
Photo10:Middle Roof - Black Tar on HVAC Duct [7311-A11]

Asbestos containing materials and surfaces with lead-based paints will be disturbed during the roof replacement process. All work involving hazardous building materials must be completed by one of the City of Vancouver's pre-qualified abatement contractors. Workers performing any disturbance or removal of hazardous building materials must be adequately trained and qualified to do so and follow Work Safe BC Occupational Health & Safety Regulations.

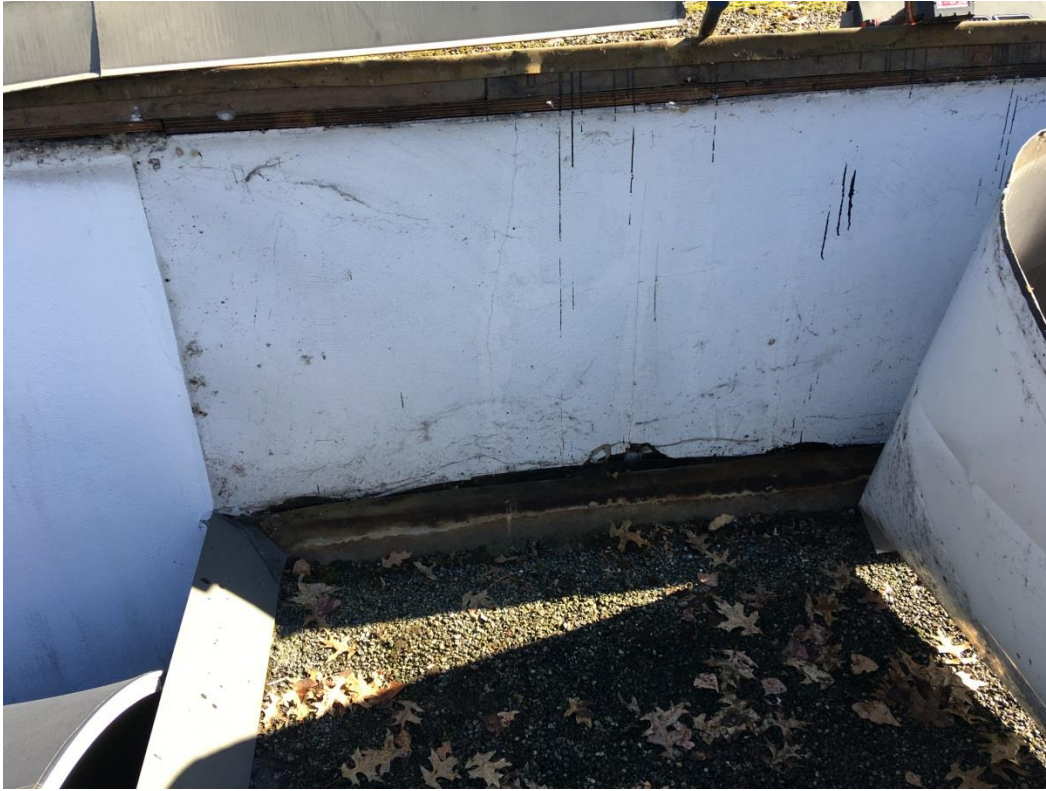
Photo11: Middle Roof - Grey Caulking Around Gas Pipe [7311-A13]

* Subjected To An Ashing Procedure						
13	7311-A13	Grey Caulking Around Gas Pipe, Middle Roof, North End	Asbestos Fibres Not Detected 95 -100 % Non-fibrous	Mar 14 2019	HH	---

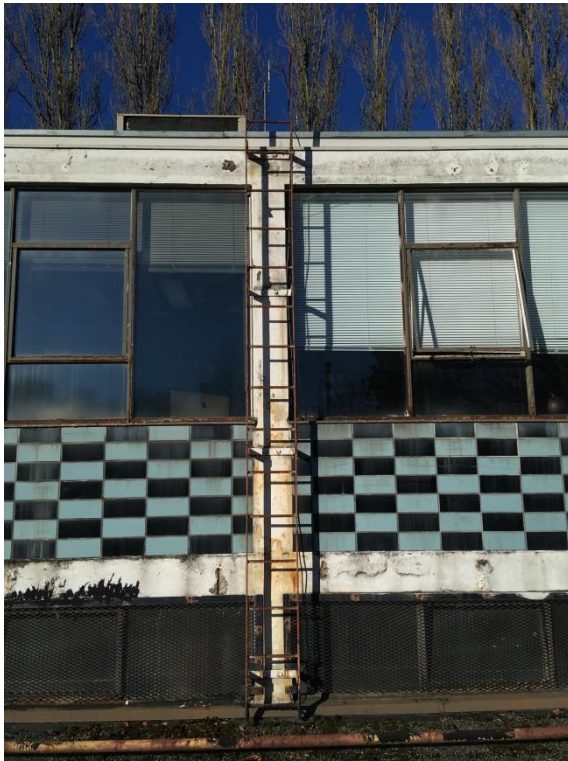
Photo12: Middle Roof - (East Wall - Behind Flashing) - Stucco Wall [7311-A14]

* Subjected To An Ashing Procedure						
14	7311-A14	Stucco Wall, Middle Roof, East Wall (Behind Flashing)	Asbestos Fibres Not Detected DNQ Quartz DNQ Micaceous Material 95 -100 % Non-fibrous	Mar 14 2019	HH	---
