**Our Reference:** 1803-cov-002-l-dpg.doc

**Re:** Granville Bridge - Load Limit Review

This letter report presents the results of a preliminary load limit review for the Granville Bridge conducted by Buckland & Taylor Ltd. (B&T) for the City of Vancouver (City).

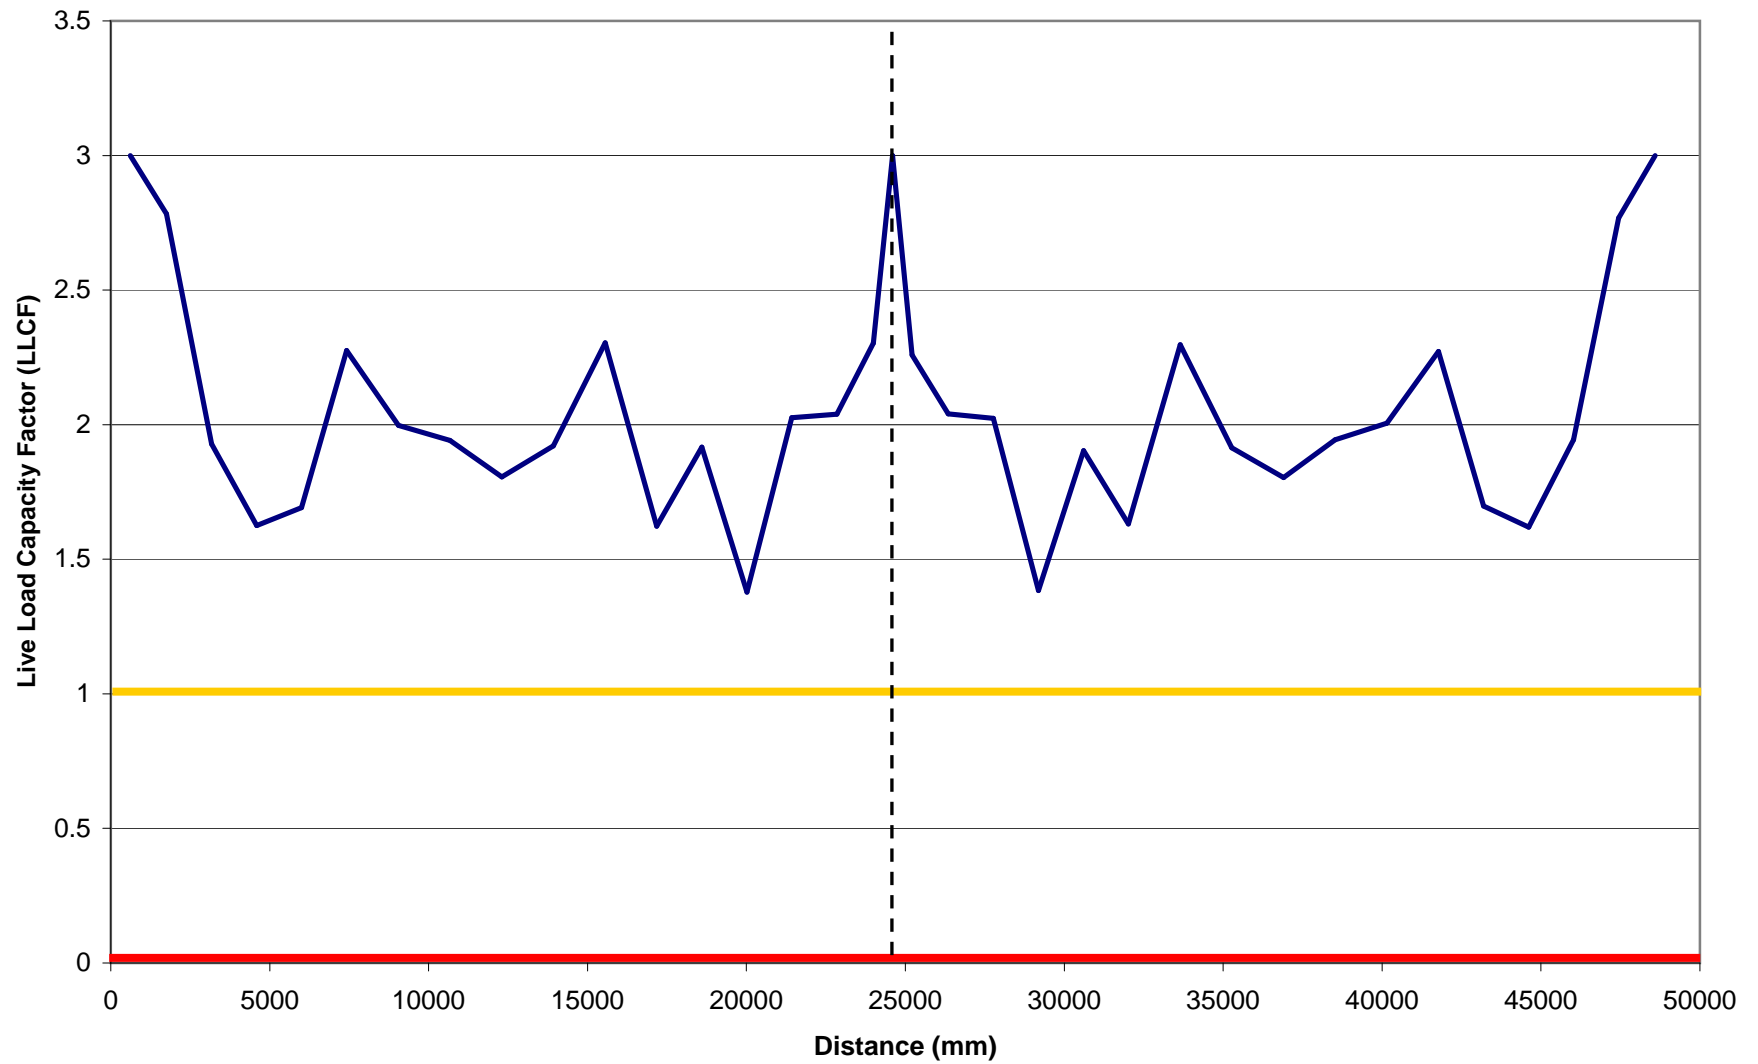
**Figure 1 - Seven Girder Concrete Approaches 2 Span (S24-S26)**  
**CL-3 Moment**

The seven girder concrete approach spans, 11 spans in total, are located at either end of the steel truss spans prior to the side approach ramps separating from Granville Street. As shown in Figure 1, these spans have sufficient moment capacity for the CL-3 loading which indicates that they are also adequate in flexure for all the proposed bus loadings. However, these spans were found to contain shear capacity deficiencies for both the CL-3 and Tour Bus loadings, as shown in Figures 2 and 3. Note that the vertical dashed lines on the shear capacity plots indicate the limits of zones close to the piers where the shear forces are considered to transfer directly to the piers and any indicated shear capacity issues are not applicable. For the CL-3 loading the shear deficiencies are more pronounced at the non-continuous ends of the spans and near midspan. For the Tour Bus the deficiencies are less severe or extensive but still significant. Minimum live load capacity factors for the CL-3 and Tour Bus loadings are approximately 0.25 and 0.50, respectively. Live load capacity factors of less than 1.0 indicate that the structure does not provide the desired level of safety for the loading being evaluated. Less severe shear deficiencies could also be expected for the two axle transit bus configurations.

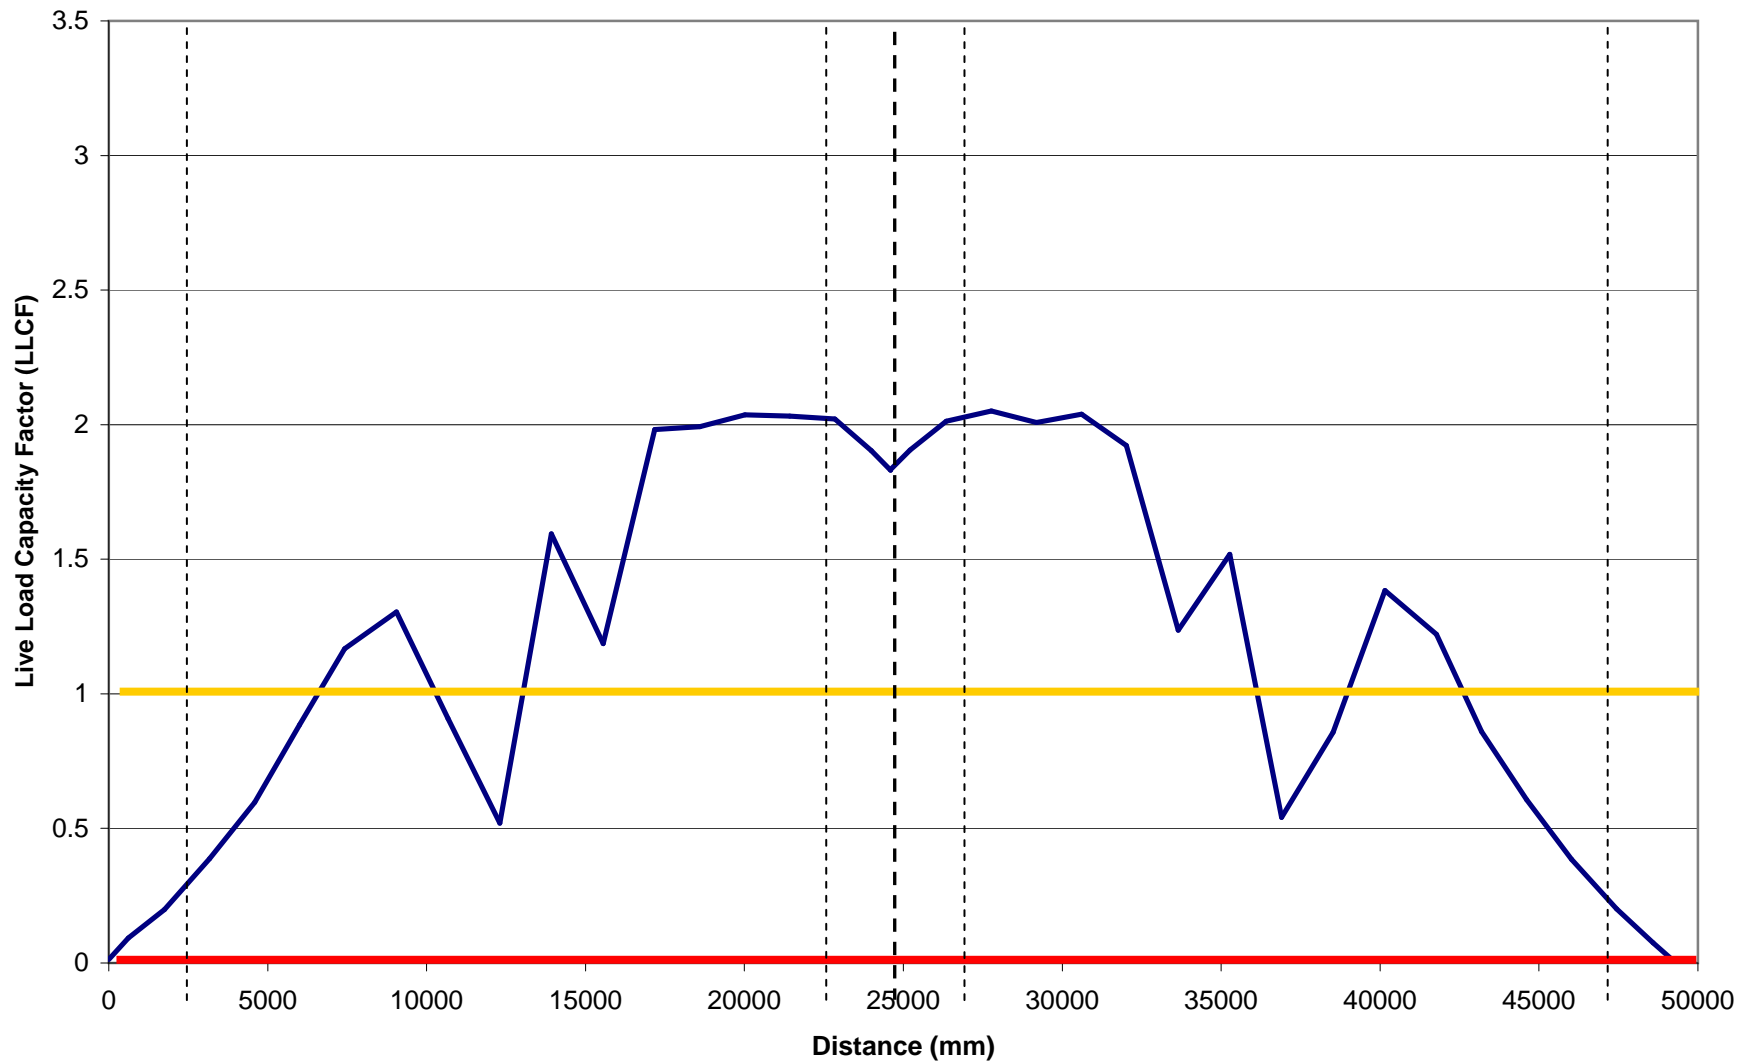
**Figure 2 - Seven Girder Concrete Approaches 2 Span (S24-S26)**  
**CL-3 Shear**

While the steel deck system on the truss spans were adequate for the shear loadings imposed by the CL-3 loading, substantial and widespread shear deficiencies were identified in the girders of the concrete approach spans for both the CL-3 and the bus loadings. This was not unexpected as shear capacity issues are often identified in concrete girders from this time period. The shear capacity of a concrete section is typically comprised of a component provided by the concrete,  $V_c$ , and by the transverse reinforcement (stirrups),  $V_s$ . Since the design of the Granville Bridge, the amount of shear capacity that is permitted to be obtained from the concrete,  $V_c$ , has dropped dramatically. The design specifications for the Granville Bridge limited the allowable shear stress on a concrete section to  $0.03f'_c$  with no requirements for a minimum amount of transverse reinforcement. While the

Although the bridge has performed well to date under the existing loadings, the identified shear deficiencies are significant and it is recommended that appropriate upgrades to the structure be developed and implemented in a timely manner. In addition, it is recommended that no increases be permitted in the weights of the vehicles using the bridge.

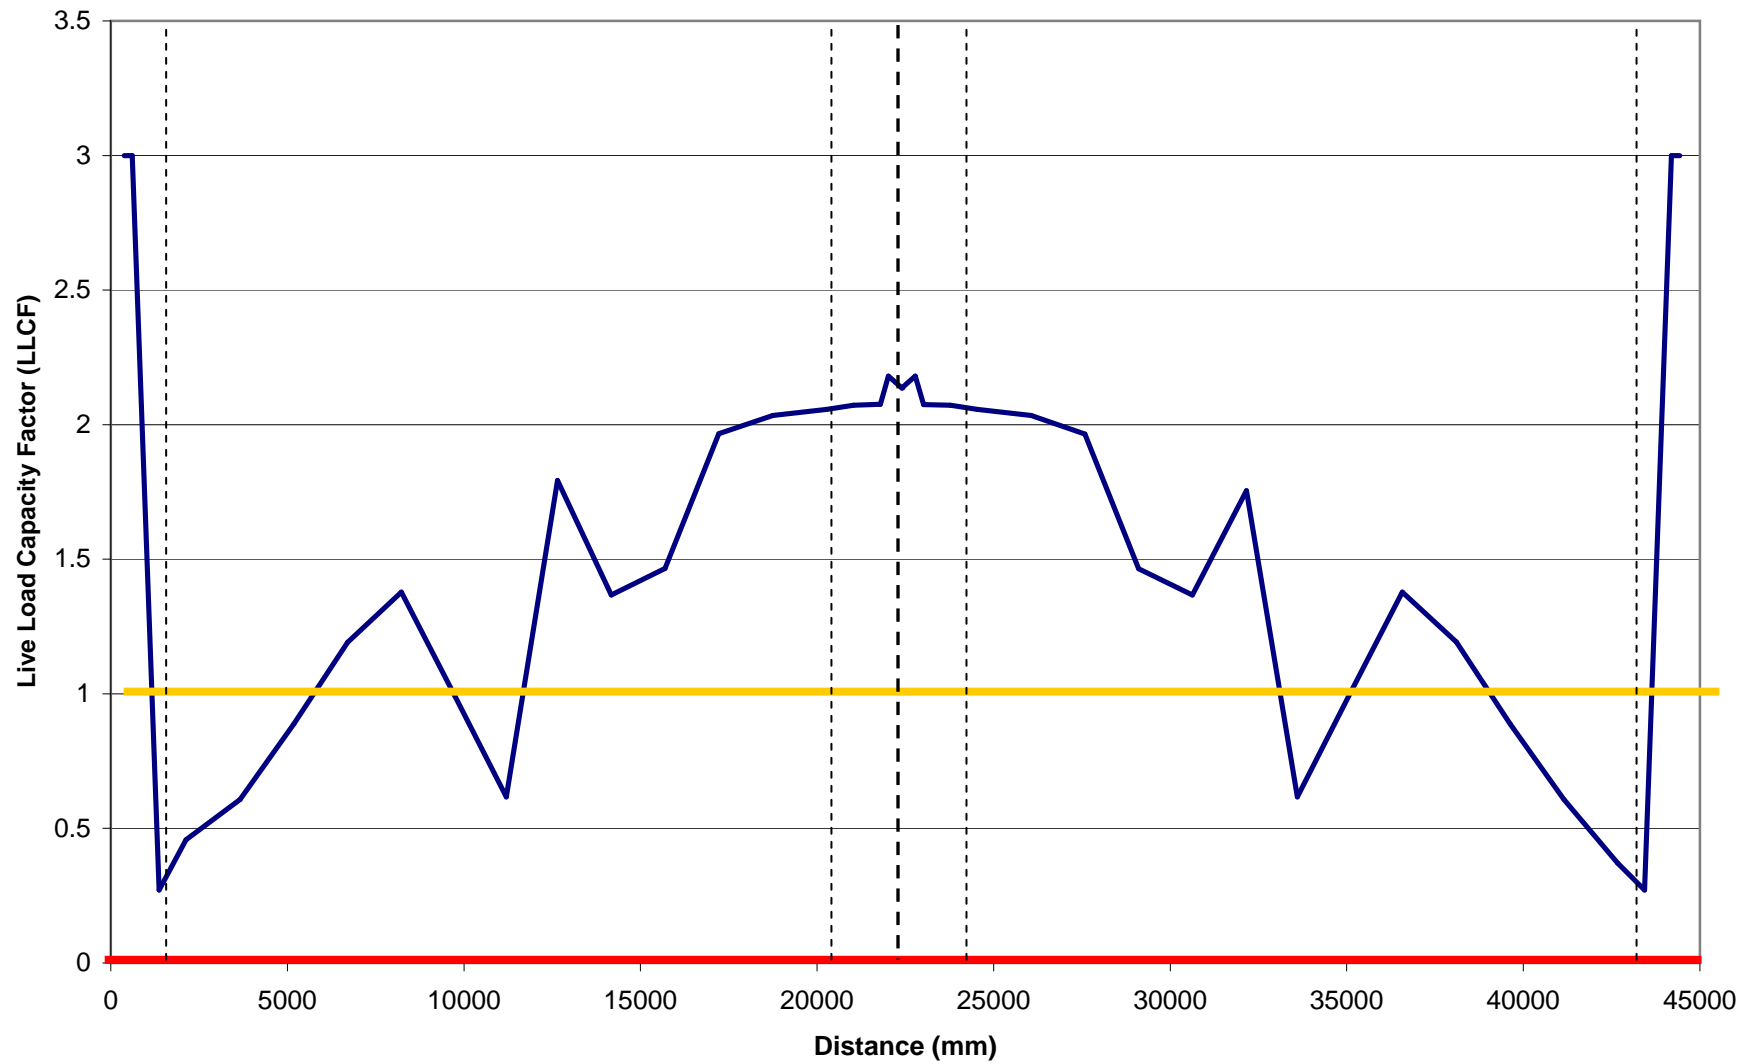
**Figure 4 - Five Girder Concrete Approaches 2 Span (N14-N16)**  
**CL-3 Shear**

The five girder concrete approach spans, 22 spans in total, are located along Granville Street from the points where the side approach spans separate from Granville to the ends of the bridge. These spans have sufficient moment capacity for the CL-3 loading and all bus configurations. However, similar to the seven girder spans, these spans were found to contain shear capacity deficiencies for both the CL-3 and bus loadings, as shown in Figures 4 and 5. Minimum live load capacity factors for the CL-3 and Tour Bus loadings are approximately 0.28 and 0.50, respectively.

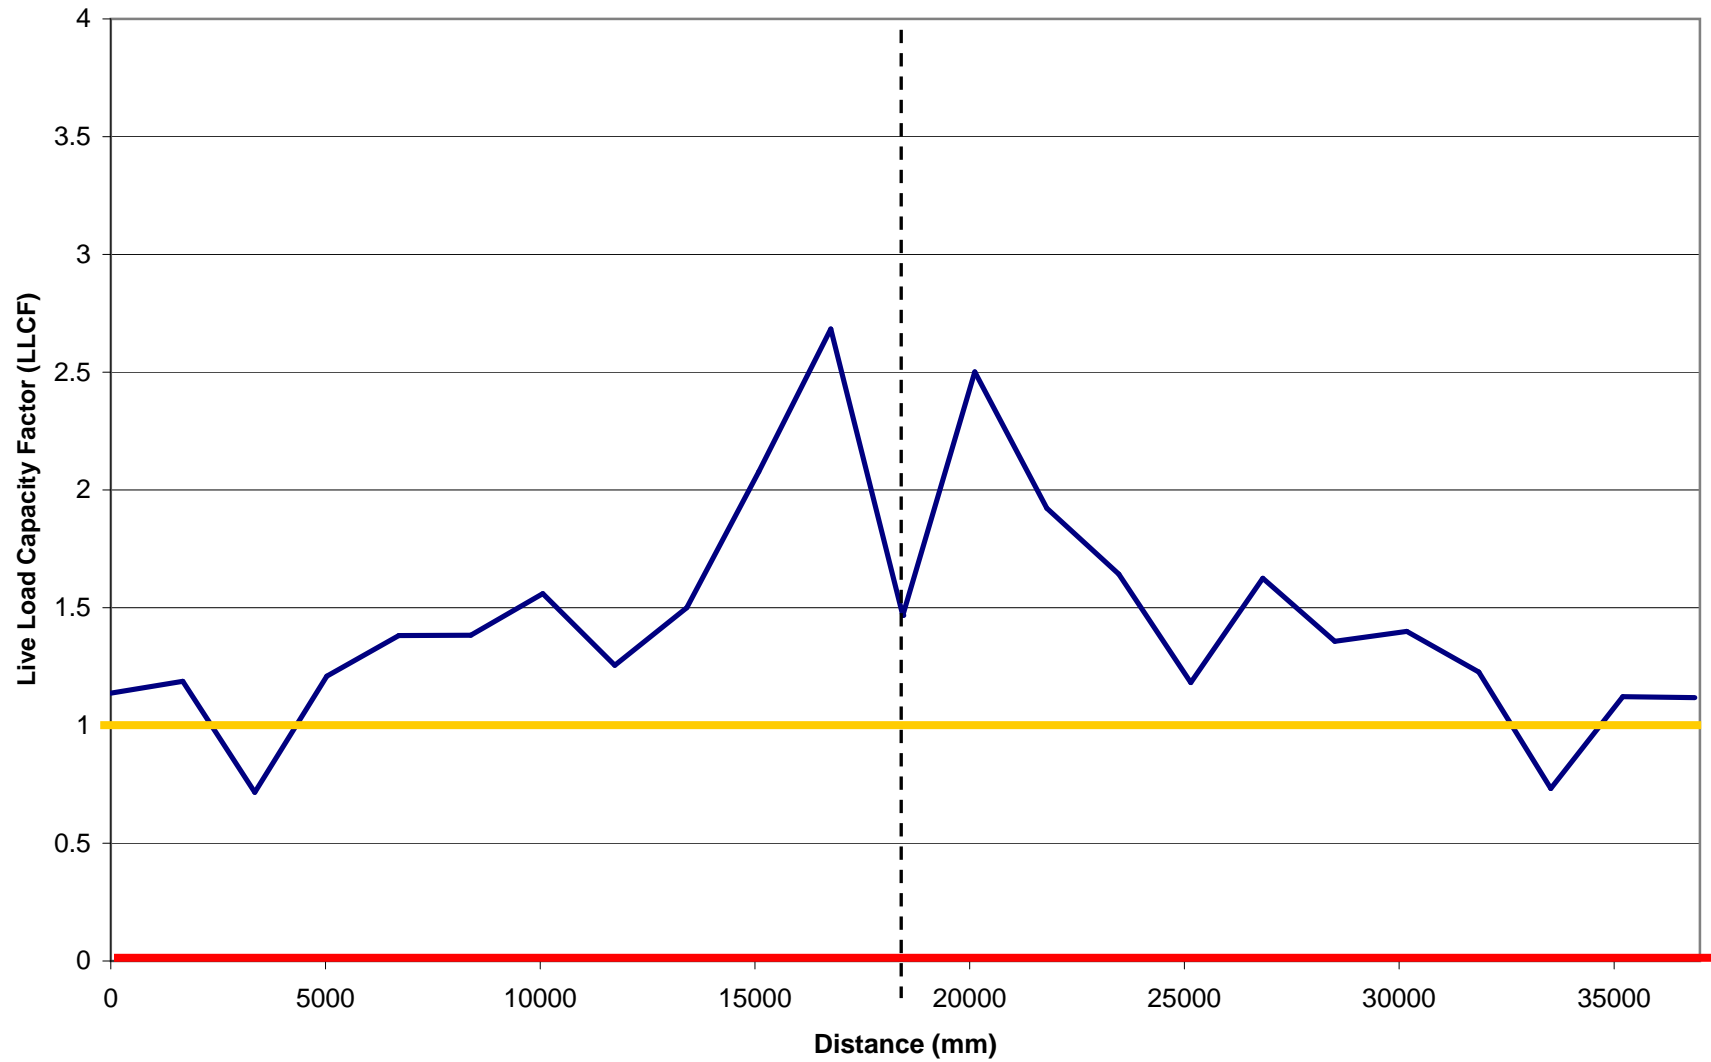
**Figure 6 - Three Girder Concrete Approaches 2 Span (N52-N54)**  
**CL-3 Moment**

The three girder concrete approach spans, 23 spans in total, consist of the Howe and Seymour Street ramps at the north end of the bridge. These spans were found to be acceptable for all transit and tour bus configurations but are deficient for the CL-3 loading in both shear and moment, shown in Figures 6 and 7. The minimum live load capacity factors for the CL-3 moments and shears are approximately 0.75 and 0.95, respectively.

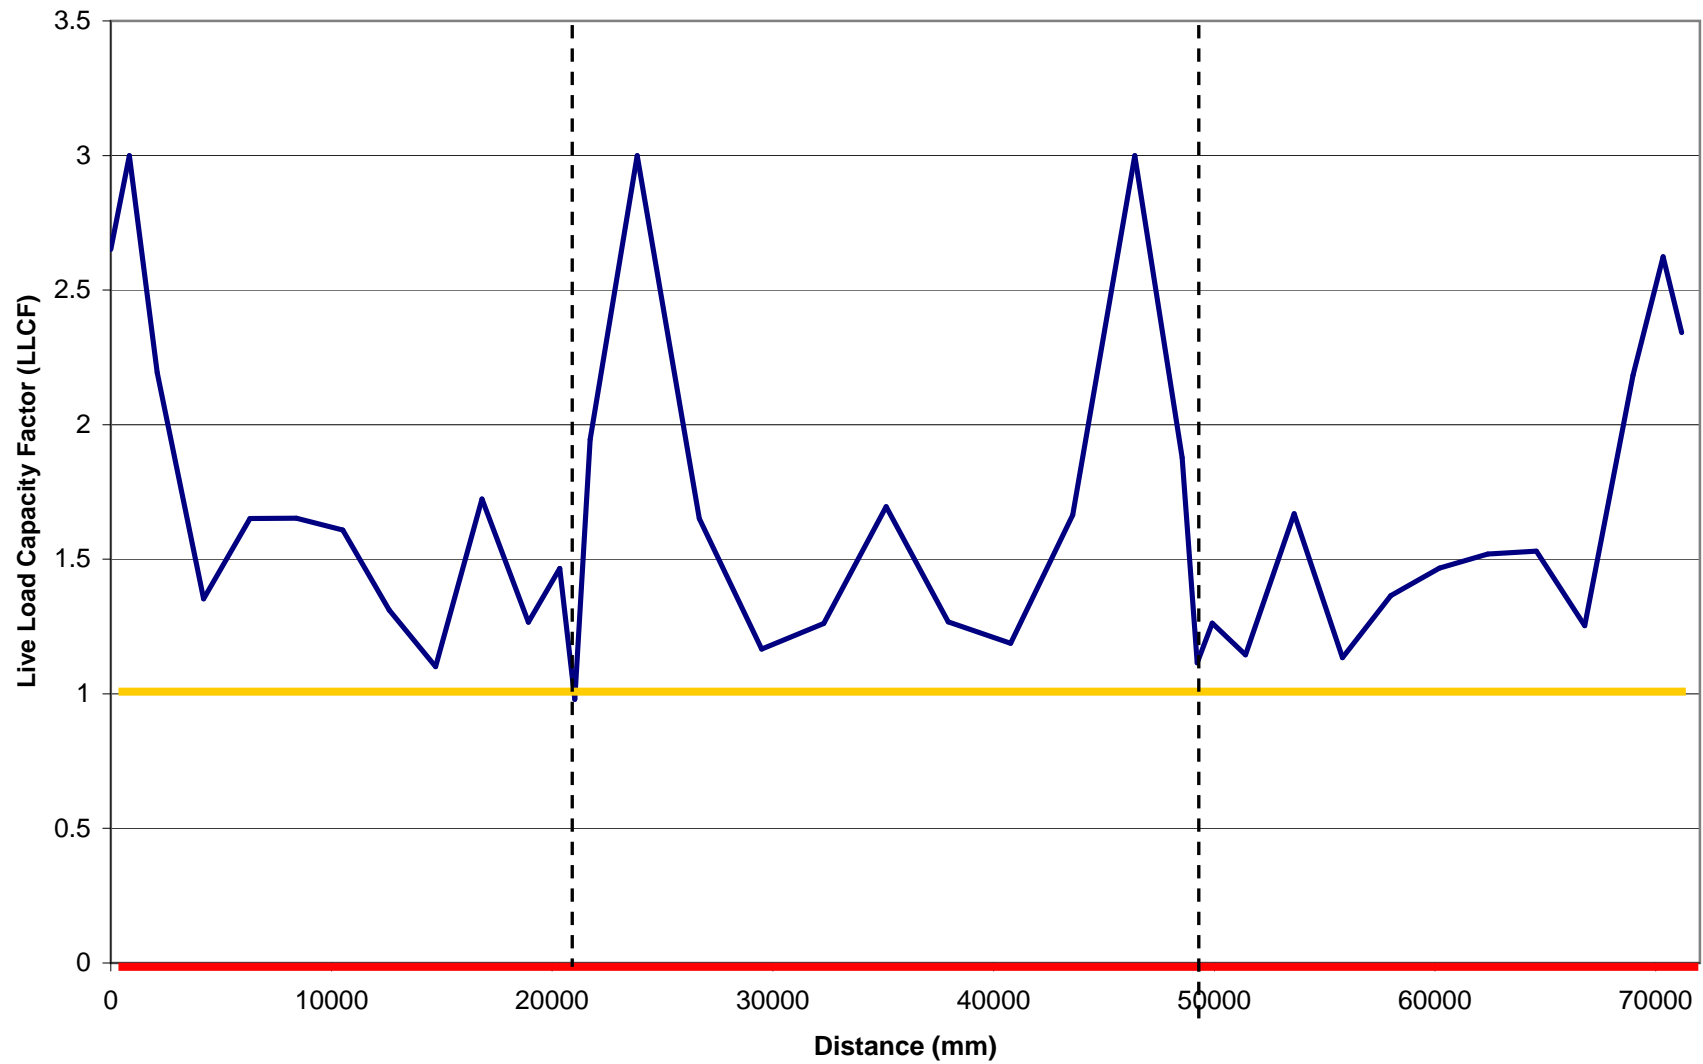
**Figure 8 - Two Girder Concrete Approaches 3 Span (S88 - S91)**  
**CL-3 Moment**

The two girder concrete approach spans, 45 spans in total, consist of the Hemlock, Fir and 4<sup>th</sup> St. ramps on the south end of the bridge. These spans were found to have sufficient moment capacity for all the bus configurations and the CL-3 loading, as shown in Figure 8. However, these spans were found to be deficient in shear for both the CL-3 and Tour Bus loadings over substantial lengths of the spans, as shown in Figures 9 and 10. Minimum live load capacity factors for the CL-3 and Tour Bus loadings are approximately 0.20 and 0.25, respectively.
