City of Vancouver Burrard Sewage Pump Station Condition Assessment

19 Jan 2018
Rev. 0

WATER STREET ENGINEERING LTD.

TITLE	Condition Assessment		
PROJECT	City of Vancouver Burrard Sewage Pump Station		
AUTHOR	Allan Bronsro, MCIP, PEng		
DISTRIBUTION			
DATE	19 Jan 2018	FILE REF	Client PO #4500576473 WSE File #087.300
VERSION	Rev. 0	STATUS	Final
DISTRIBUTION	Wally Konowalchuk, PEng, City of Vancouver

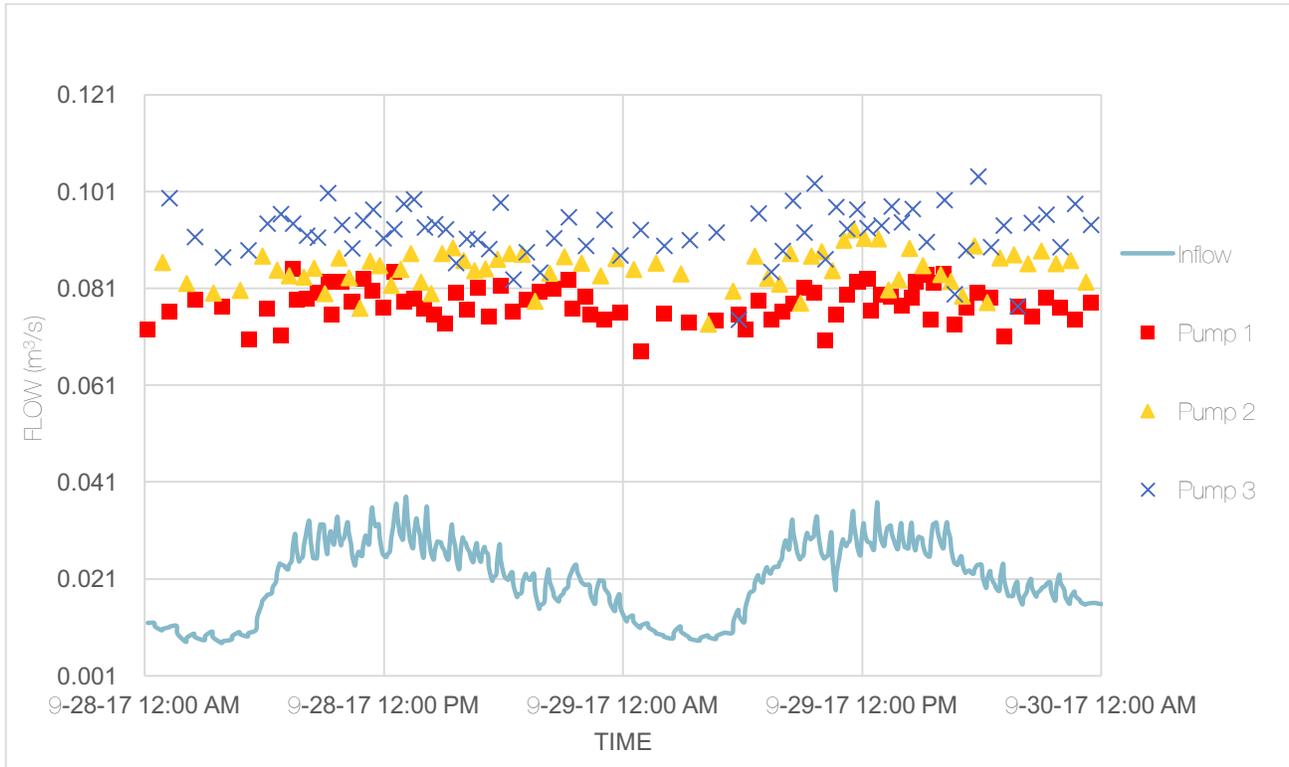
Figure 3-1: Estimated Inflows and Pumped Flows, 28-29 Sep 2017

The highest inflow estimated by the above method was 38 L/s. While this value does not represent a design flow, it provides some evidence that the station has plenty of capacity on days with moderate rainfall. September 28 was a dry day. September 29 had some rain in the morning, but not enough to constitute a design event for inflow and infiltration. While there was a clear diurnal pattern to the sewage inflows, there was no obvious difference between the two days, indicating that I&I was not significant during the event of 29 Sep. The City reports that the station rarely requires two pumps to operate together.
