REQUEST FOR PROPOSAL NO. PS20210991
CONSULTING SERVICES FOR THORNTON PARK PUMP STATION UPGRADES

ADDENDUM NO.1

TECHNICAL MEMORANDUM

SUBJECT	Thornton Park Pump Station Wet Well Condition Assessment		
PROJECT	City of Vancouver Thornton Park Pump Station Repairs		
TO	Thomas Mah, PEng City of Vancouver	FROM	Stuart Fretwell, PEng
DATE	28 July 2021	FILE REF	WSE File #165.300
VERSION	A	STATUS	Draft

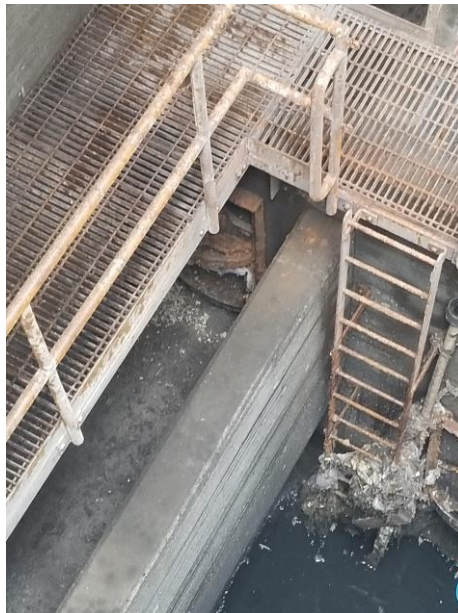
Figure 3: Ladder, platforms and guard rails

The intermediate ladders and platforms are in fair overall condition; however, the guardrails are in generally poor condition. The lower ladders are in very poor condition and should be removed or replaced. Stainless steel anchor rods at supports were found to be in good condition with no visible evidence of corrosion.

It is recommended that the platforms are not used unless the guardrails are replaced or rehabilitated as described in the structural assessment memorandum included in Appendix 2.

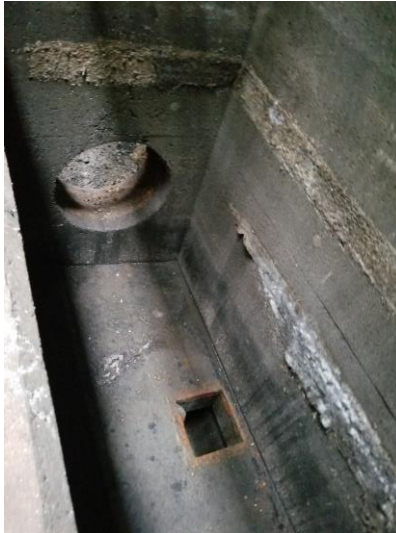
Figure 4: West diffuser trough

The inlet sewage diffuser troughs distribute the incoming wastewater between the wet wells. There are two openings in the bottom of each trough that can be manually plugged with steel plates to isolate each side of the wet well. The trough holes were fully or partially plugged during the assessment and were subsequently unplugged after the assessment.

The inlet trough openings should be routinely cleaned as they are prone to blockages by accumulated solids. No immediate repair work is recommended.

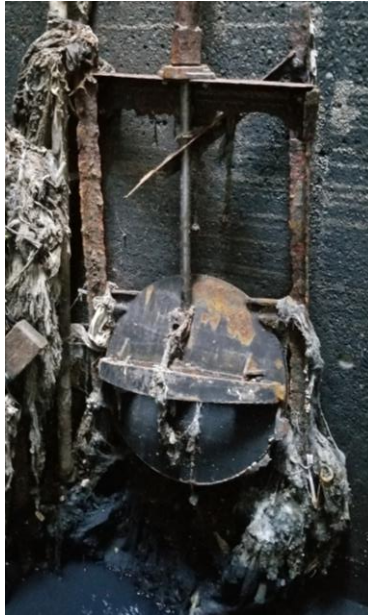
Figure 5: SG-4 Wet well dividing wall gate

SG-2, 3, and 4 are in very poor condition and require repairs or replacement as the units are inoperable. Each unit was observed as highly corroded, resulting in seizing of the gate discs and actuator mechanisms / valve stems, with some instances resulting in component deformation and breakage.

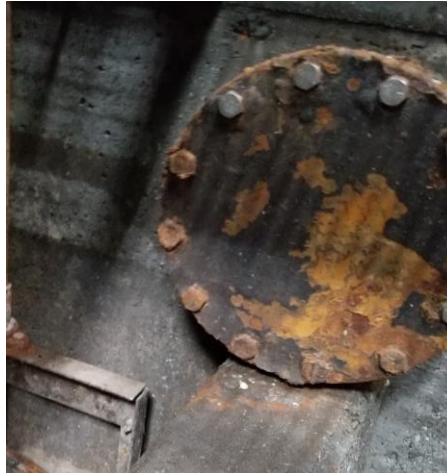
Figure 6: Overflow piping (blind flange installed)

Overflow pipe connections (300 mm diameter) are installed between the wet well and inlet manholes on both the east and west sides of the station. The overflow piping connections are capped inside the wet well on both sides of the station with blind flanges as shown in Figure 6. The overflow piping was not tested as part of the assessment but the piping is assumed to be in similar condition to the other wall piping penetrations. Surface corrosion was noted on the flange, piping and bolts.

If the City plans to use the overflow connections in the future, the surface of the piping should be cleaned and the wall thickness measured to check the suitability of the piping for service.

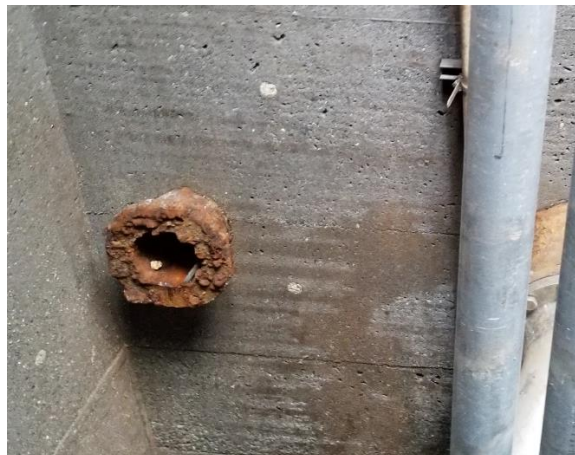
Figure 7: 200 mm dia. blowdown connection

The 200 mm dia. steel blowdown wall piping and flange is in very poor condition and is heavily corroded as shown in Figure 7. If the City intends to use the blowdown piping, the wall piping should be replaced and the vertical drop piping re-installed (as shown on record drawings).

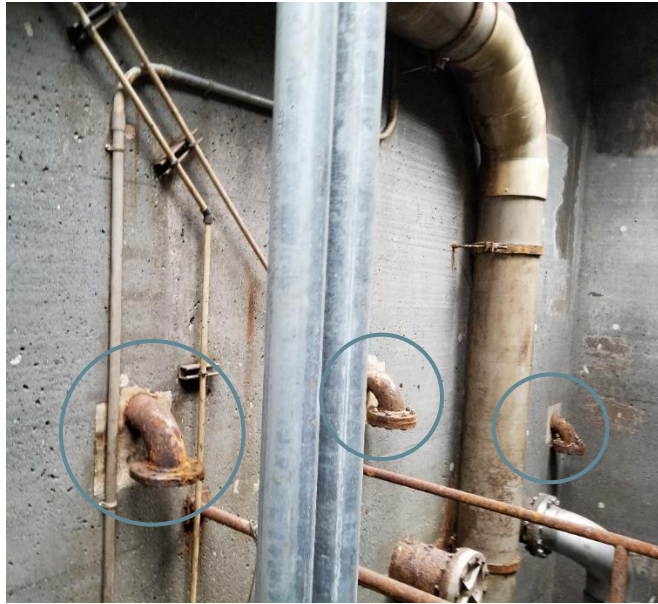
Figure 8: 100 mm dia. wet well flush pipes

The 100 mm dia. wet well flushing pipes, shown in Figure 8, are in poor condition and appear to have been replaced since original construction based on the appearance of concrete patches. Two of the three pipes have been capped with blind flanges and do not appear to be in use. If the City intends to use the flushing pipes in

the future, the surface corrosion should be removed and the piping inspected and re-coated or the piping should be replaced with stainless steel.

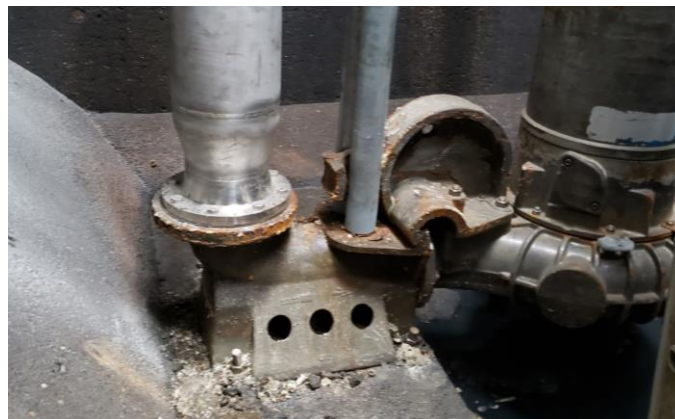
Figure 9: Pump #4 discharge elbow

The pump bases are assessed to be in good condition with no need for major repair or replacement. Minor levels of corrosion were observed. All pump leak tests were completed with no signs of leakage at the pump discharge flanges or the discharge spool flanges. All mounting hardware for the bases should be inspected periodically but no visible corrosion was noted.

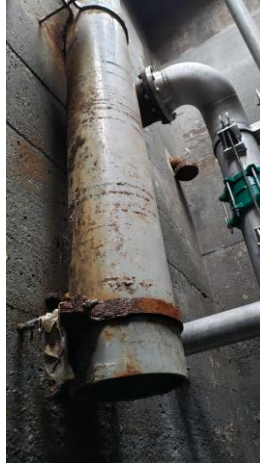
Figure 10: PVC ventilation ducting and supports

Wet well ducts were observed to be in generally fair condition, without signs of deformation or deterioration. Discoloration was observed on the surface of the ducts but is primarily attributed to the corrosion of duct supports and other metal components. Replacement or repair of the ducts is not considered necessary based on the condition of the ducts but the City may want to consider replacement of the relatively low-cost materials at the same time as the supports are replaced. Sizing of the ducts should also be reviewed as part of future upgrade work.

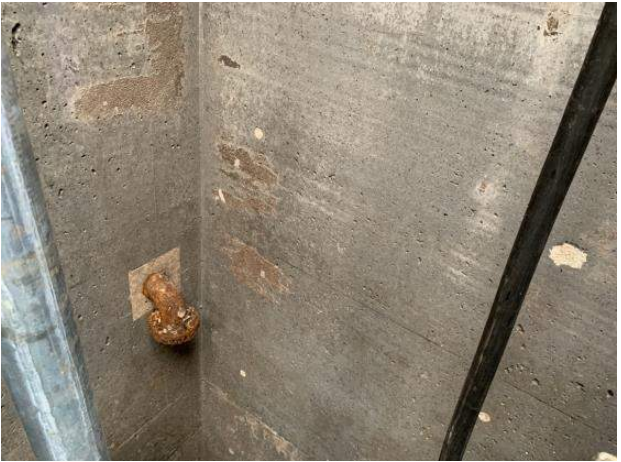
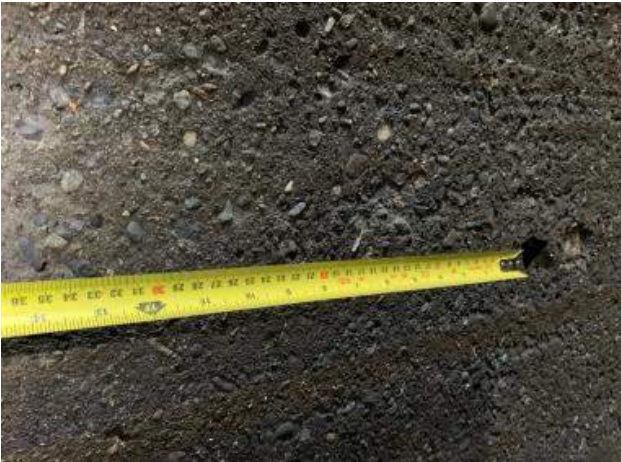
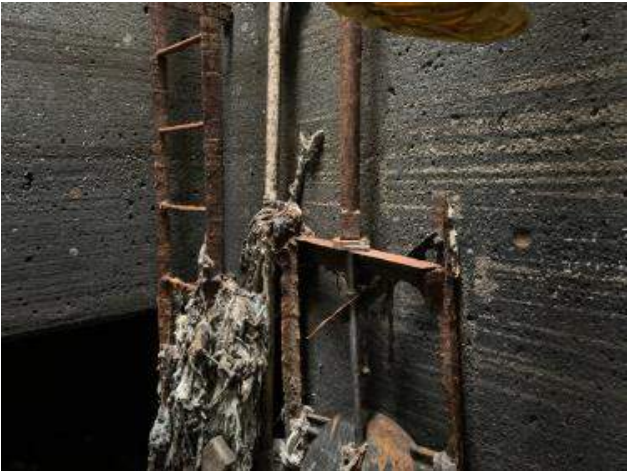
Item	Condition Rating	Repair Category	Condition Description	Recommended Repairs	Photo
Wet Well Concrete					
Wet well concrete (walls)	2	1	<p>Interior faces of wet well and visible portions of base slab appear to be in generally good condition.</p> <p>Lower portions of the walls below normal wet well liquid levels have minor erosion and exposed aggregate due to exposure to effluent and/or scour.</p>	<p>No items were identified for immediate repair. Portions of the base slab were not visible due to liquid levels in the wet well. These should be inspected during future pump station upgrades.</p>

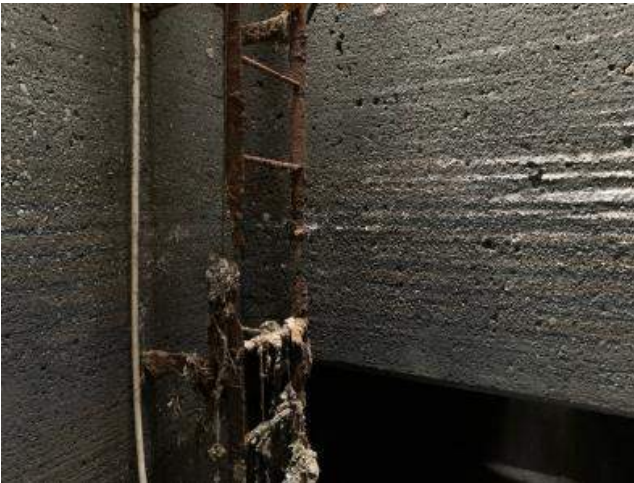
Item	Condition Rating	Repair Category	Condition Description	Recommended Repairs	Photo
Ladders, Grating and Guardrails					
Ladders	2/4	3/4	<p>The intermediate ladders and platforms are assessed to be overall in fair condition.</p> <p>The lower ladders are assessed to be in very poor condition</p>	<p>Intermediate Ladders: Remove corrosion from material and inspect to confirm no significant section loss; re-coat material with suitable coating or replace with stainless steel or fiberglass</p> <p>Lower Ladders: Remove and replace ladders with stainless steel or fiberglass or remove permanent ladders from lower wet well if not intended for use in the future</p>

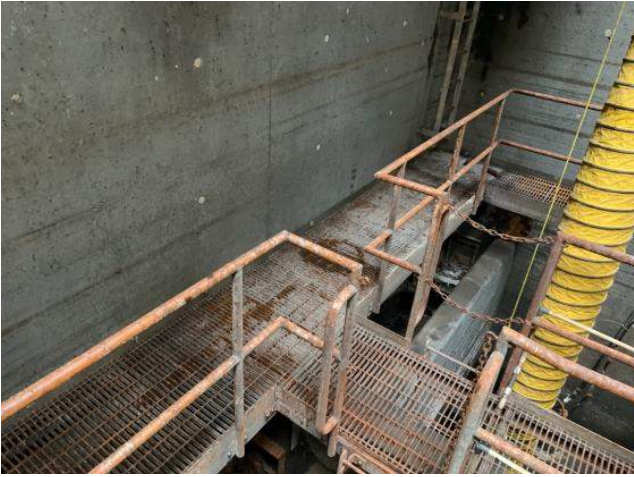
Guardrails	3/4	3	<p>The guardrails for the intermediate platform are in fair to poor condition. They show extensive visible corrosion in some areas and likely have some section loss of structural steel. The thickness of remaining sound steel is unknown.</p>	<p>Remove corrosion from guardrails and inspect to confirm no significant section loss; re-coat material with suitable coating</p> <p>or</p> <p>replace all guardrails with new structure fabricated from 316 stainless steel or fiberglass</p>

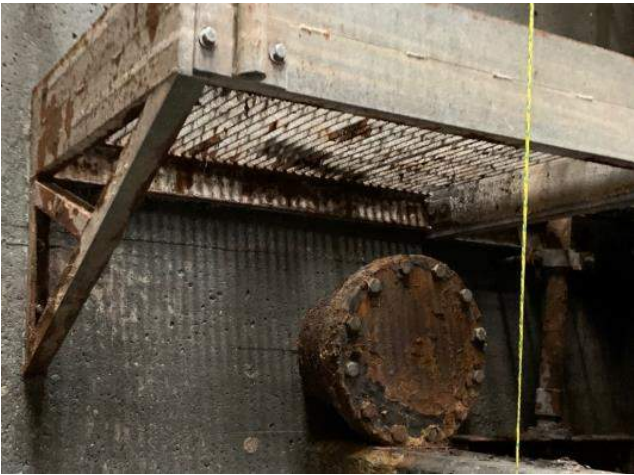
Platforms and platform supports	3	3	<p>The primary steel structure (channels and angles) and bar grating for the intermediate platform and ladder from the intermediate platform to the top of the wet well appear to generally be in fair condition. There is surface corrosion and loss of galvanized coating in many areas. There does not appear to be significant section loss of the structural steel.</p> <p>The anchor rods to the concrete are of stainless steel and appear to be free of corrosion.</p>	<p>Remove corrosion from base material and inspect to confirm no significant section loss; re-coat material with suitable coating</p> <p>or</p> <p>replace all materials with new structure fabricated from 316 stainless steel or fiberglass.</p>

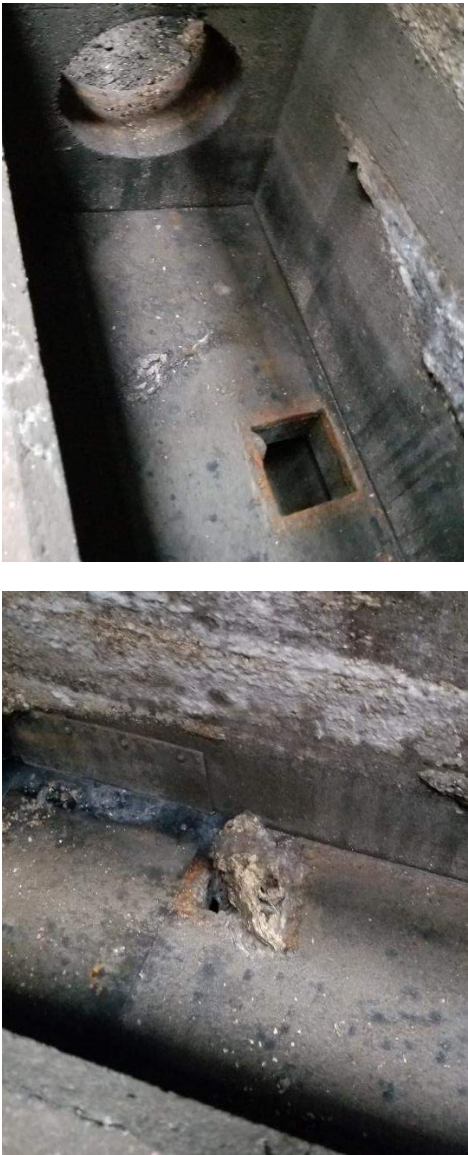
Item	Condition Rating	Repair Category	Condition Description	Recommended Repairs	Photo
Trough Inlets					
Inlet troughs / trough openings	1	1	Trough diffuser openings were fully/partially plugged prior to wet well cleaning	No repair work required. Increase frequency of opening clean out.

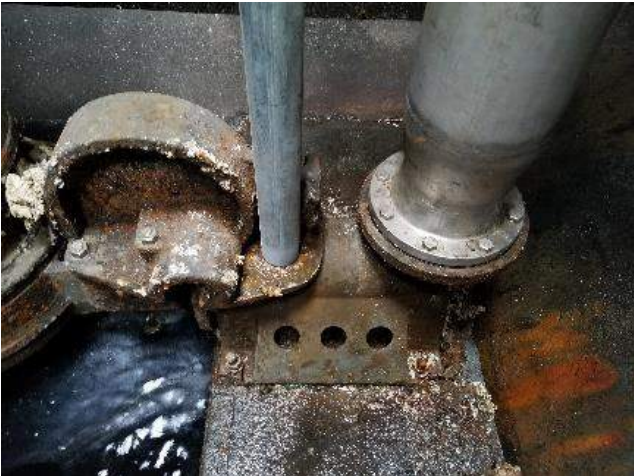
Item	Condition Rating	Repair Category	Condition Description	Recommended Repairs	Photo
Pump Discharge Elbows					
Discharge Elbow (Pump 1)	2	2	Minor corrosion noted, no significant deterioration on exterior body of elbow.	Mounting bolts/nuts should be inspected periodically for signs of deterioration

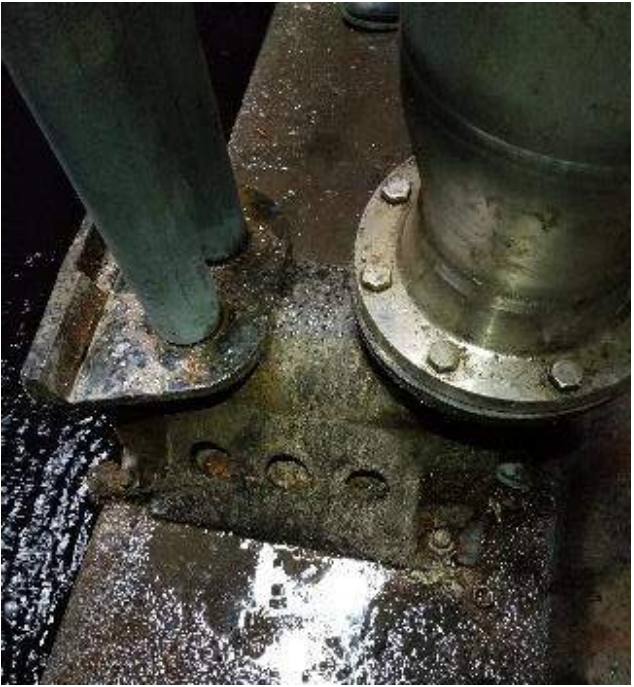
Discharge Elbow (Pump 2)	2	2	Minor corrosion noted, no significant deterioration on exterior body of elbow.	Mounting bolts/nuts should be inspected periodically for signs of deterioration

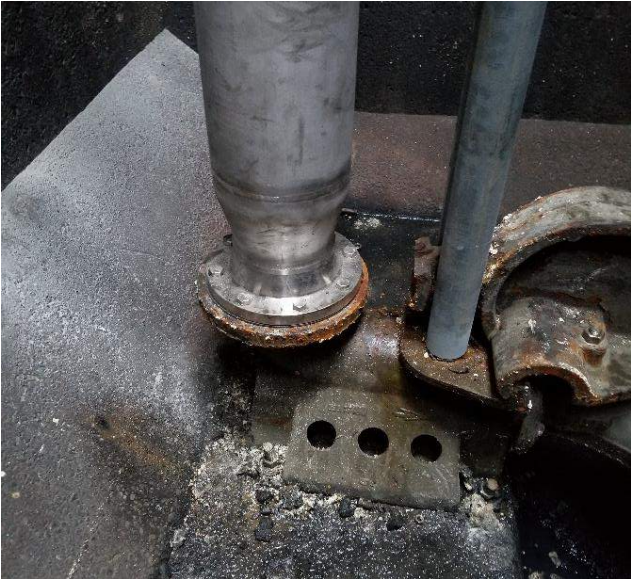
Item	Condition Rating	Repair Category	Condition Description	Recommended Repairs	Photo
Discharge Elbow (Pump 4)	2	2	Minor corrosion noted, no significant deterioration on exterior body	Mounting bolts/nuts should be inspected periodically for signs of deterioration

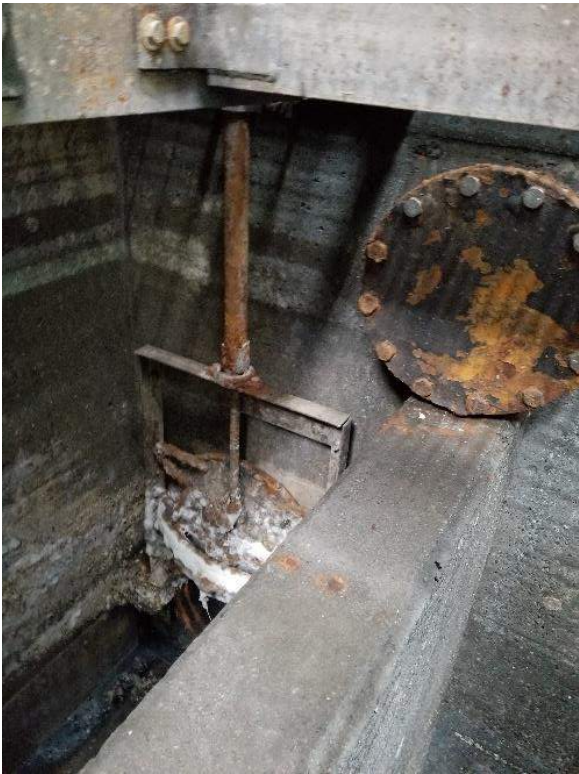
Sluice Gates					
Sluice gate (West inlet)	3/4	3	Gate operable. Some corrosion/buildup noted on gate and frame.	Remove gate and frame for cleaning/servicing; inspect all hardware for loss of structural material

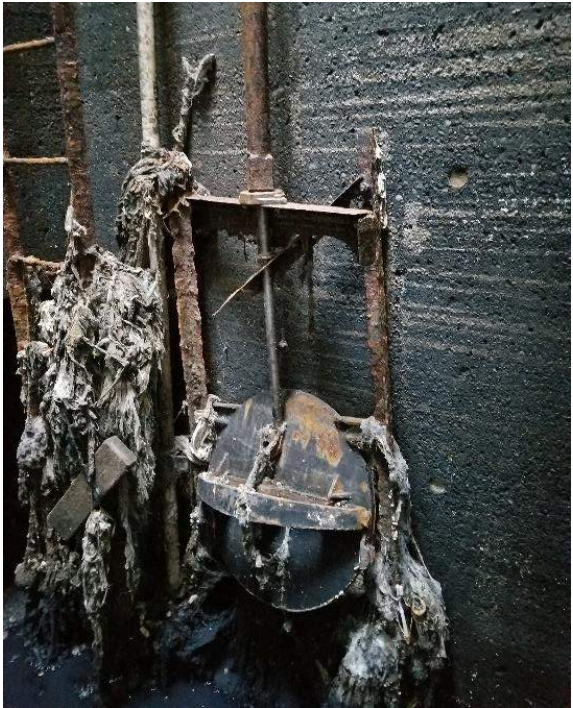
Item	Condition Rating	Repair Category	Condition Description	Recommended Repairs	Photo
Sluice gate (Middle wet well dividing wall)	5	4	Gate inoperable. Significant deterioration of frame and mounting hardware	Remove and replace gate, frame and mounting hardware

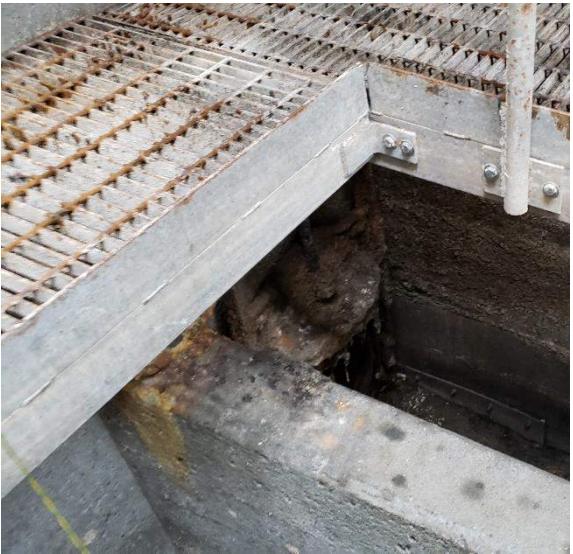
Sluice gate (East inlet)	5	4	Gate inoperable. Significant corrosion/buildup noted on gate and frame	Remove and replace gate, frame and mounting hardware

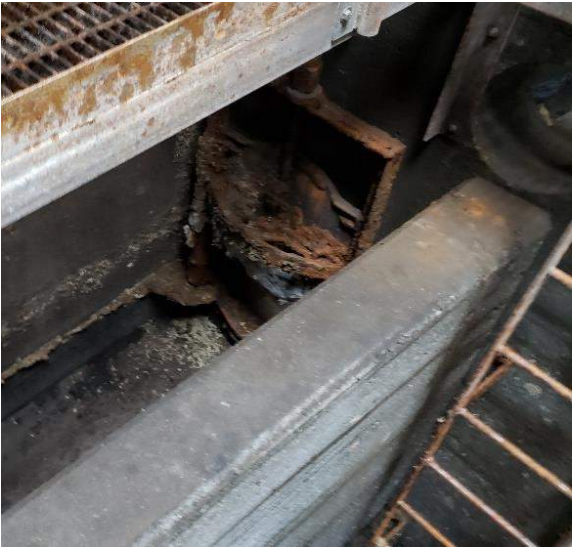
Item	Condition Rating	Repair Category	Condition Description	Recommended Repairs	Photo
Sluice gate (Trough separation)	5	4	Significant corrosion/buildup noted on gate and frame. Gate operation was not tested	Remove and replace gate, frame and mounting hardware

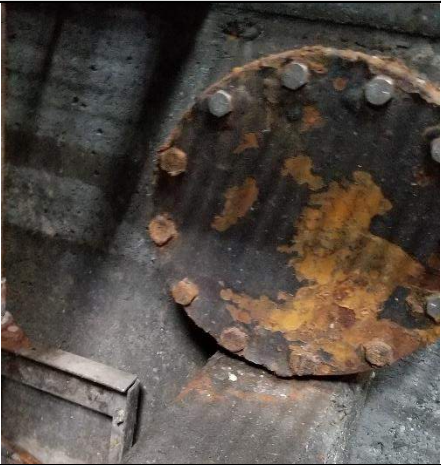
Miscellaneous Piping and Wall Penetrations					
Overflow Piping Connections	3	3	The overflow piping was not tested as part of the assessment but the piping is assumed to be in similar condition to the other wall piping penetrations. Surface corrosion was noted on the flange, piping and bolts.	Remove surface corrosion, check pipe wall thickness and re-coat with suitable coating. Or Replace piping, flange and bolts with stainless steel.

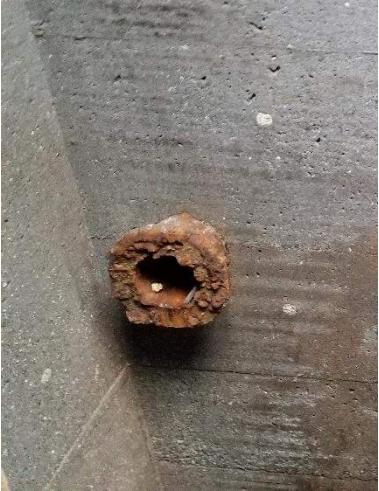
Item	Condition Rating	Repair Category	Condition Description	Recommended Repairs	Photo
Pipe wall penetration: 200 mm dia. blow down	5	4	Heavy corrosion noted, resulting in surface deformation. PVC drop pipe and bend have been removed.	Complete replacement of wall spool recommended with stainless steel. Remove piping through wall if not used by the City

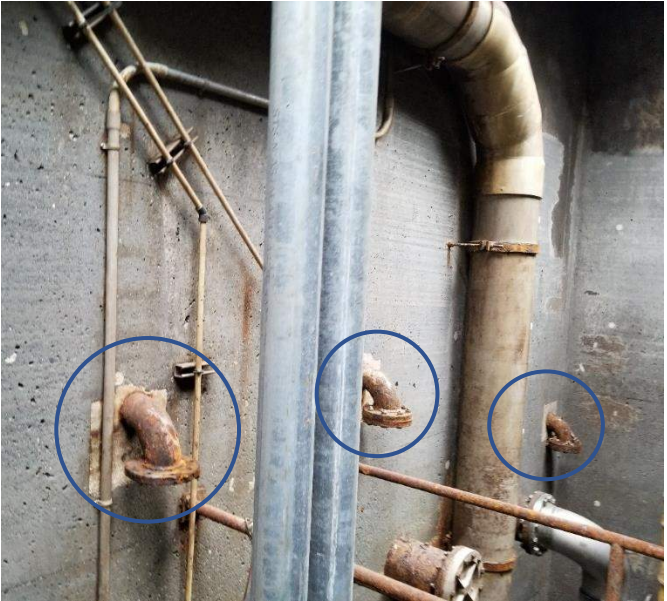
100 mm diameter flush piping	3	3	Surface corrosion on all piping, PVC drop pipes have been removed, blind flanges installed on 2 of 3 pipes.	Replace piping through walls with stainless steel or remove surface corrosion and re-coat piping. Remove piping through walls if not used by City.

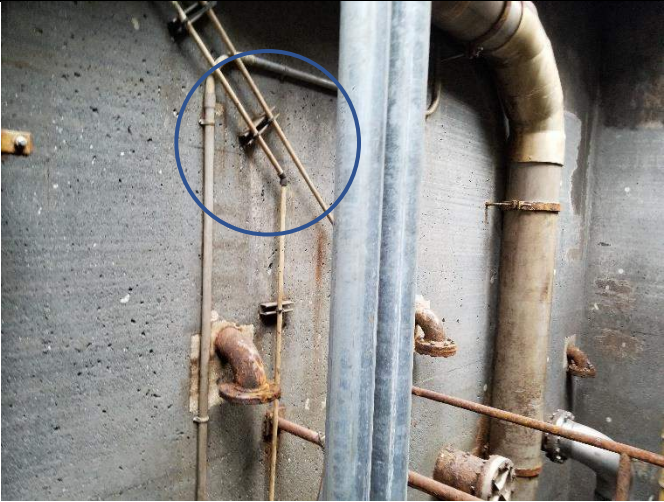
Item	Condition Rating	Repair Category	Condition Description	Recommended Repairs	Photo
25 mm PVC bubbler piping	3	4	Pipe and supports appear to be in fair condition	Remove piping system if not used by the City

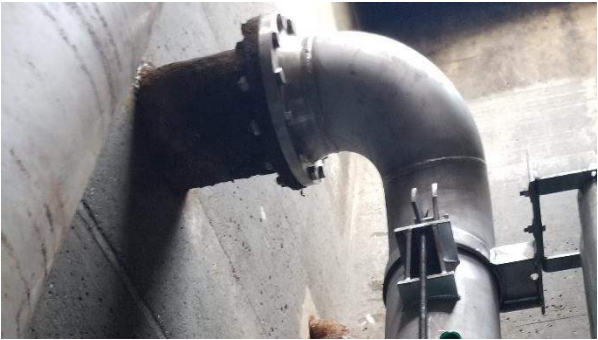
Item	Condition Rating	Repair Category	Condition Description	Recommended Repairs	Photo
Pump Discharge piping wall penetrations	4	4	Surface corrosion on all piping; existing flange face (pump #2) in poor condition but currently maintains seal	Replace wall piping with stainless steel or remove surface corrosion and test wall thickness to confirm suitability for service. Re-coat piping with suitable coating.

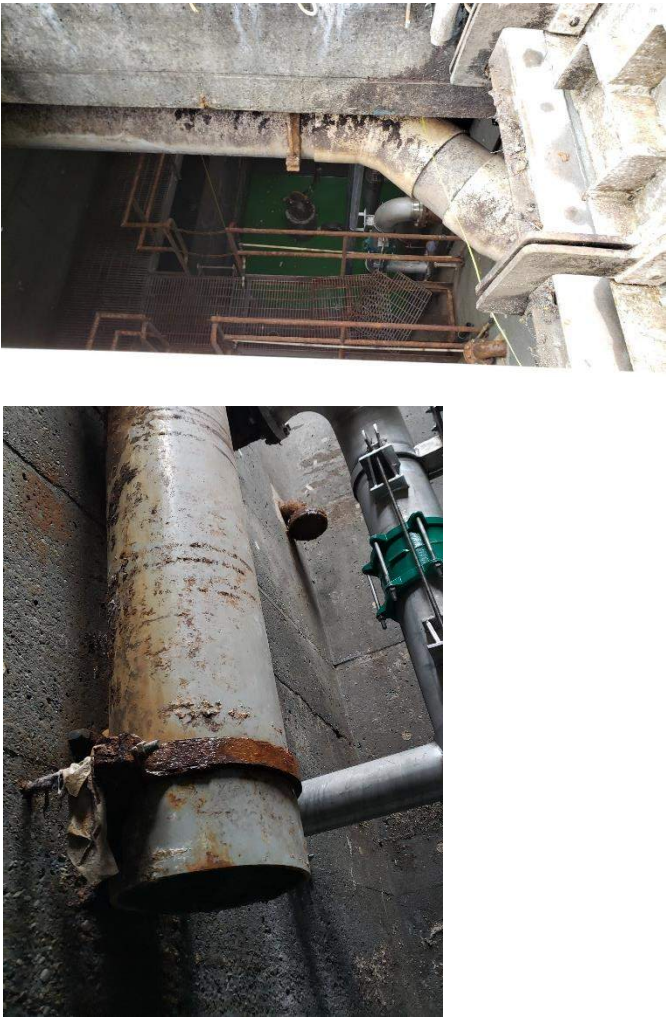
Ventilation					
Foul air ducting	3	2	Fair condition, no deformation or deterioration noted. Surface discoloration from support corrosion.	No significant repair or replacement required but ducting may be replaced at the same time as the supports due to low cost of replacement.

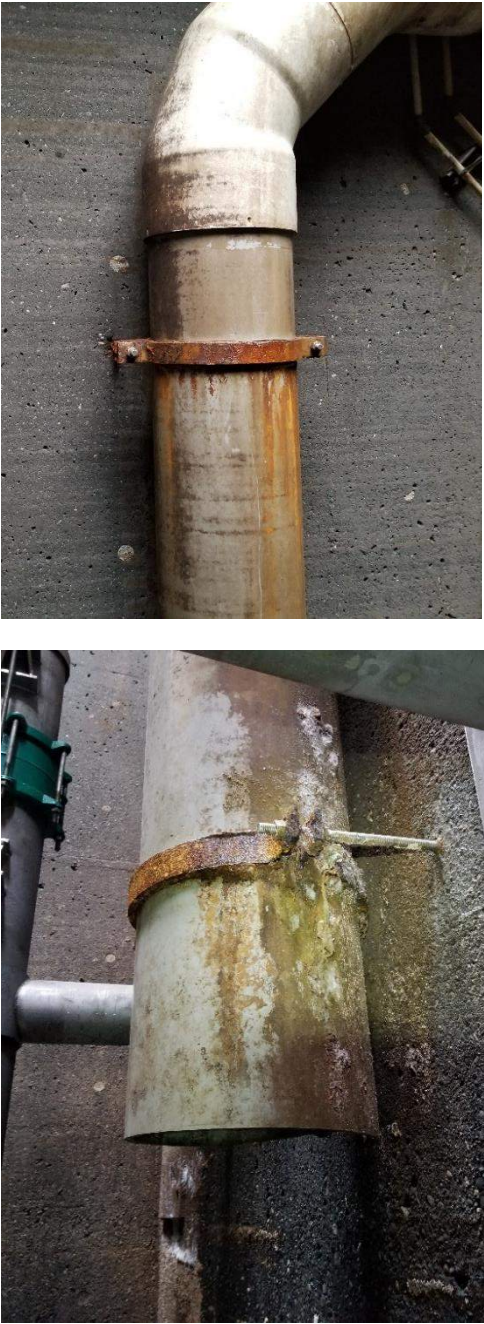
Item	Condition Rating	Repair Category	Condition Description	Recommended Repairs	Photo
Duct supports and hangers	5	4	Heavy corrosion of brackets and anchors noted. Deterioration of concrete at anchors noted in several locations.	Replacement of all anchor rods and support brackets recommended with stainless steel.

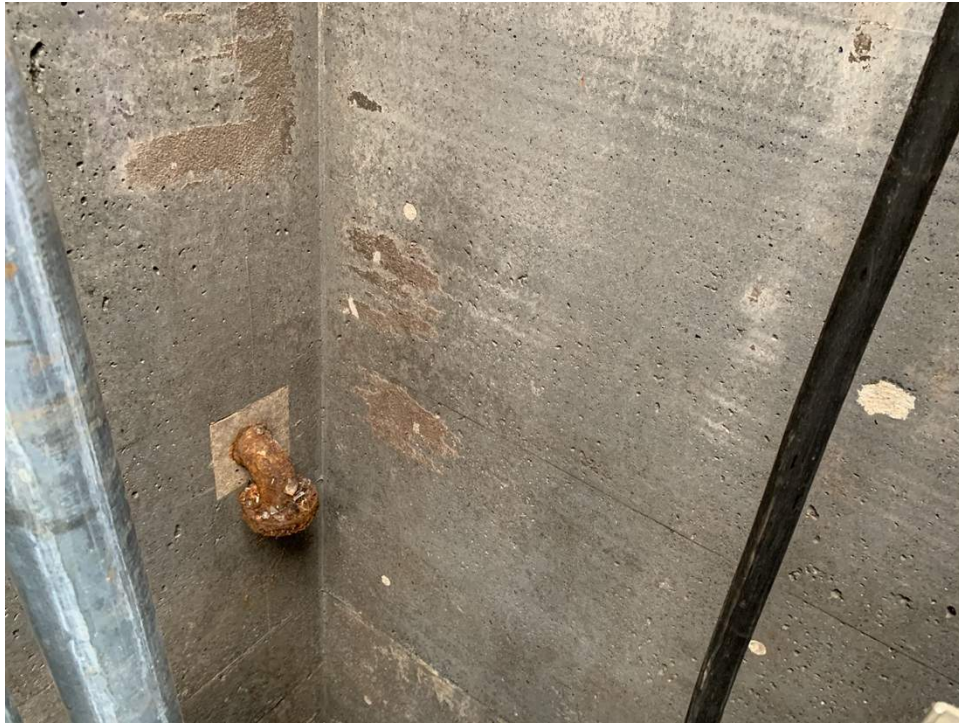
For the upper 2/3rds of the wall height, above the wet well dividing wall, the inner formed concrete surface is in good condition. The wall has a smooth formed finish with minor bug holes dating from the original construction (see Photo #3).

Photo 3: Typical concrete wall condition, upper walls.

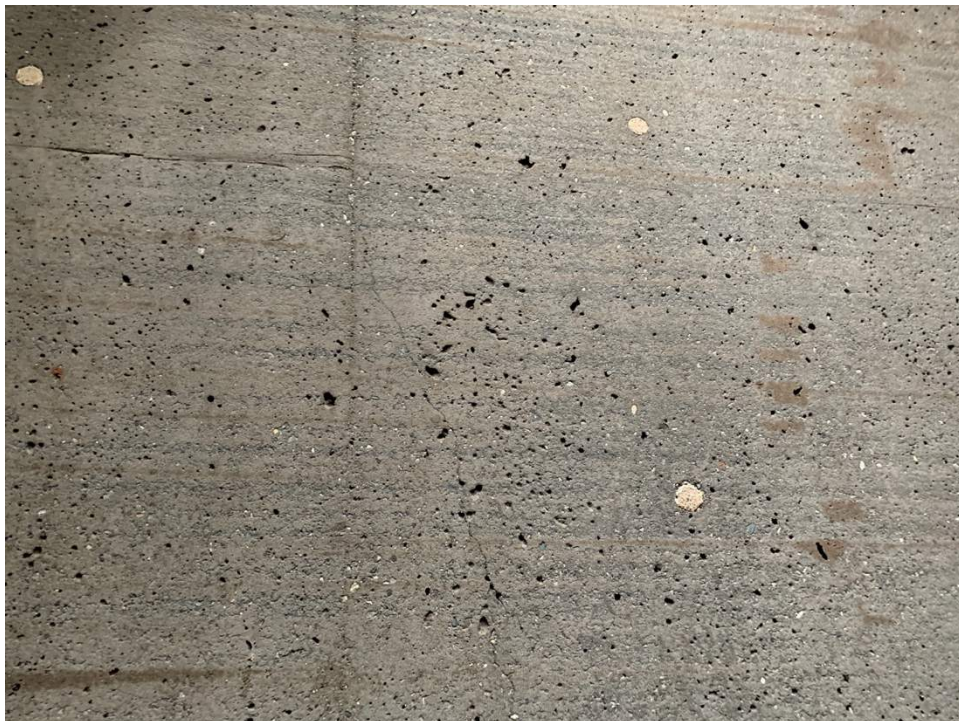
The only area of visible cracking to the concrete is on the upper half of the north wall, consisting of a vertical crack, with a width estimated at <0.5 mm (see Photo #4). There is no sign of efflorescence, water flow, rust staining or other visible deterioration to the crack or surrounding area. Based on the location and appearance, it is assessed to be a shrinkage crack and not a structural concern at this time.

Photo 4: One visible crack, west wall, upper portion.

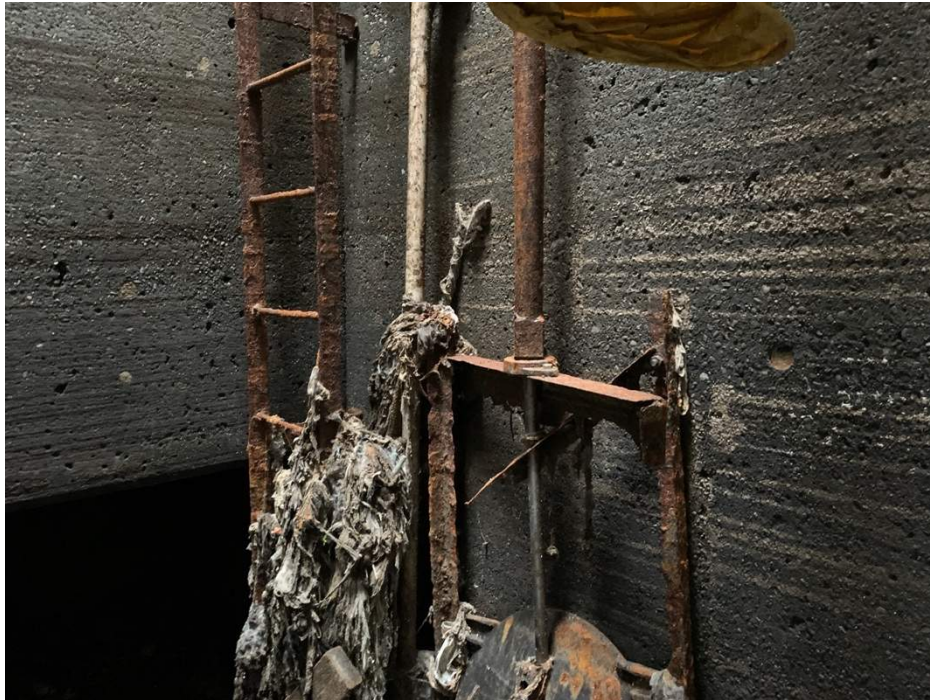
Photo 5: Concrete walls, lower wet well at dividing wall. Some erosion of concrete surface exposing aggregate.

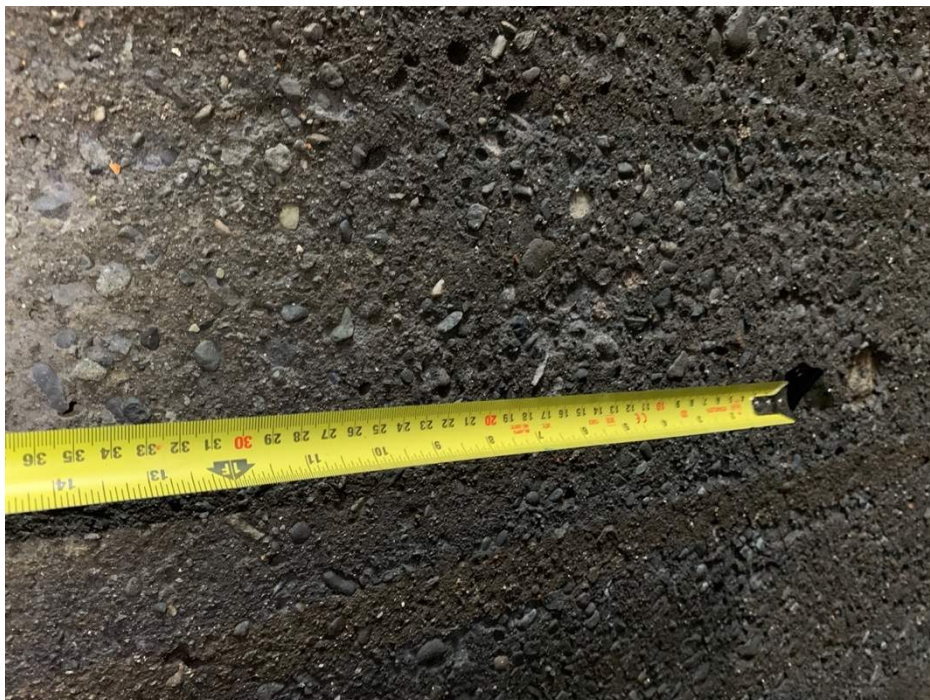
Below the wet well dividing wall, in the area close to the normal liquid level in the wet well, some areas of concrete have eroded to expose the aggregate. We estimate there is a maximum depth of erosion of around 5 mm (see Photo #6), due to exposure to effluent and/or scour. The remaining concrete appears sound, and the walls are still assessed to be in generally good condition.

Photo 6: Maximum observed erosion of concrete surface, lower walls of wet well

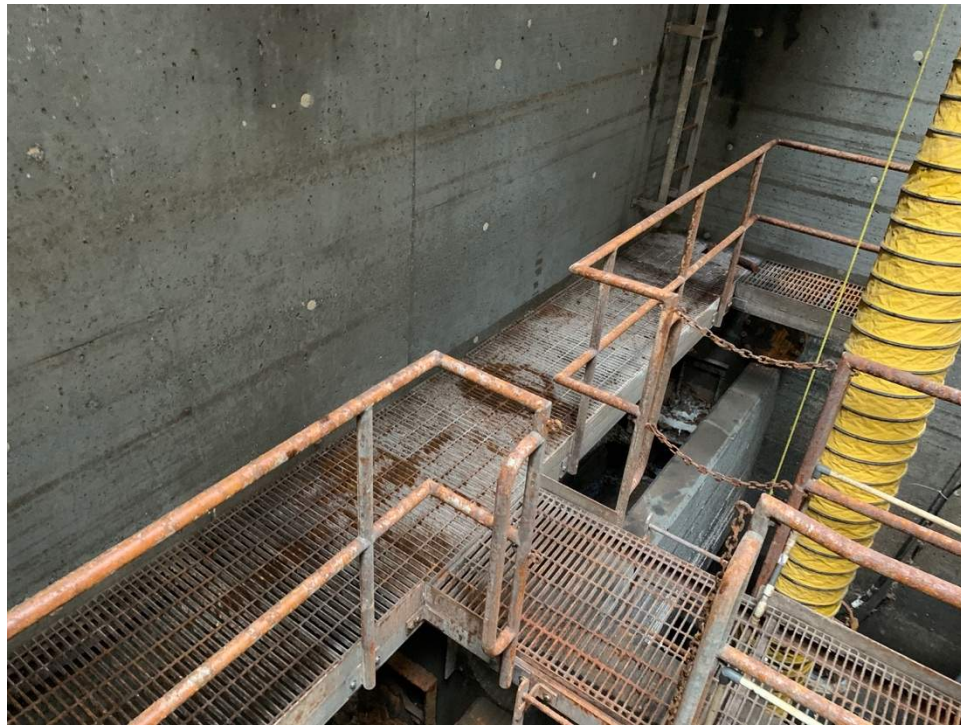
The primary steel structure (channels and angles) and bar grating for the intermediate platform and ladder from the intermediate platform to the top of the wet well appear to generally be in fair condition. There is surface corrosion and loss of galvanized coating in many areas. There does not appear to be significant section loss of the structural steel at this time. The anchor rods to the concrete are of stainless steel and appear to be free of corrosion. (see Photos #7, #8)

Photo 7: Intermediate platform. Steel in fair condition.

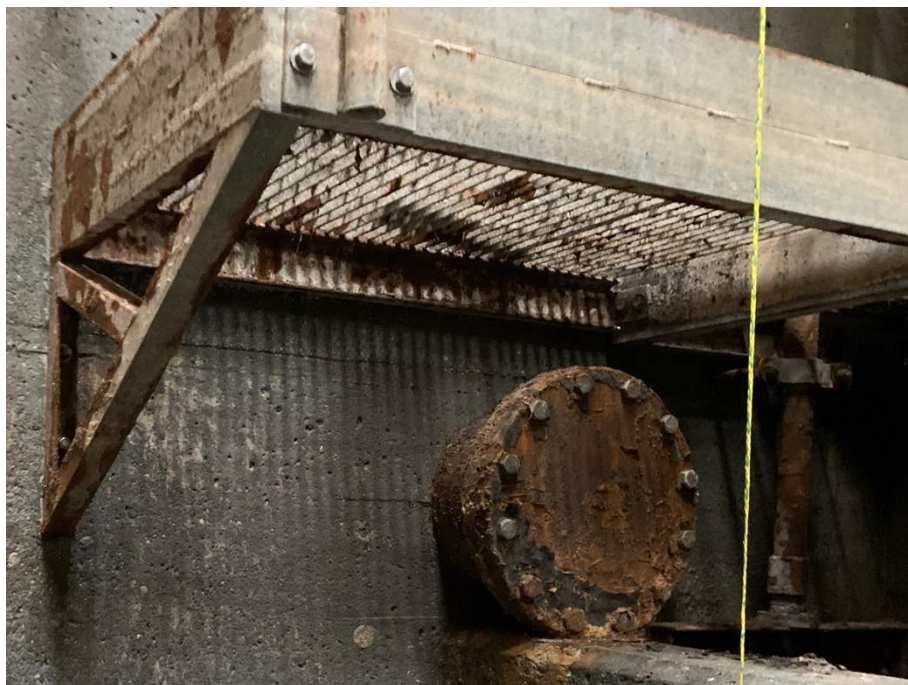
Photo 8: Intermediate platform, supporting steel in fair condition. Anchors to concrete appear stainless steel and with no visible corrosion.

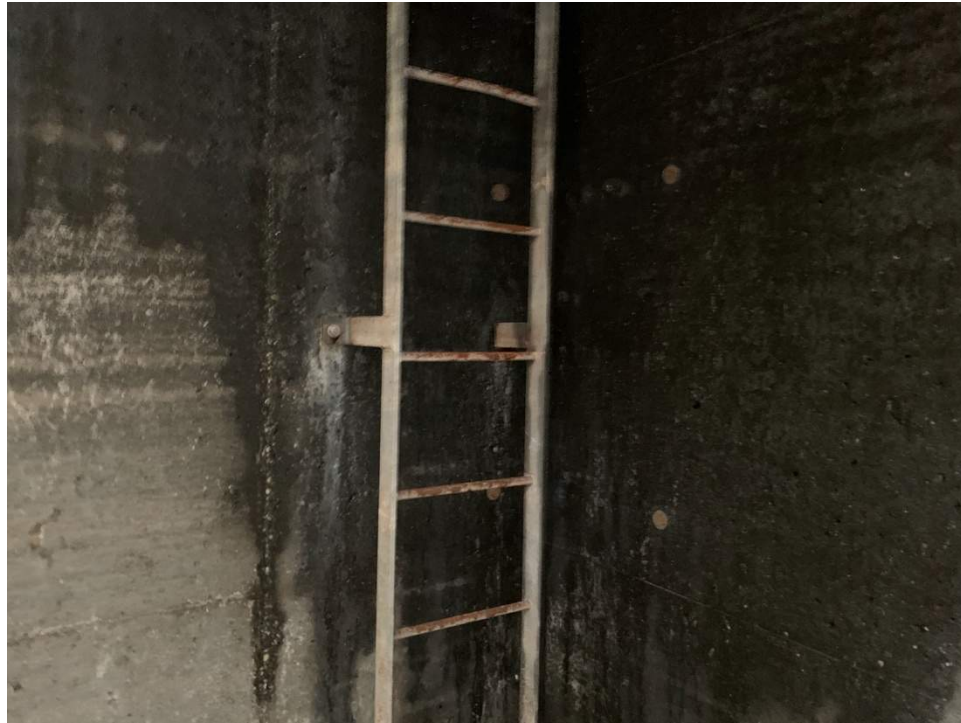
Photo 9: Upper ladder, good to fair condition, limited surface corrosion only.

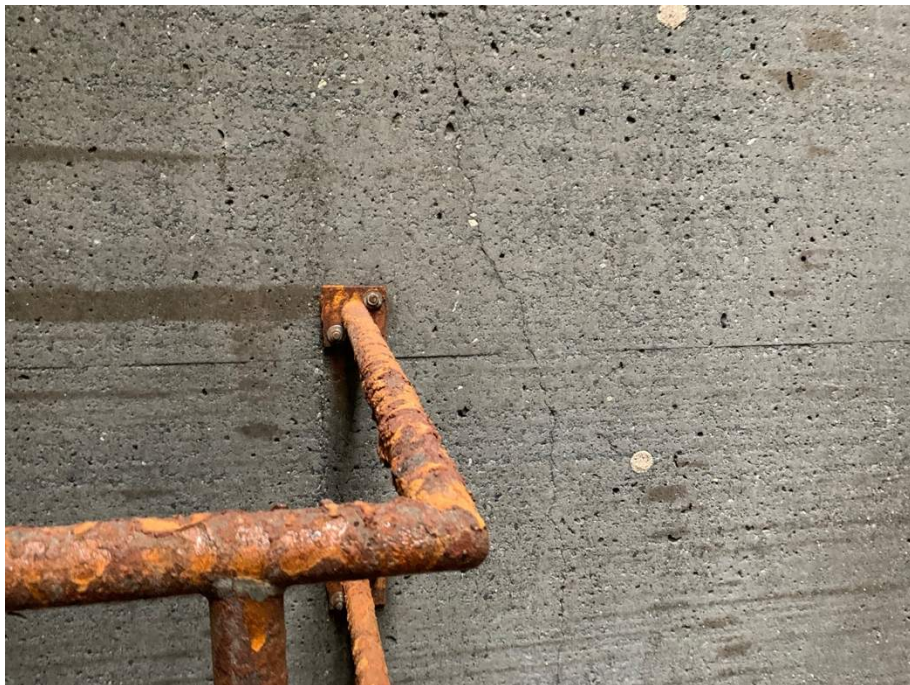
The guardrails for the intermediate platform are in fair to poor condition. They show extensive visible corrosion to some areas, particularly on the west side (see Photo #10), and likely have some section loss of structural steel to this area, although the thickness of remaining sound steel is unknown.

Photo 10: Intermediate platform, guardrail in poor condition. Significant corrosion, complete loss of coating, potential section loss.

The intermediate ladders and platforms are assessed to be overall in fair condition, with the guardrails in poor condition. Due to the poor condition of the guardrails, we recommend these platforms are not used for access unless they are rehabilitated as described below.

If the platforms are to remain in use, they should be rehabilitated by cleaning of corrosion product to sound metal, inspecting to confirm there is no significant section loss (particularly to the guardrails), and re-coated

with a suitable coating system. Alternatively, it may be more cost effective to replace with a new structure, ideally fabricated from 316 stainless steel or fiberglass to give improved durability.

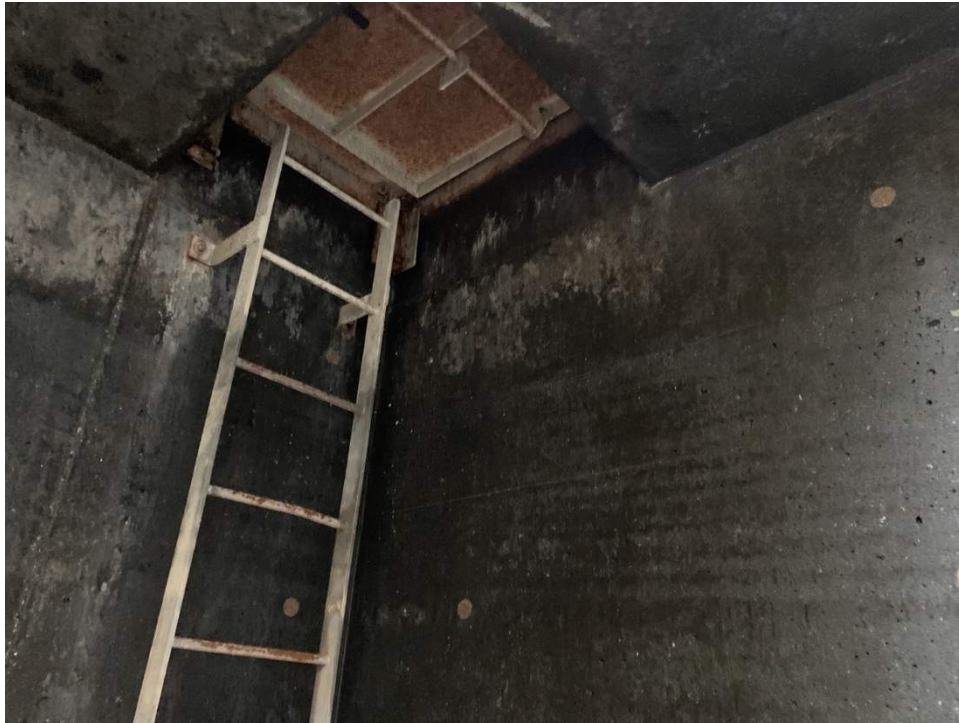
There appears to be some limited leakage around the personnel access hatches (see Photo #11), with moisture visible during the assessment and staining / efflorescence to the concrete indicating some long-term leakage. This does not appear to have caused any significant deterioration to the concrete itself at this time.

Photo 11: South-west ladder and access hatch. Appears to be some leakage around hatch.

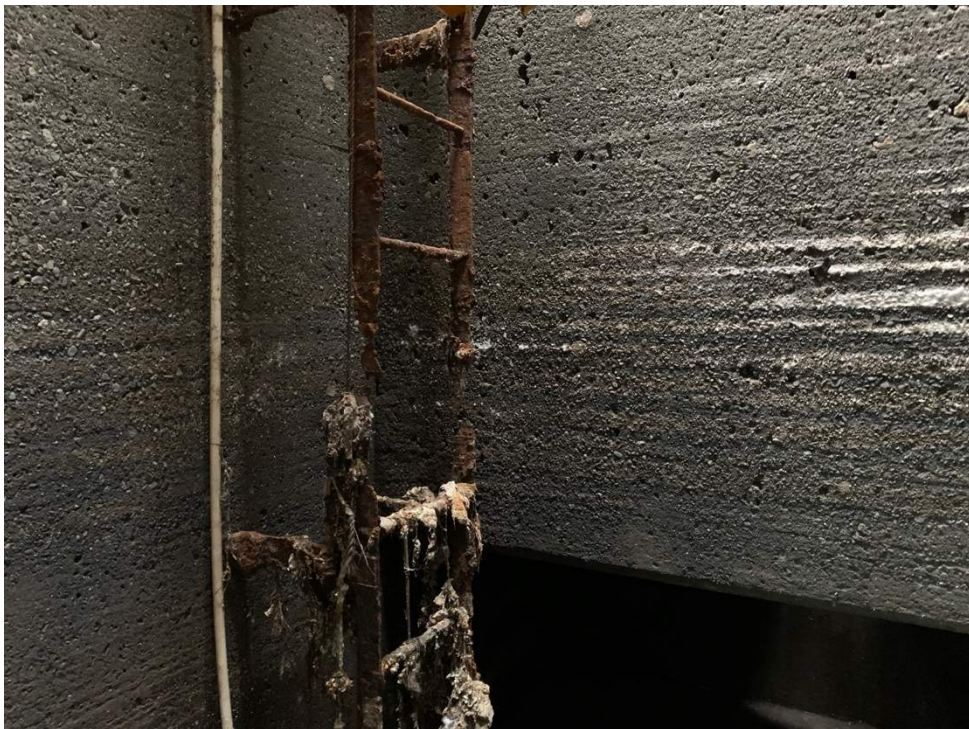
The ladders from the intermediate platform to the base of the wet well are in very poor condition. The west ladder has portions that have corroded full thickness with complete section loss (see Photo #12).

Photo 12: Lower ladder, very poor condition, complete section loss through side rail

The lower ladders to the wet well are in very poor condition and should be removed and, if required, replaced with new ladders fabricated from 316 stainless steel or fiberglass, suitable for the exposure conditions inside the wet well.
