CITY OF NORTH VANCOUVER
NORTH VANCOUVER, BC
BARGE RAMP HINGE REPAIR
GENERAL NOTES AND
REPAIR DETAILS

Drawing No. **SK01**
Project Number 2211-70466-T2001
Rev. PA

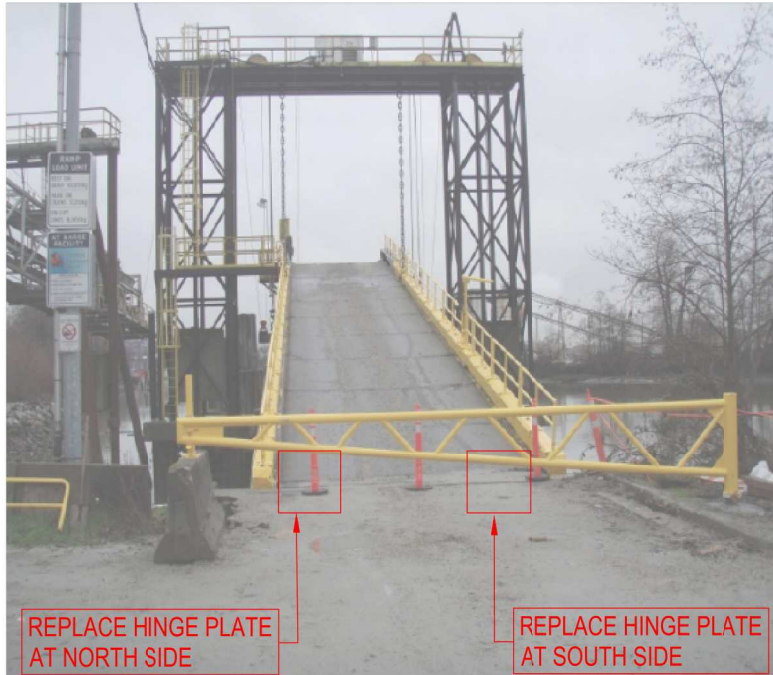
PHOTO - BARGE RAMP REPAIR LOCATIONS

REPLACE HINGE PLATE AT NORTH SIDE
REPLACE HINGE PLATE AT SOUTH SIDE
