Hazardous Materials Sampling: Granville Residence
Sampling Date: 2019/04/01; 2018/07/03
Building Code: 7904
Address: 1261 Granville Street, Vancouver BC
Surveyor(s): Jun Han Poon
Purpose: TARGETED HAZARDOUS MATERIAL SAMPLING

A City of Vancouver (COV) Hazardous Materials Technician has completed target hazardous material sampling at 1261 Granville Street in preparation for elevator upgrades.

HAZARDOUS MATERIAL SURVEY	Granville Residence	2019/05/08
---------------------------	---------------------	------------

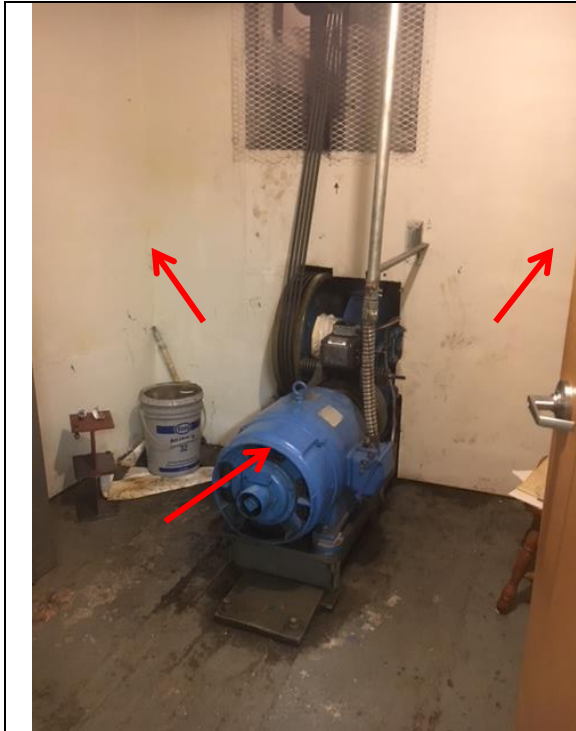
Asbestos-containing materials were identified in the drywall joint compound located in the elevator machine room and in the Storage Room located in the basement. If these areas are to be disturbed, safe work procedures must be followed in compliance with the requirements of the WorkSafeBC Occupational Health & Safety Regulation (current edition).

Paint on the metal elevator machine equipment in the elevator machine room was found to be lead containing. All other paints should be presumed to be lead-based unless determined otherwise by testing.

Photo 1: Drywall joint compound on walls in the Elevator Machine Room is asbestos containing. Blue paint on metal elevator machine equipment is lead containing.

In the event that the surfaces to which lead-based paint has been applied are to be disturbed by sanding, grinding, cutting or otherwise disturbing lead-based paint then the paint must be removed prior to these activities. The removal of lead paint must be accomplished in compliance with the requirements of the WorkSafeBC Occupational Health and Safety Regulations (current edition).

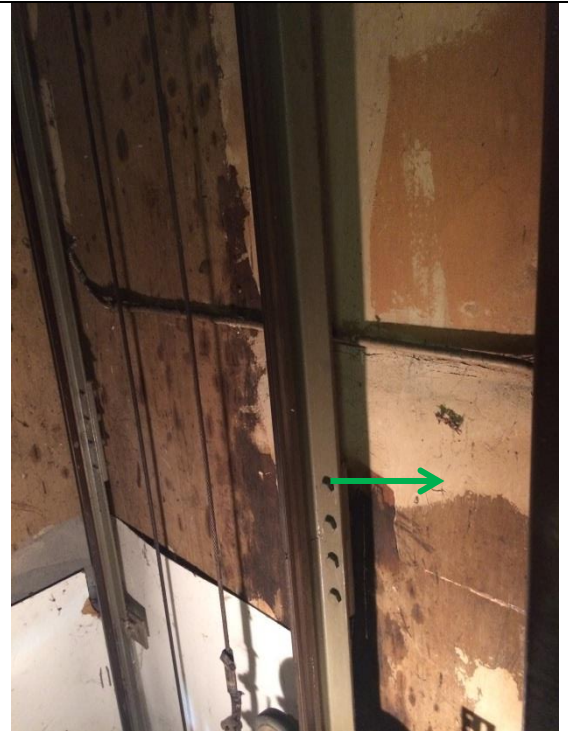
Photo 2: Unpainted Plaster walls in elevator hoist are non-asbestos.

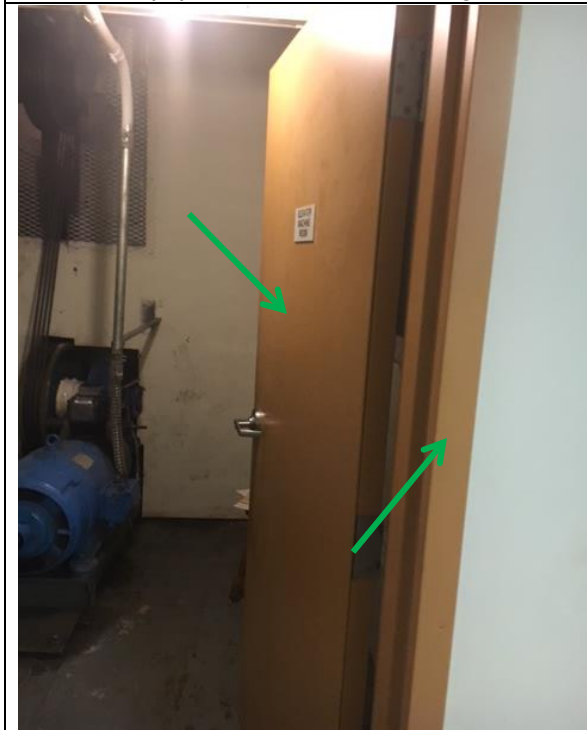
Photo 3: Orange paint on metal door and door frame is not lead containing.

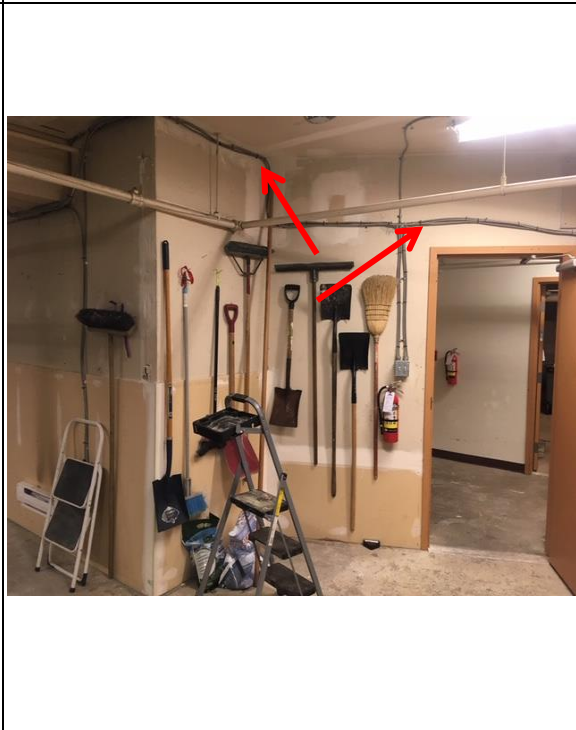
Photo 4: Drywall joint compound throughout is asbestos containing.
