**INVITATION TO TENDER NO. PS20180920
PROVISION OF CONTRACTOR SERVICES FOR WASHROOM UPGRADES
AT 3214 W 10 AVE**

ADDENDUM NO. 1

"Hazmat Investigation Report"

RJFR – St. James Community Square	RJFR180829
Final Report – Hazardous Materials Investigation	Effective: August 29, 2018

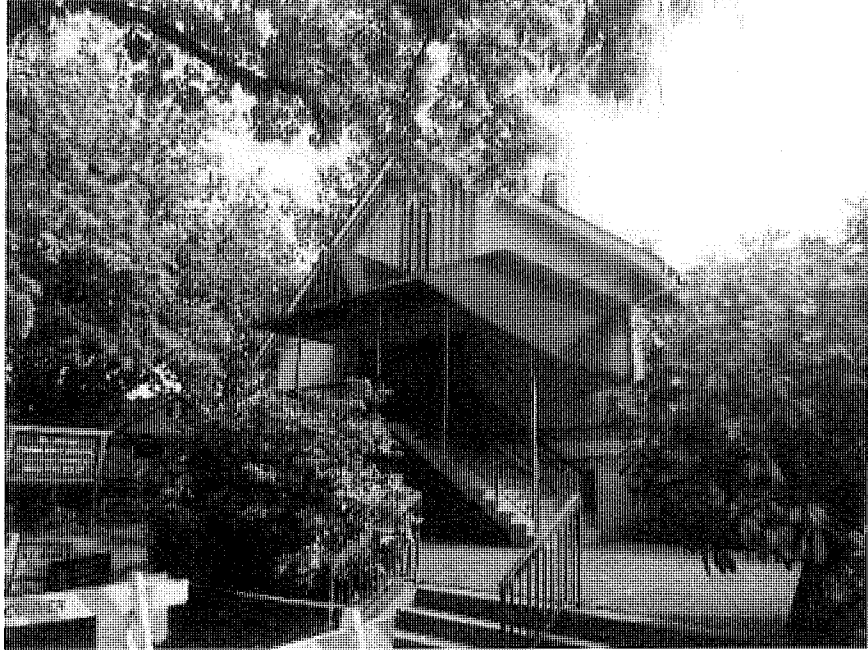
<p>General view of the exterior of the St. James Community Square.</p>
<p>Location</p> <p>Entry Hallway, Level 2</p> <p>Results</p> <p>Floor Tiles: 1-5% Chrysotile Asbestos;</p> <p>Mastic: non-asbestos</p>

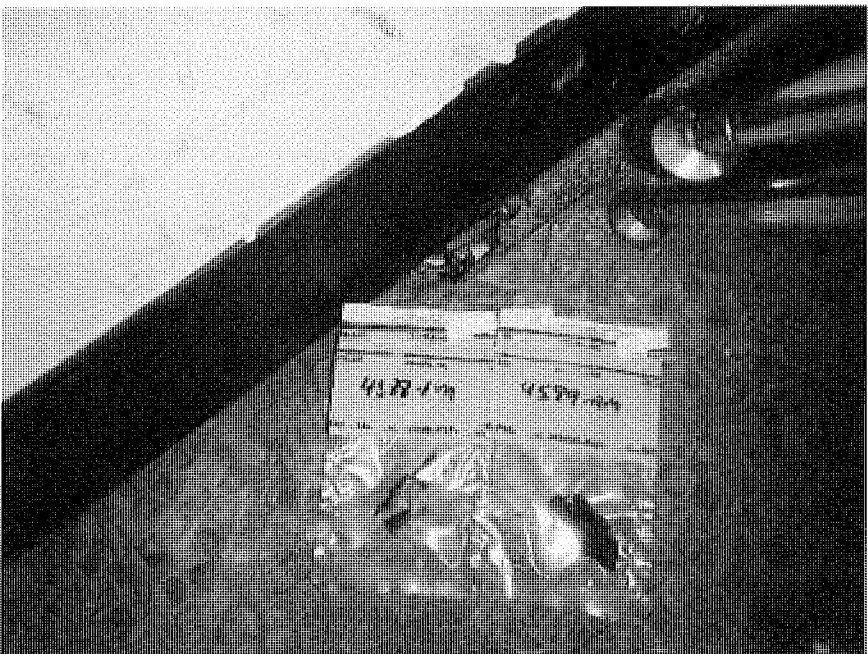
<p>Results</p> <p>Vinyl Sheet Flooring: Non- asbestos; Black felt paper: Non-asbestos</p>	
<p>View of beige vinyl sheet flooring (4588-AM) overtop black felt paper (4589-AM) concealed under new flooring.</p>

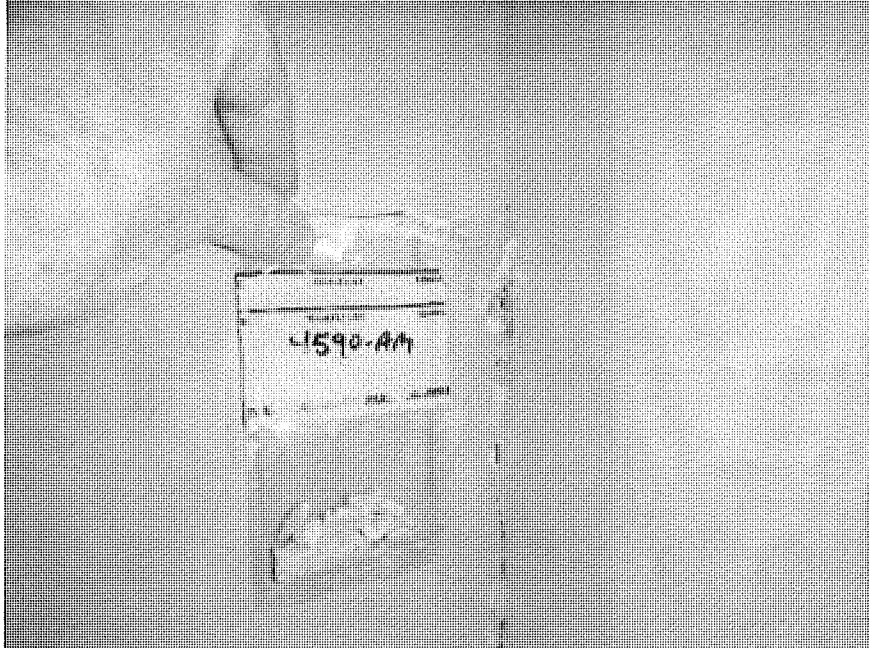
Description	Photo
Suspect Asbestos-Containing Materials	
<p>Location</p> <p>Janitor Closet, Level 2</p>

<p>Results</p> <p>Non-asbestos</p>	
View of green painted plaster on gypsum board (4590-AM).	
<p>Location</p> <p>Hallway, Level 2</p>

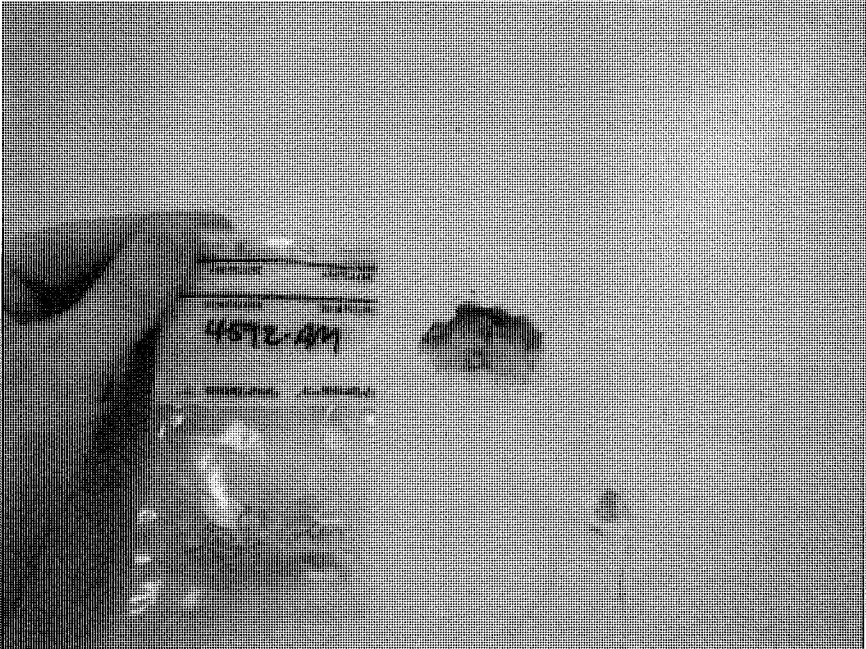
<p>Results</p> <p>Non-asbestos</p>	
<p>Mudded joint compound (4591-AM) on drywall wall with wood panel on bottom.</p>	
<p>View of beige painted plaster material (4592-AM) over gypsum wall board.</p>

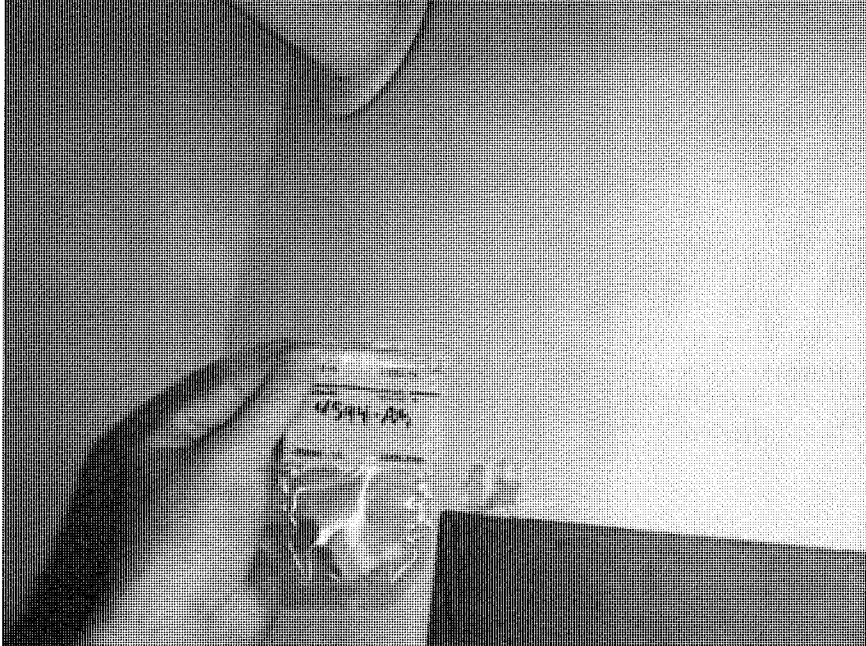
<p data-bbox="511 1060 1372 1123">View of white painted mudded drywall joint compound (4594-AM) at double door openings.</p>
Hallway, Level 1	
Results	
Non-asbestos	
Location

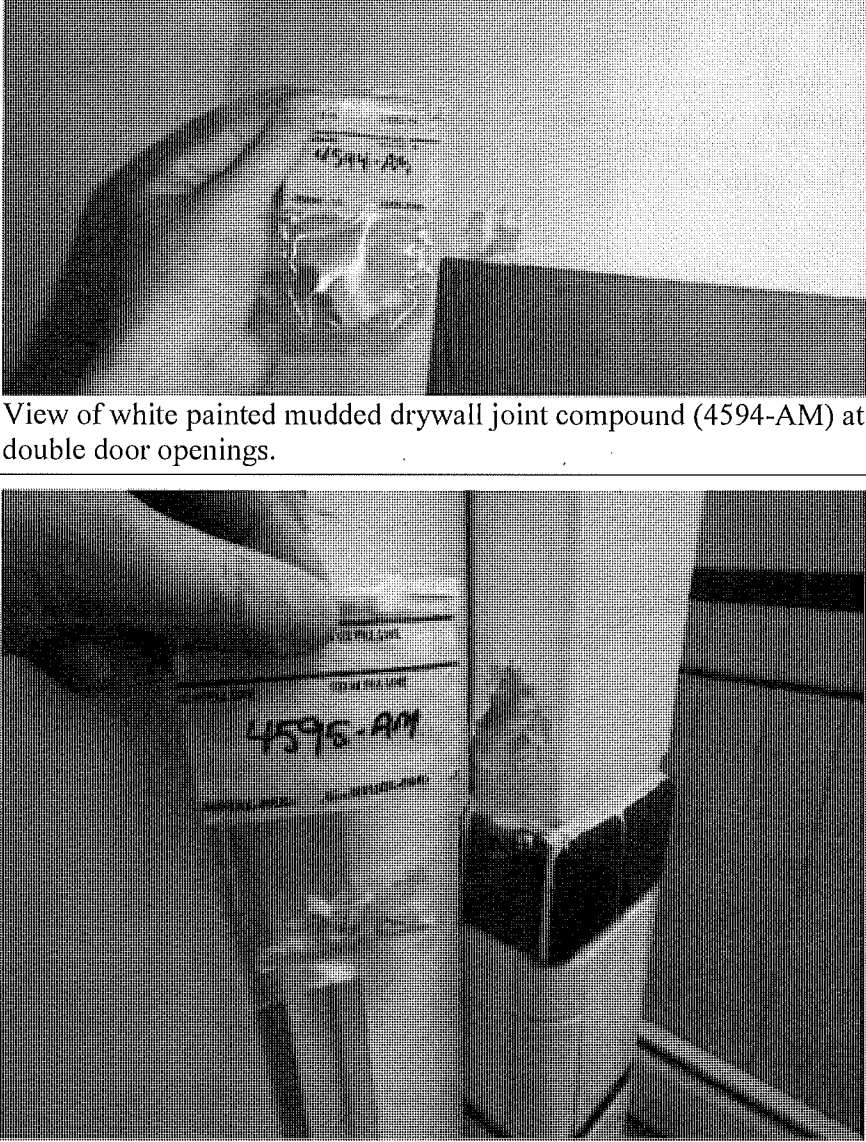
<p data-bbox="511 1806 1372 1869">View of beige painted plaster materials (4595-AM) over gypsum wall board.</p>
Women's Washroom, Level 1	
Results	
Non-asbestos

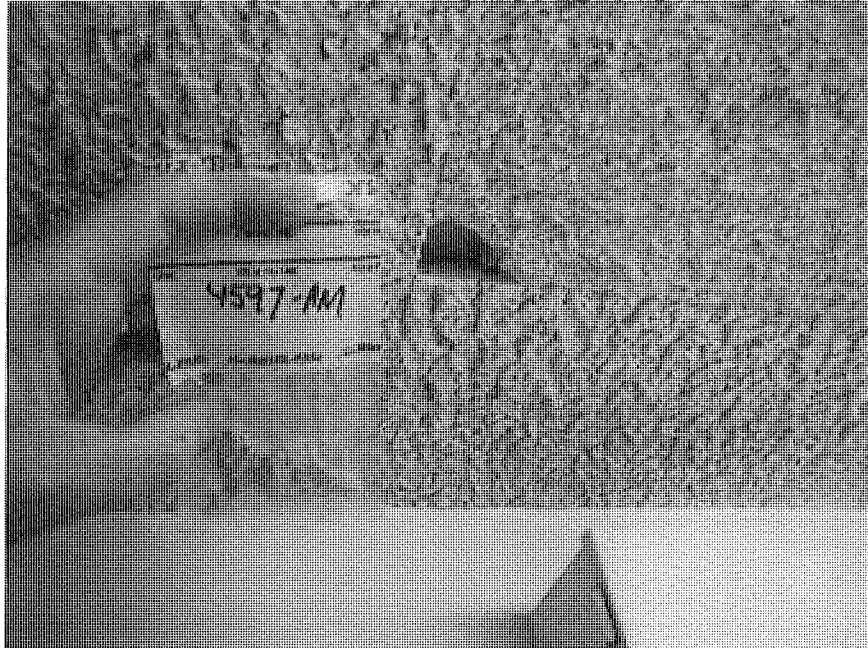
Description	Photo
Suspect Asbestos-Containing Materials	
<p>Location</p> <p>Assembly Area Hallway, Level 1</p>

<p>Results</p> <p>Non-asbestos</p>	
<p>View of 12" x 12" white rough texture ceiling tiles (4597-AM) on plaster.</p>	
<p>Location</p> <p>Assembly Area Hallway, Level 1</p>

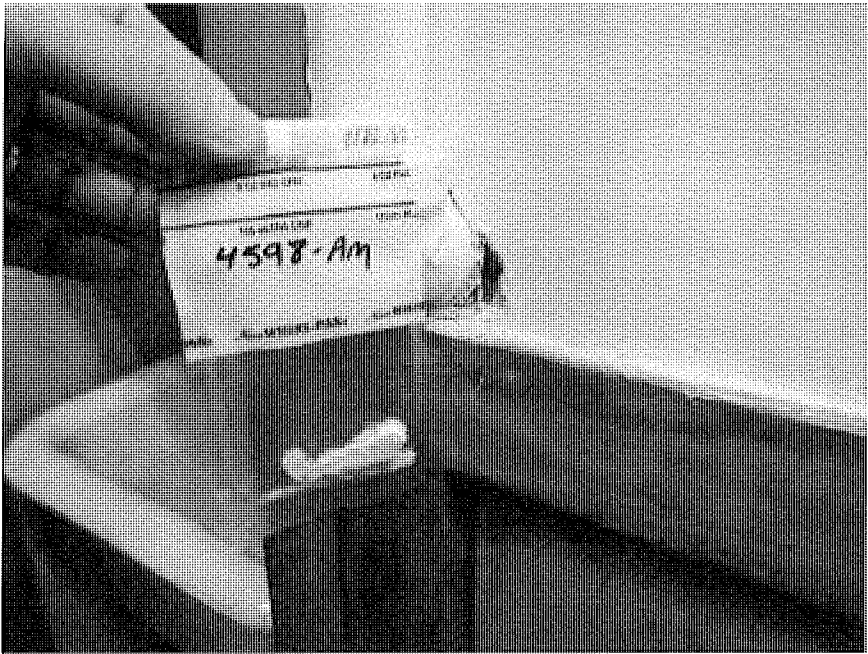
<p>Results</p> <p>Non-asbestos</p>	
<p>View of white painted plaster materials (4598-AM) over gypsum wall board.</p>

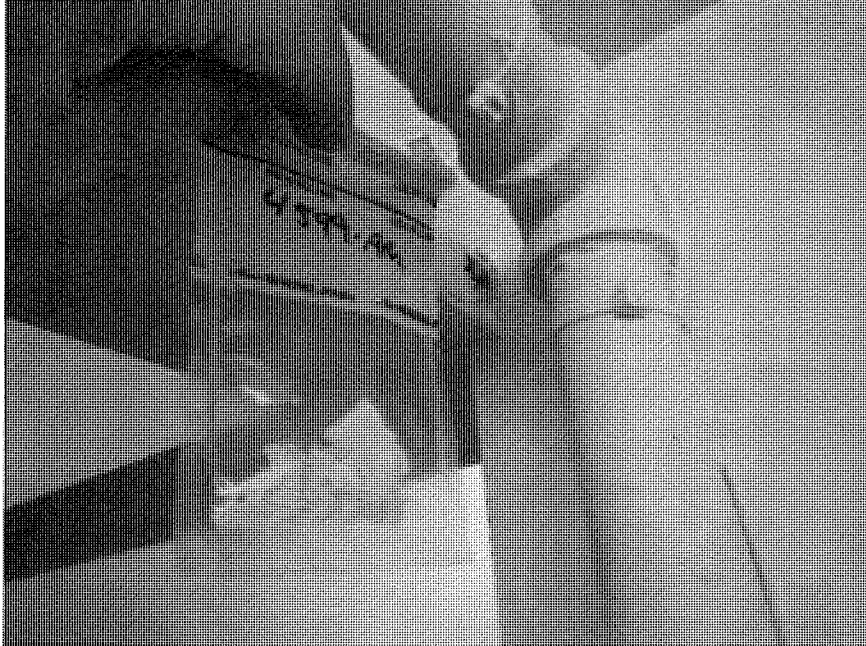
Description	Photo
Suspect Asbestos-Containing Materials	
<p>Location</p> <p>Assembly Area Hallway, Level 1</p>

<p>Results</p> <p>Non-asbestos</p>	
<p>Location</p> <p>Assembly Area Washroom, Level 1</p>

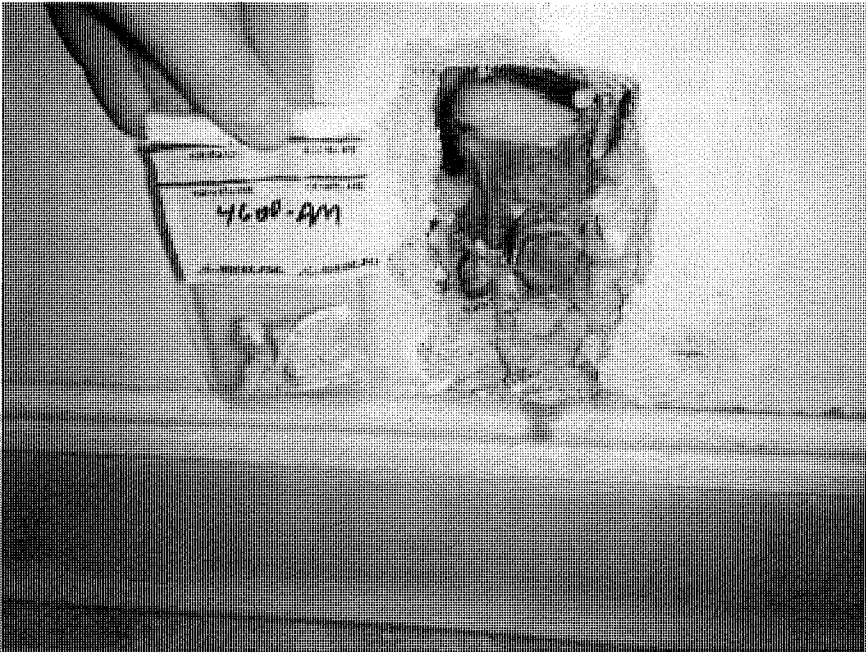
<p>Results</p> <p>Non-asbestos</p>	
<p>View of grey painted plaster materials (4600-AM) over gypsum wall board.</p>

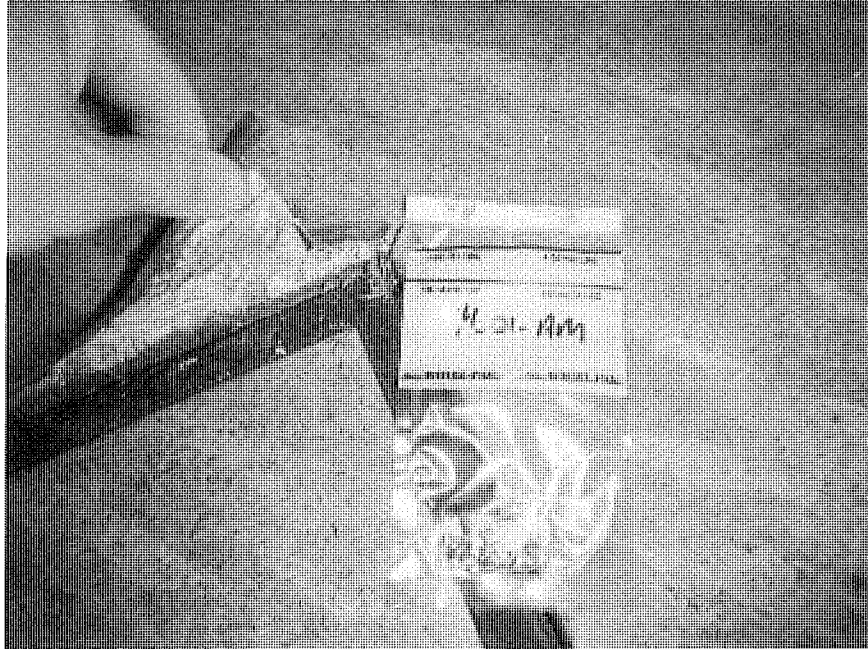
Assembly Area Washroom, Level 1	
Results	
Non-asbestos	View of white residual level compound (4601-AM) under vinyl sheet flooring.

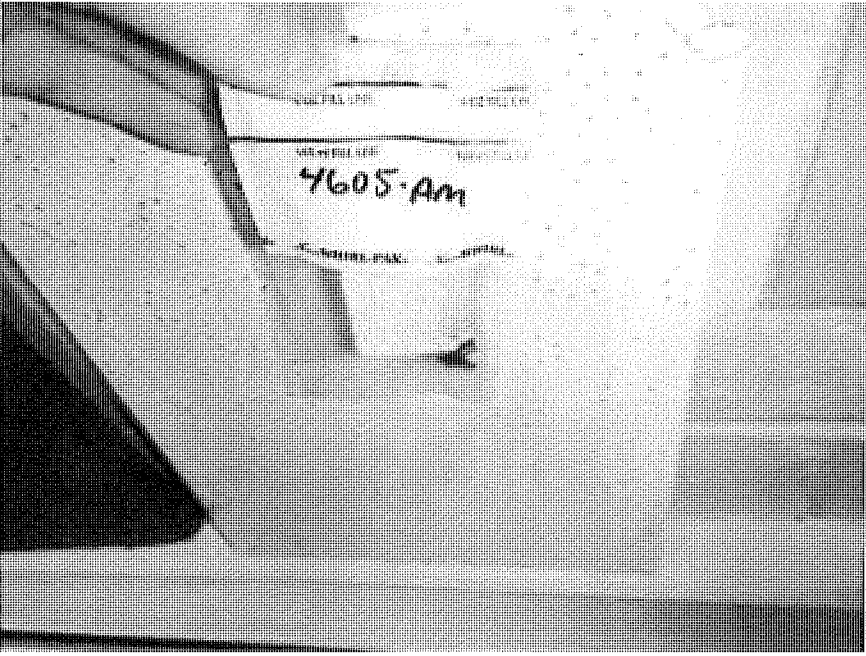
<p data-bbox="511 1795 1372 1858">View of 12" x 12" pin-hole ceiling tiles with dark brown adhesive pucks (4605-AM).</p>
<p>Results</p> <p>Non-asbestos.</p>

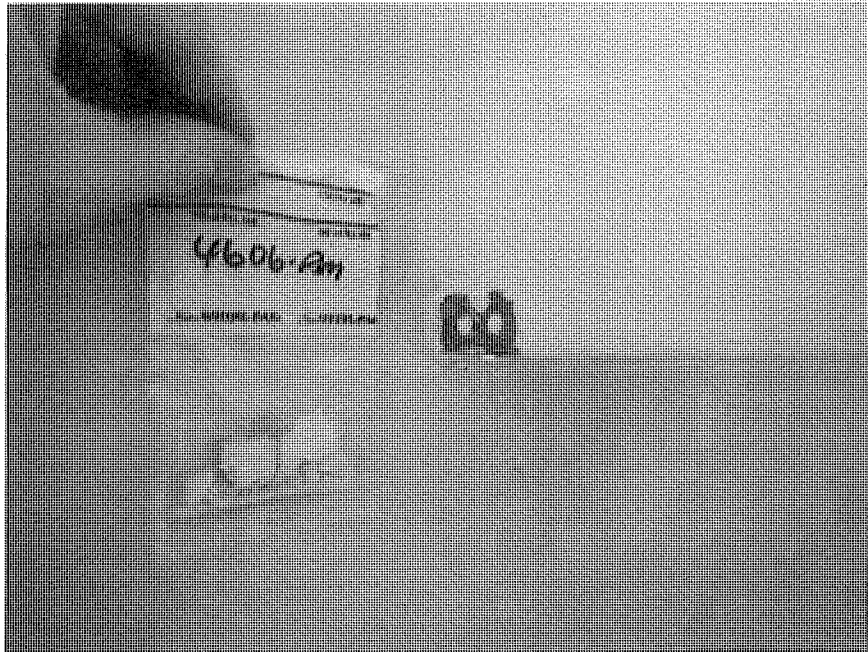
Daycare Area, Level 1	
Results	<p>View of beige painted mudded drywall joint compound (4606-AM) on bulkhead.</p>
Non-asbestos	
Location

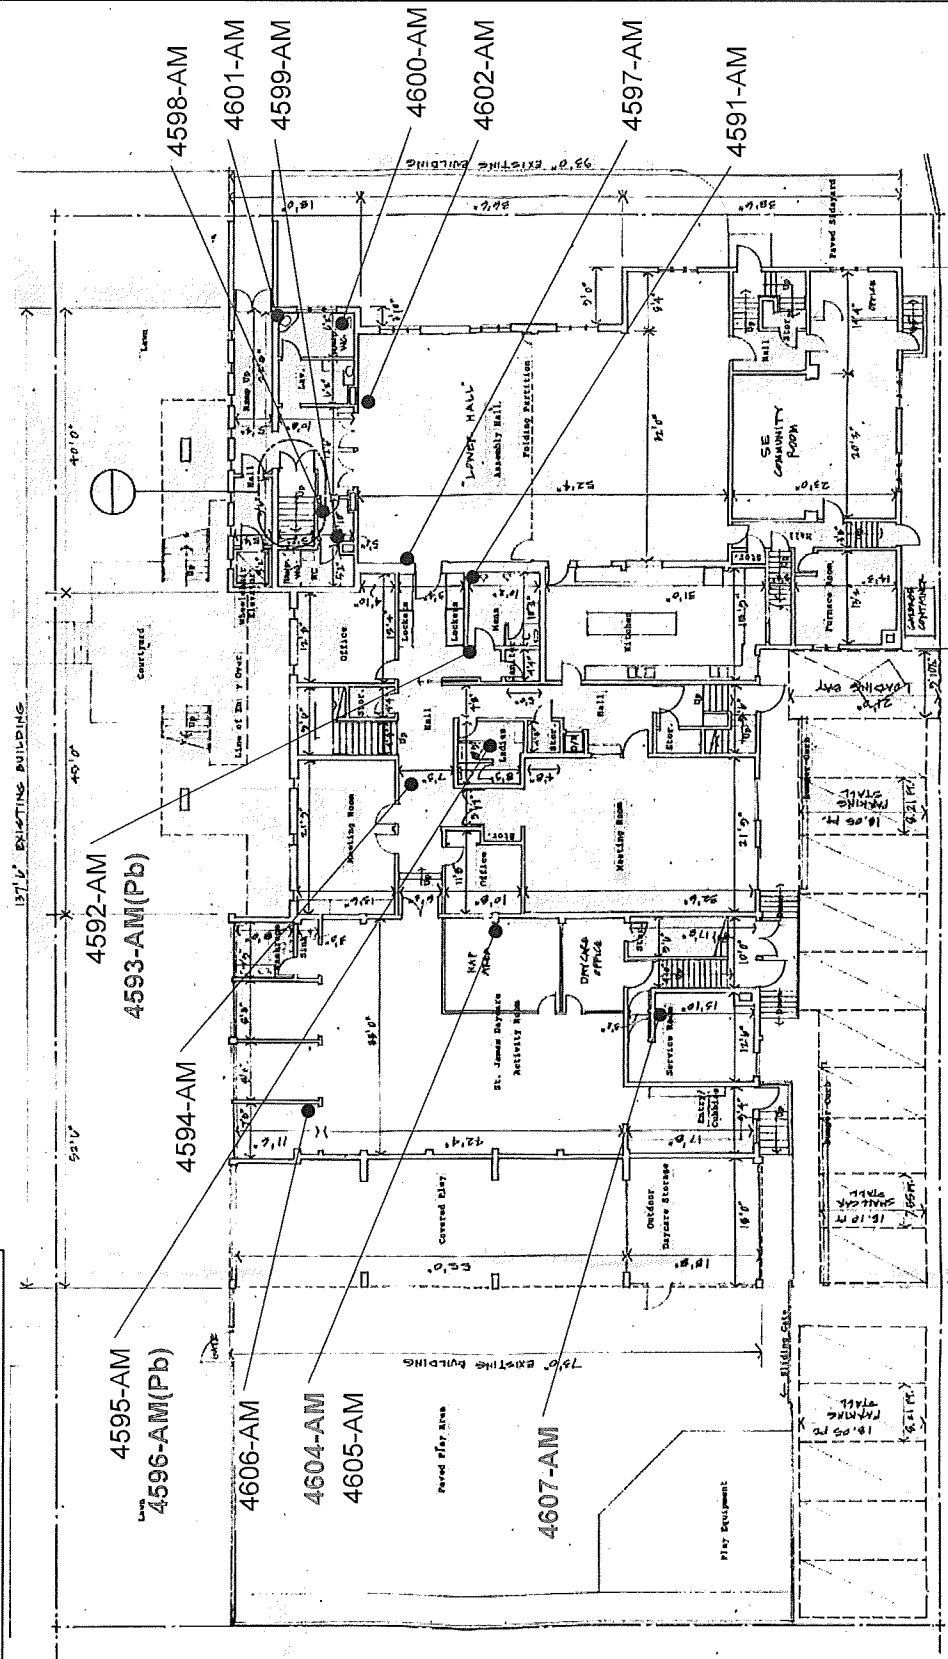
Date: August 23, 2018
 Figure: 1.0
 (Drawing not to scale)

St James Community Square
 3214 West 10th Avenue, Vancouver, BC
 Level 1
 Bulk Sampling Location

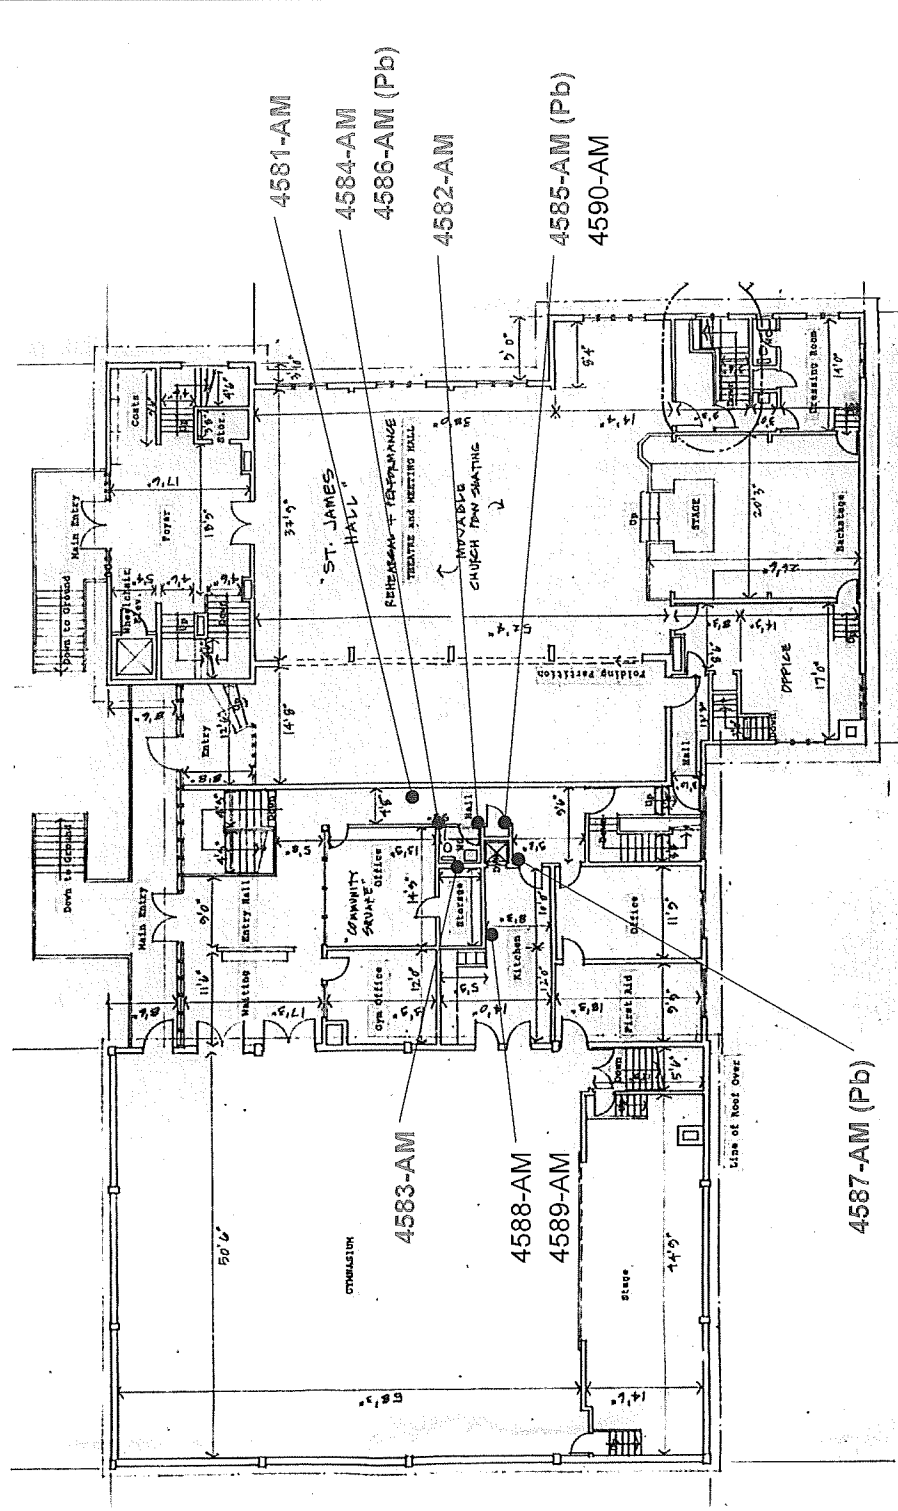
Date: August 23, 2018
 Figure: 1.1
 (Drawing not to scale)

St James Community Square
 3214 West 10th Avenue, Vancouver, BC
 Level 2
 Bulk Sampling Location
