City of Vancouver Burrard Sewage Pump Station Condition Assessment

19 Jan 2018
Rev. 0

WATER STREET ENGINEERING LTD.

TITLE	Condition Assessment		
PROJECT	City of Vancouver Burrard Sewage Pump Station		
AUTHOR	Allan Bronsro, MCIP, PEng		
DISTRIBUTION			
DATE	19 Jan 2018	FILE REF	Client PO #4500576473 WSE File #087.300
VERSION	Rev. 0	STATUS	Final
DISTRIBUTION	Wally Konowalchuk, PEng, City of Vancouver

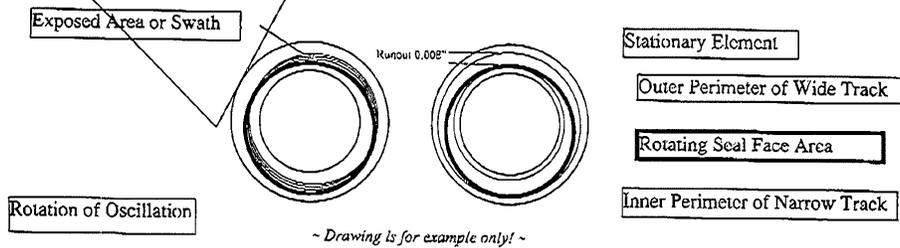
The windings were surge tested and did not indicate any electrical deficiencies

The rotating motor assembly on this second unit was also found to have a bent shaft. The shaft runout at the impeller fit was 0.014"; the factory maximum seal runout tolerance is 0.002". Further inspection of the rotor shaft confirmed a runout of 0.008" at the seal area. This can cause premature seal failure because it allows the one side of the rotating seal face to make a wider track or swath that will then swipe across the narrow track taken by the opposite side. On the stationary element debris can collect on the exposed area of the swath left by the narrow track. Then the opposite side with the wider track will come around and clear the debris from the exposed area.
