REQUEST FOR PROPOSAL NO. PS20210991
CONSULTING SERVICES FOR THORNTON PARK PUMP STATION UPGRADES

ADDENDUM NO.1

TECHNICAL MEMORANDUM

SUBJECT	Thornton Park Pump Station Wet Well Condition Assessment		
PROJECT	City of Vancouver Thornton Park Pump Station Repairs		
TO	Thomas Mah, PEng City of Vancouver	FROM	Stuart Fretwell, PEng
DATE	28 July 2021	FILE REF	WSE File #165.300
VERSION	A	STATUS	Draft

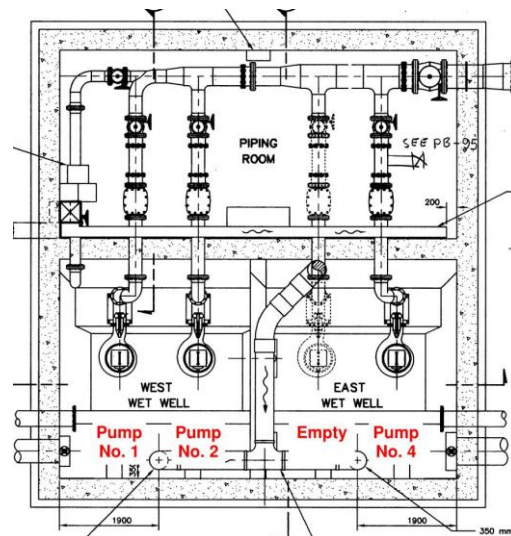
Figure 1: Thornton Park Pump Station wet well layout (record drawing)

There are currently three pumps (numbered 1, 2 and 4) installed in the wet well, which discharge to a common header in the dry well as shown in Figure 1. There is also an empty pump bay reserved for a future pump installation.

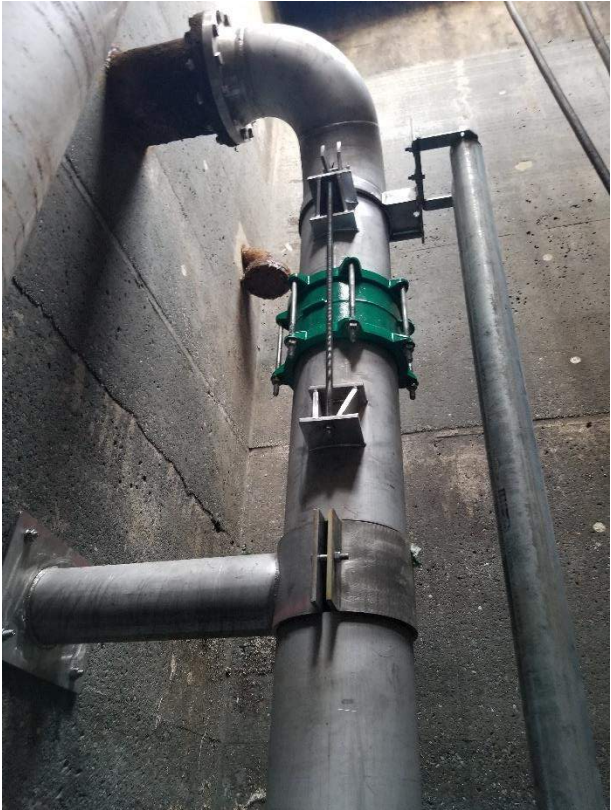
Item	Condition Rating	Repair Category	Condition Description	Recommended Repairs	Photo
Pump Discharge piping wall penetrations	4	4	Surface corrosion on all piping; existing flange face (pump #2) in poor condition but currently maintains seal	Replace wall piping with stainless steel or remove surface corrosion and test wall thickness to confirm suitability for service. Re-coat piping with suitable coating.

the future, the surface corrosion should be removed and the piping inspected and re-coated or the piping should be replaced with stainless steel.

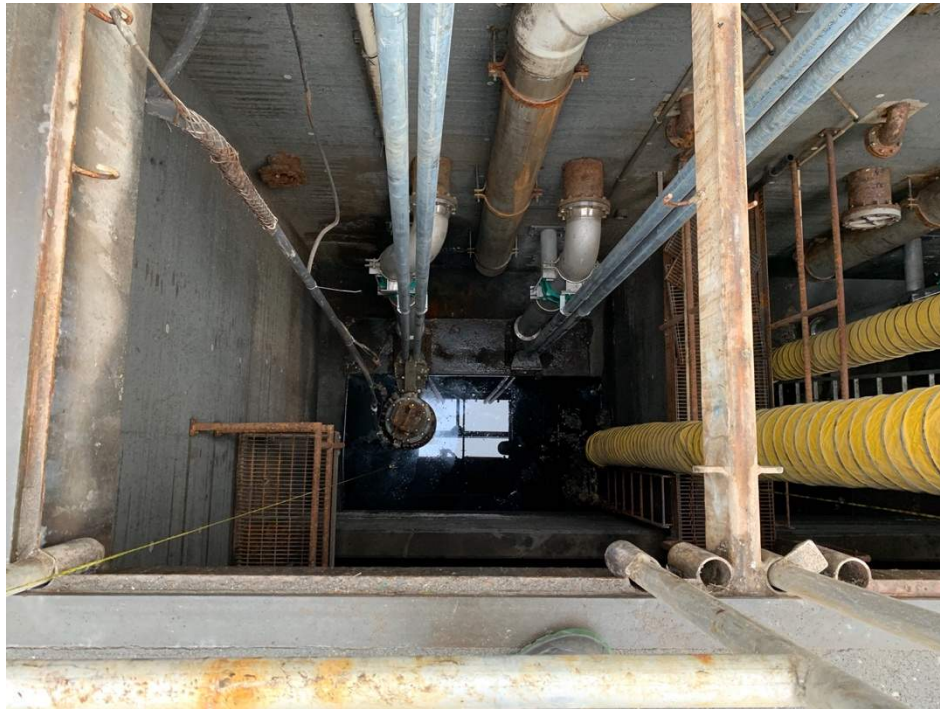
Photo 1: Wet Well (west side)

The interior faces of the concrete walls and visible portions of the base slab are in generally good condition. The lower walls (below normal operating liquid levels) have some areas with exposed aggregate. The maximum depth of erosion was assessed to be 5 mm.
